# B. C. TAP WATER ALLIANCE

## THE MOUNT POLLEY “TAILINGS STORAGE FACILITY”: Landsat 8 Satellite Imagery, 2009 - 2014

Will Koop, Coordinator, September 1, 2014

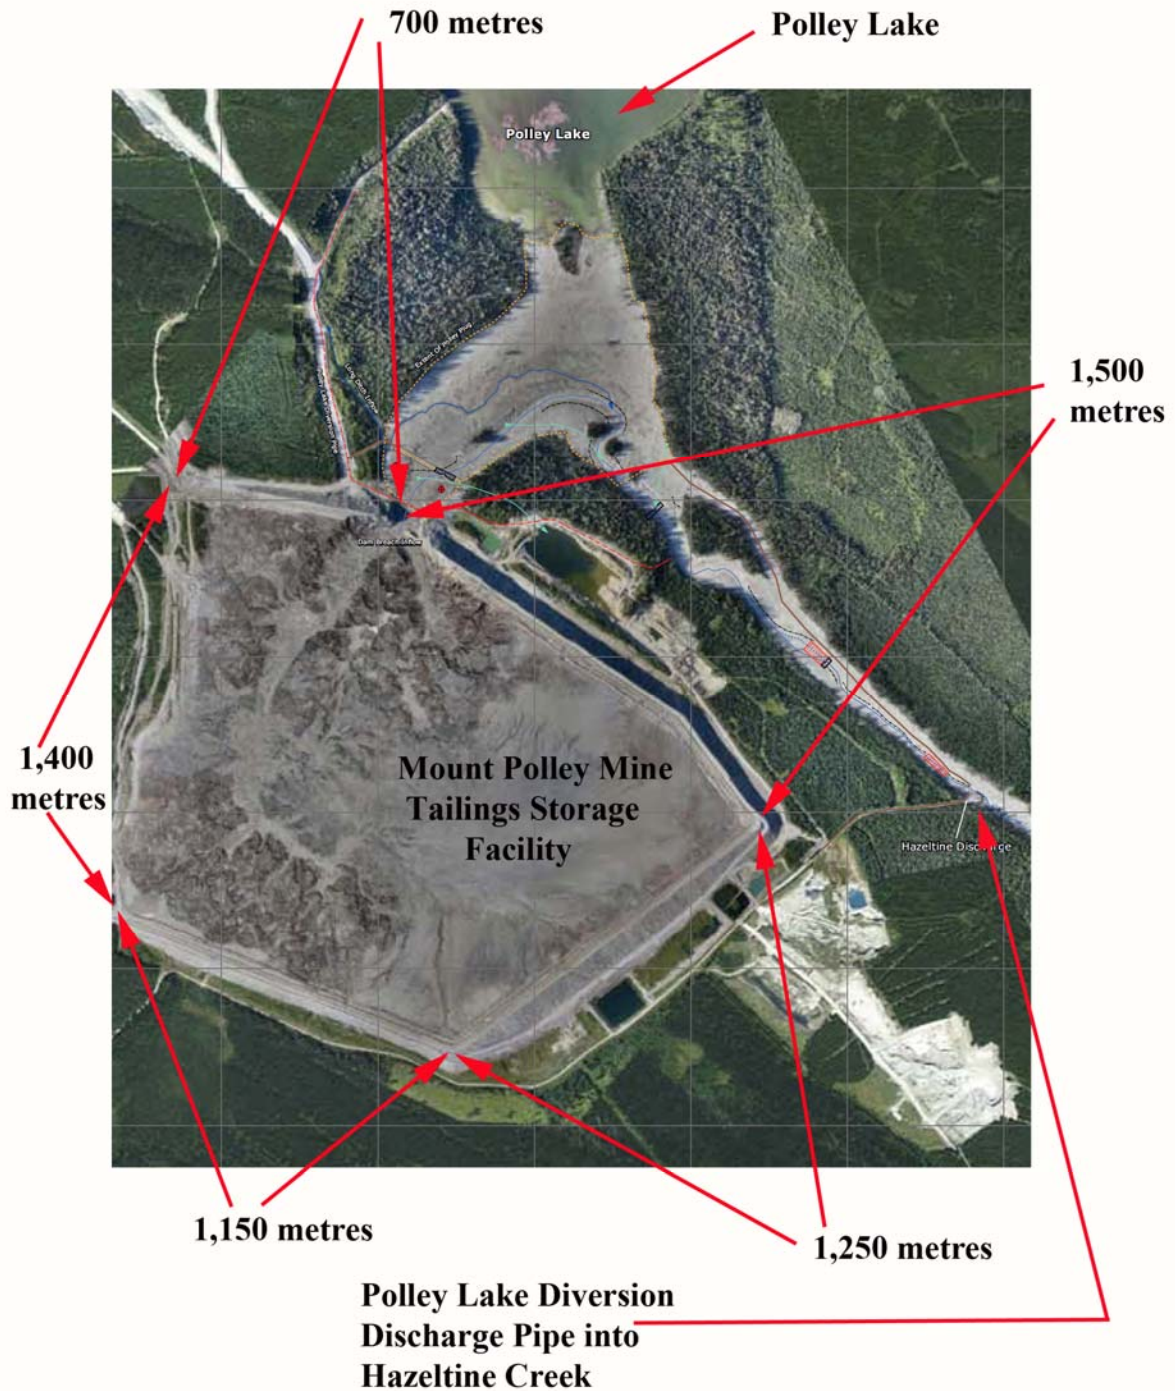
Above: Close-up of an August 2014 satellite image posted within Imperial Metals' September 1, 2014 [Mount Polley Update](#), showing the Mount Polley mine Tailings Storage Facility. The re-rendered photo shows the perimeter distance of the storage facility, totalling 6,000 metres. **This is equivalent to an area of 2.25 square kilometres, or 225 hectares.** Below, Imperial Metals website PR photo showing the discharged piped water from Polley Lake into Hazeltime Creek.

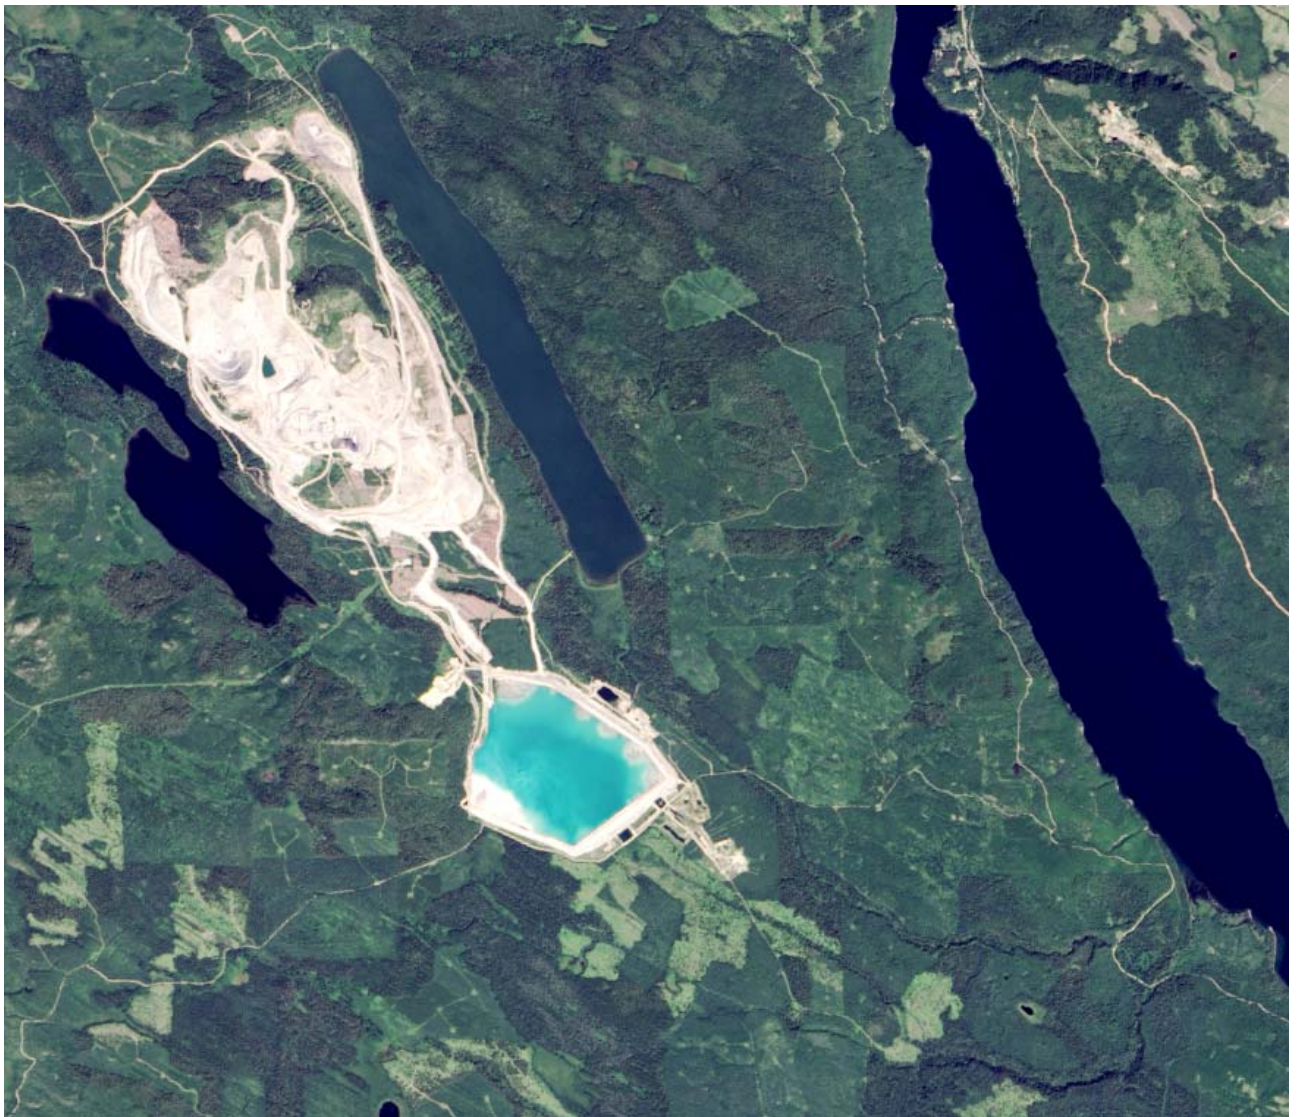
July 29, 2014

On August 17, 2014, the [NASA Earth Observatory](http://www.nasa.gov) website featured an article, [Dam Breach at Mount Polley Mine in British Columbia](#), with two comparative before (July 29) and after (August 5) higher resolution satellite images. The article included a link to the [Operational Land Manager](#) website which, in turn, includes a data link to the USGS [Landsatlook Viewer](#).

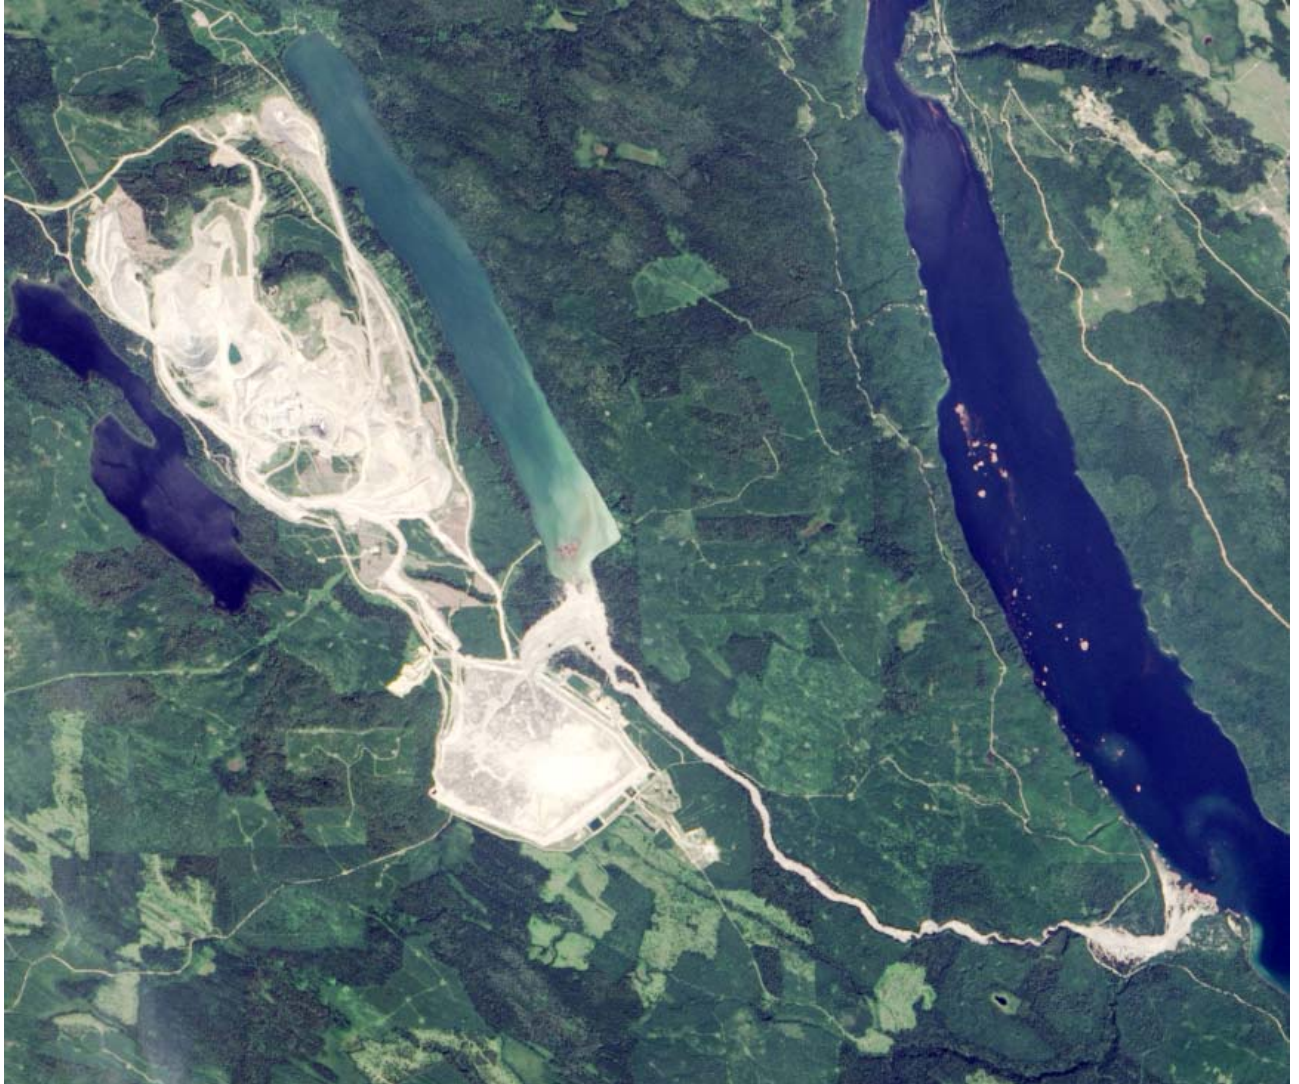
August 5, 2014

On September 1, 2014, Imperial Metals released new data ([Mount Polley Update](#)), stating that an astounding 25 million cubic metres of combined waters, tailings slurry and construction materials gushed out of the Mount Polley Tailings Storage Facility from August 4, 2014 onwards.
