**ON MARCH 24, 2007 – BC TAP WATER ALLIANCE
PRESENTATION IN PORT ALBERNI TO SOVA
(SAVE OUR VALLEY ALLIANCE)
COMPLAINTS ABOUT TIMBERWEST LOGGING AND
DRINKING WATER
- Compilation of Photos (by Will Koop) on March 25, 2007**

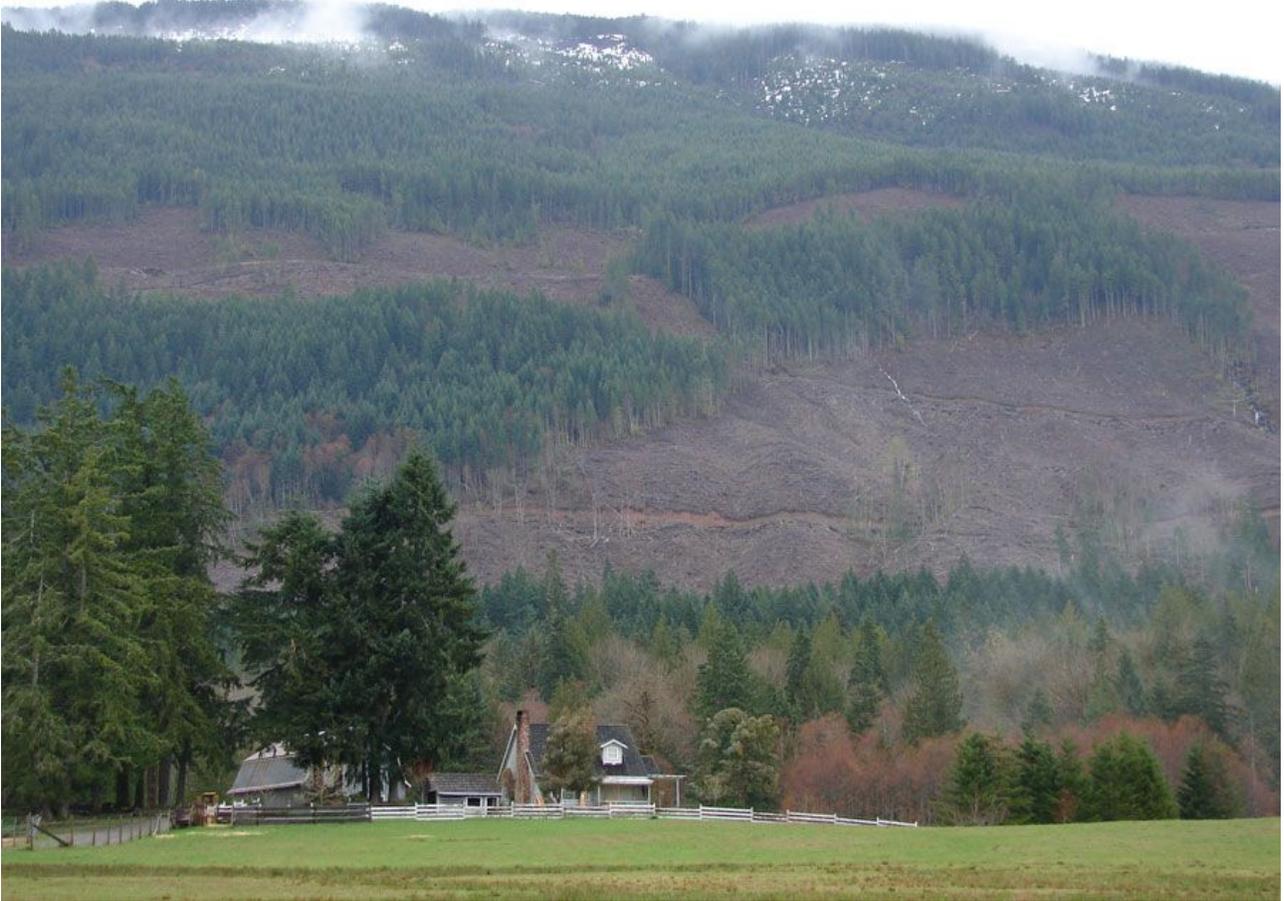
Photo 1. Cut-Block T-141. Recent clearcut logging by TimberWest above Wayne Crowley's property, water well, fish habitat and Beaver Creek Improvement District. The photo shows the extent of former logging of old growth to the upper reaches, or higher elevation, of the mountain slope. The existing old growth is shown as the darker shade of green at the top of the mountain, which is about to be targeted for logging. The second growth on this slope is under 60 years old. Concerns from community members in Port Alberni, as elsewhere on Vancouver Island, are not only the accelerated rate of logging of primarily very young, adolescent, second growth forest, but that raw logs are being exported out of British Columbia to the United States and other destinations. Wayne Crowley, and other residents, were successful in limiting TimberWest's logging plans that would have clearcut even more of the forest in this photo (primarily to left area). Many stories were published, repeatedly, in the Port Alberni Times newspaper. This, and the following photos, were taken on March 25, 2007.

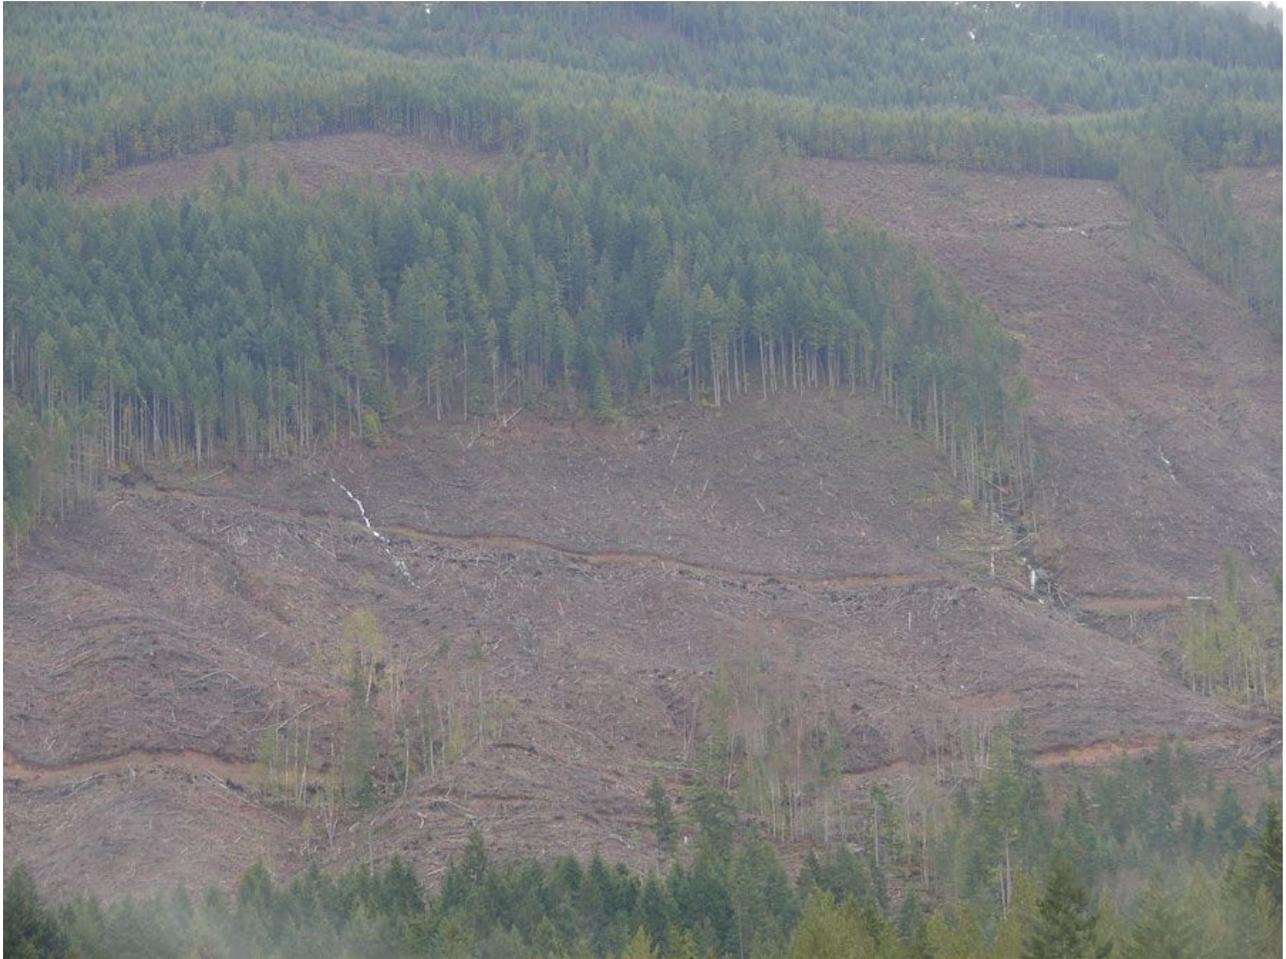
Photo 2. Close-up of northern half of block 141. Debris torrents, blocked and washed out culverts occurred throughout. To the middle right of the photo is where a large debris torrent occurred (culverts numbers 20 and 27 on company timber plan map, identified as “stream number 6”). Many of the trees left on this very thin wedge-shaped buffer left on this stream collapsed from wind storms, adding to the problems to this area. Other streams weren’t so lucky – no buffers whatsoever.

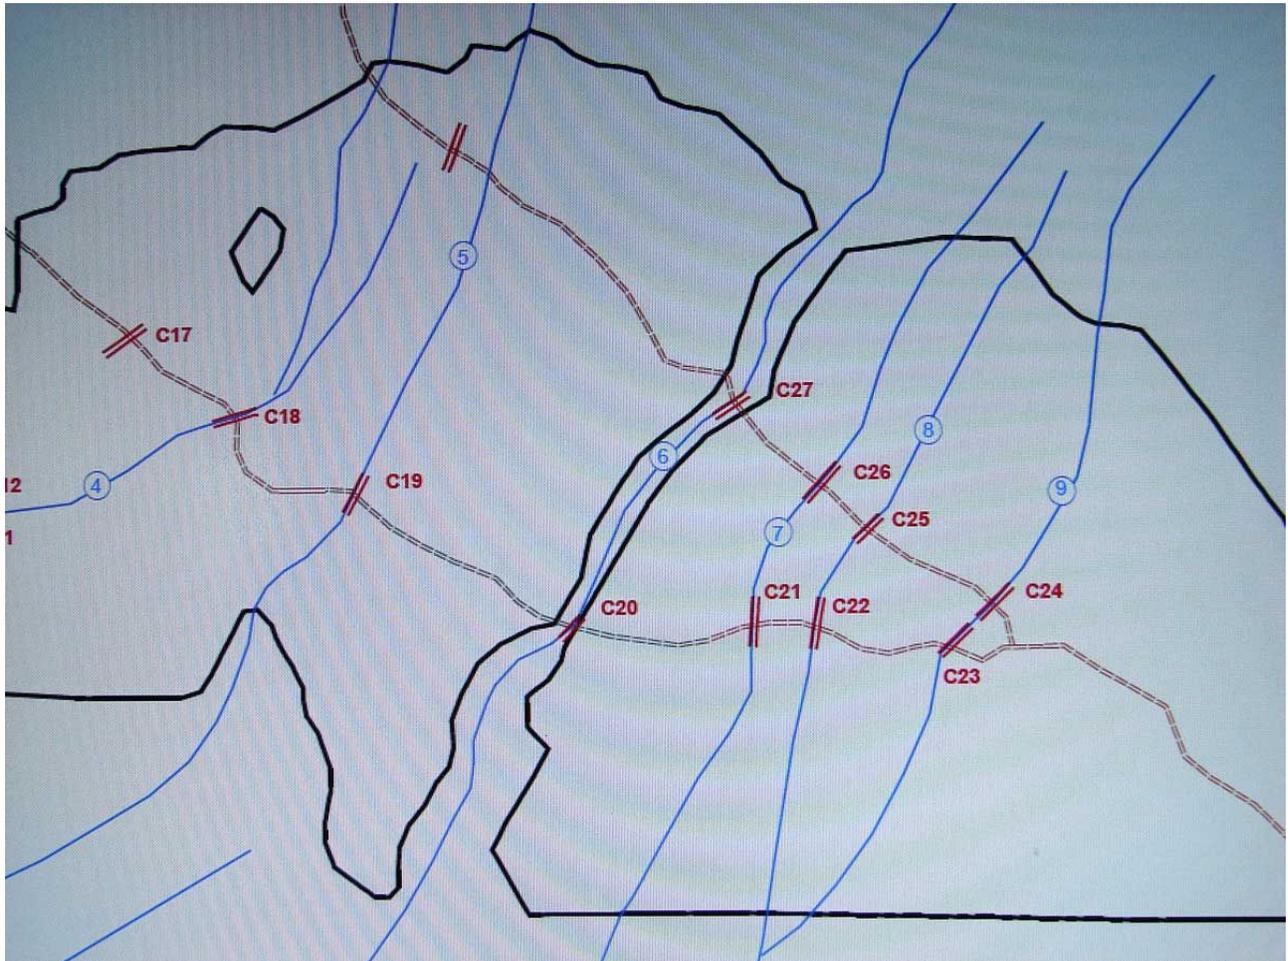
Layout of Block T-141, showing location and numbered identification of culverts. This map information is taken from page 42 of Madrone Environmental Services Ltd. February 6, 2007 report to the Private Managed Forest Land Council, *Assessment of Storm-Related Stream Erosion and Sedimentation, Block T141, Beaufort Range*. According to the map, this layout was provided to Madrone by TimberWest.

Note, in particular, the black boundary line for the cutblock layout, showing a “wide” buffer alongside stream number 6, which, of course, was never left during the logging, as clearly shown in the photos below. Was this map a final “formal” map that loggers or foresters later did not abide with, or was the map later simply changed??? No buffers are there for the other streams in the layout, though some thin, and haphazard forms, of buffers were left during the logging. The blue, circled numbers are those identifying streams in the cutblock.

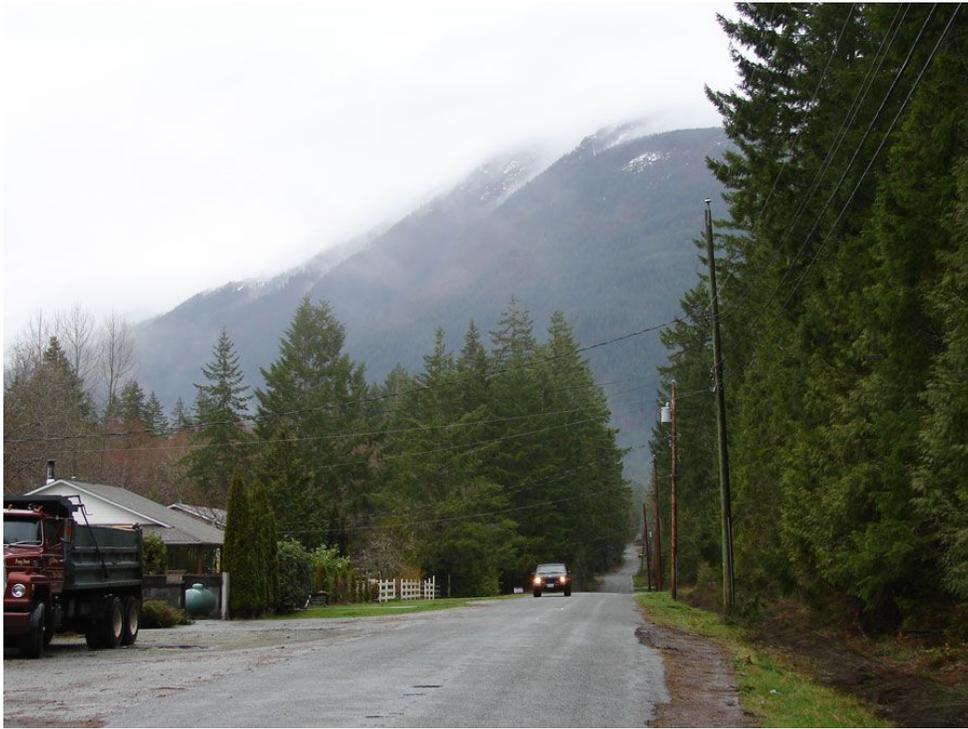
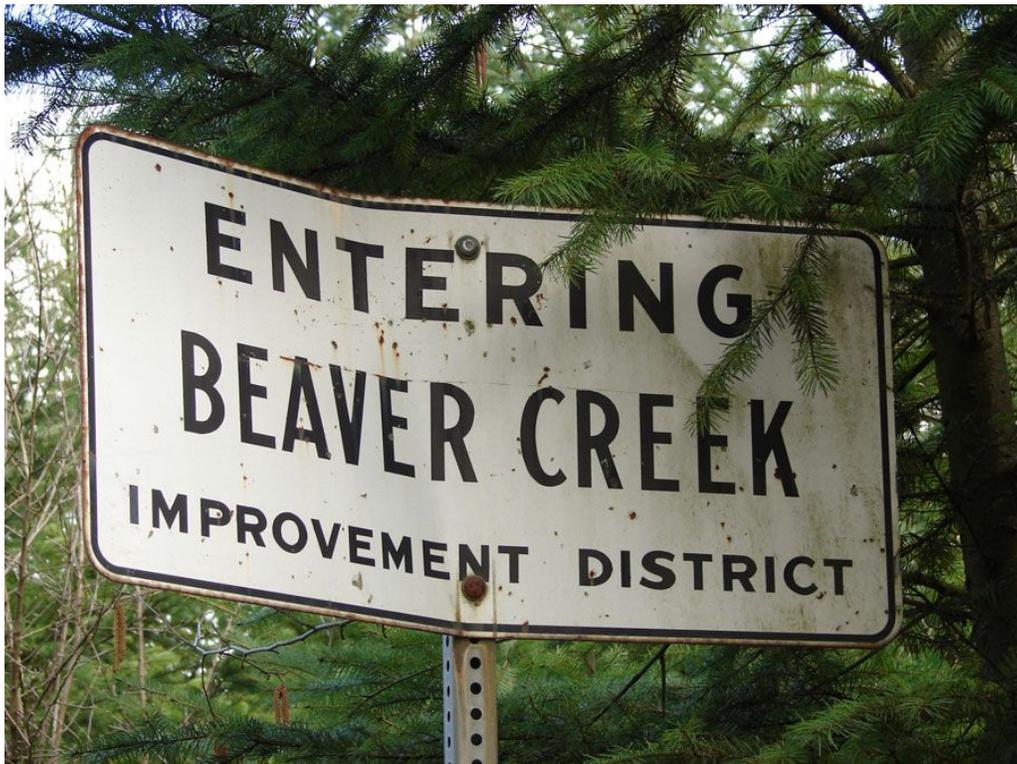
Photos 3 and 4: The community and Improvement District of Beaver Creek lies directly below the steep, westerly facing mountain slopes of the Beaufort Range.

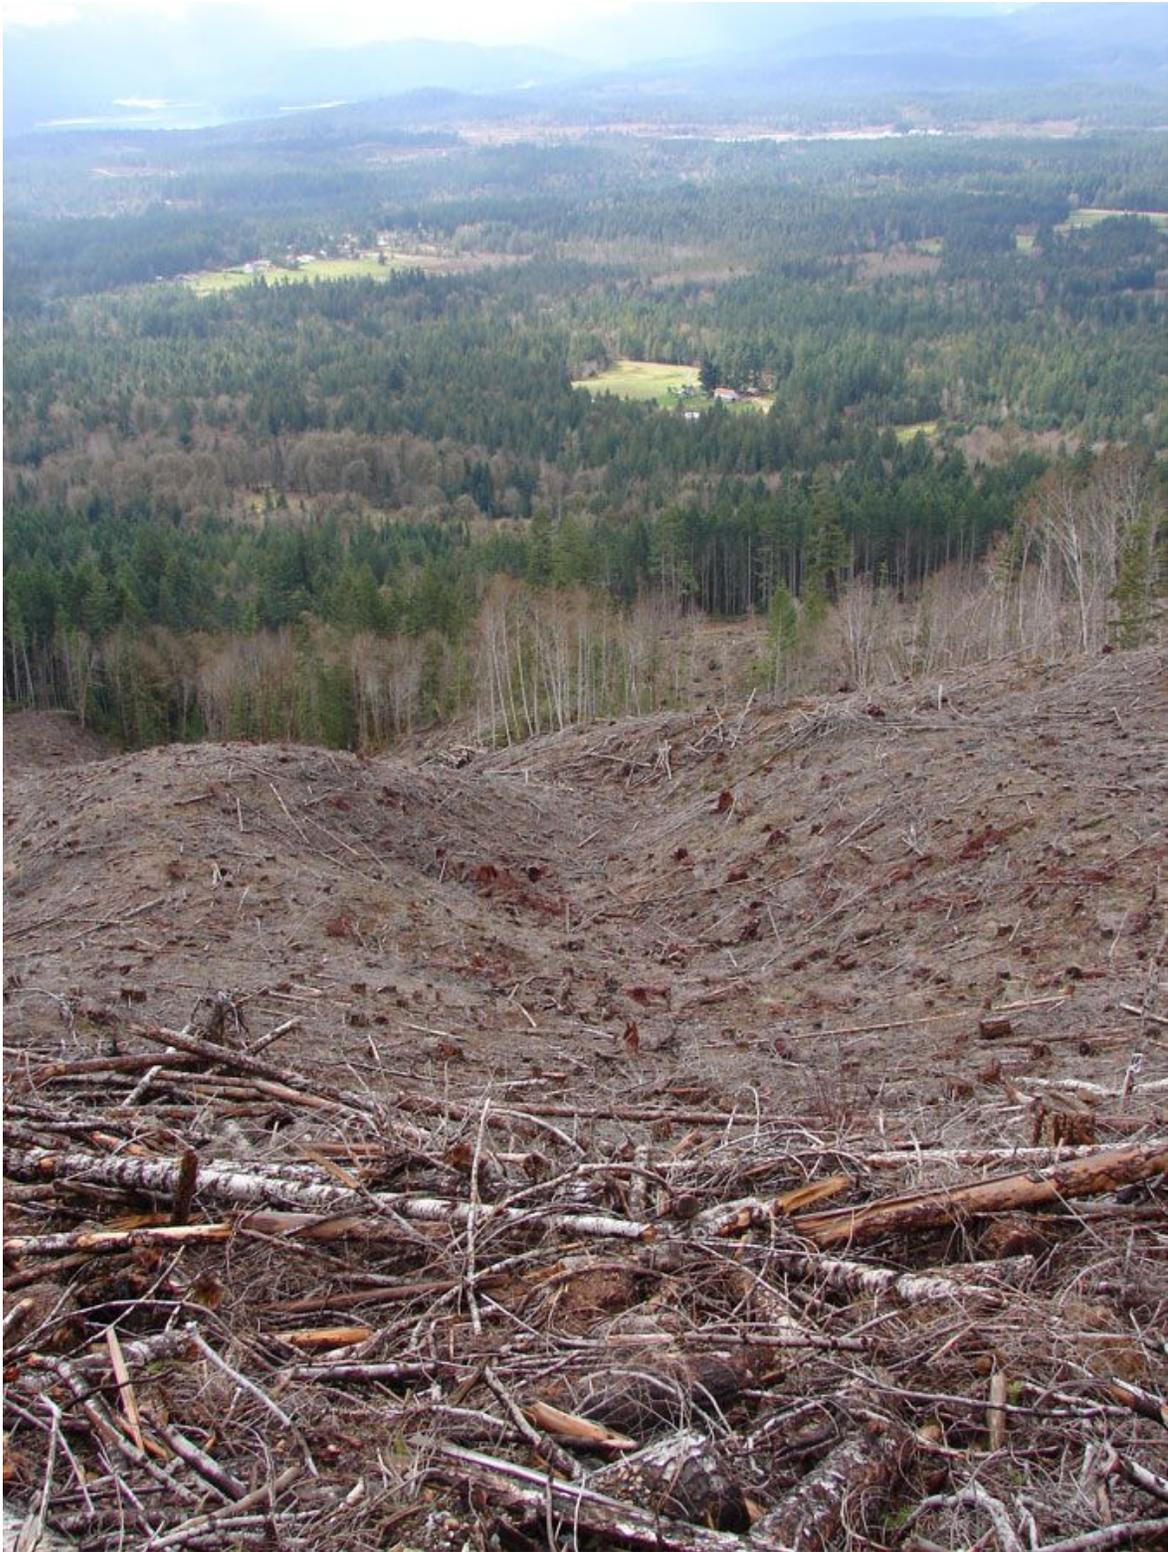
Photo 5: Looking down half way up Block 141 to Wayne Crowley's farm property.

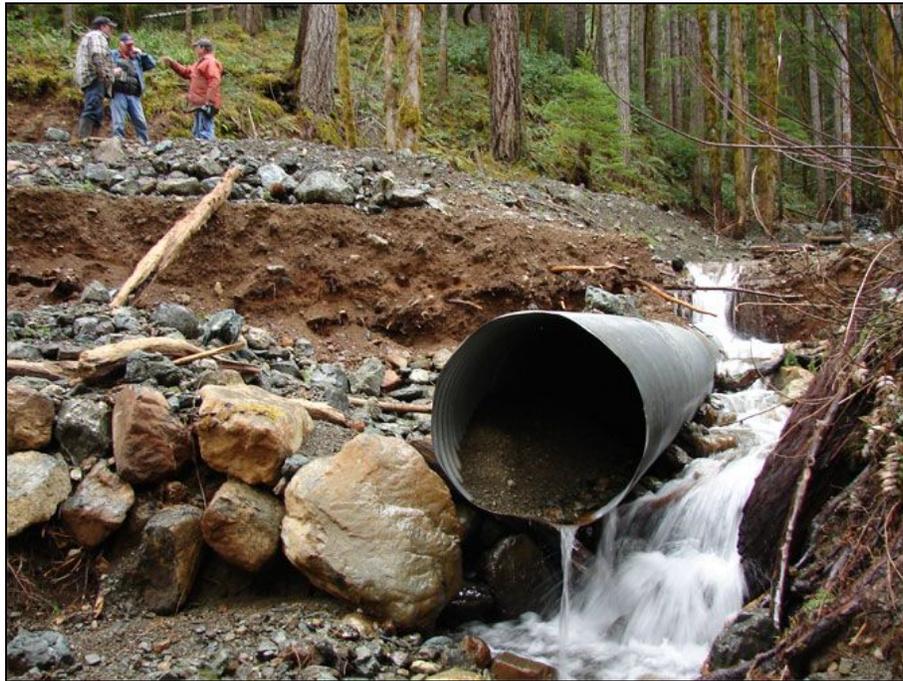
Photo 6. Below: Photo of plugged and washed out culvert below Cutblock 141. The culvert is located on the Thompson Woodlot road between block 141 and Lot 129. Until the company was stopped, TimberWest used this road, paid by public taxdollars, to haul out its logs.

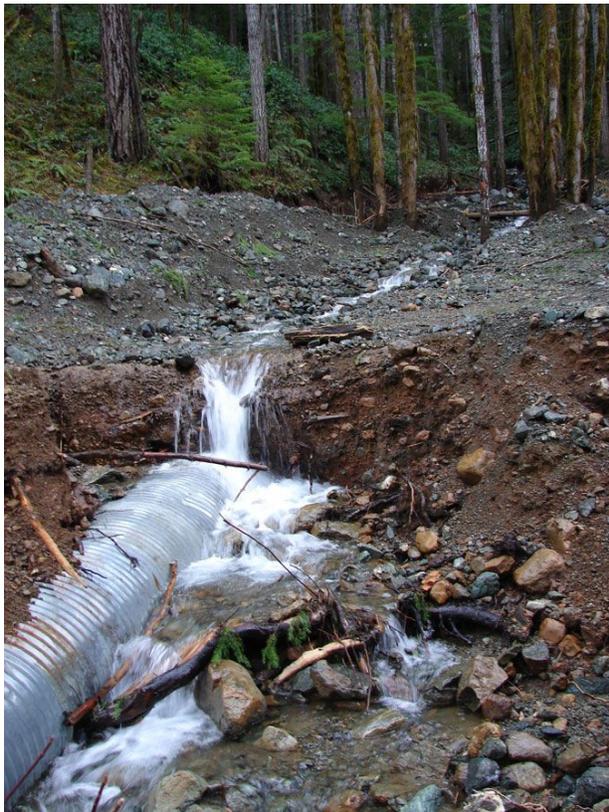
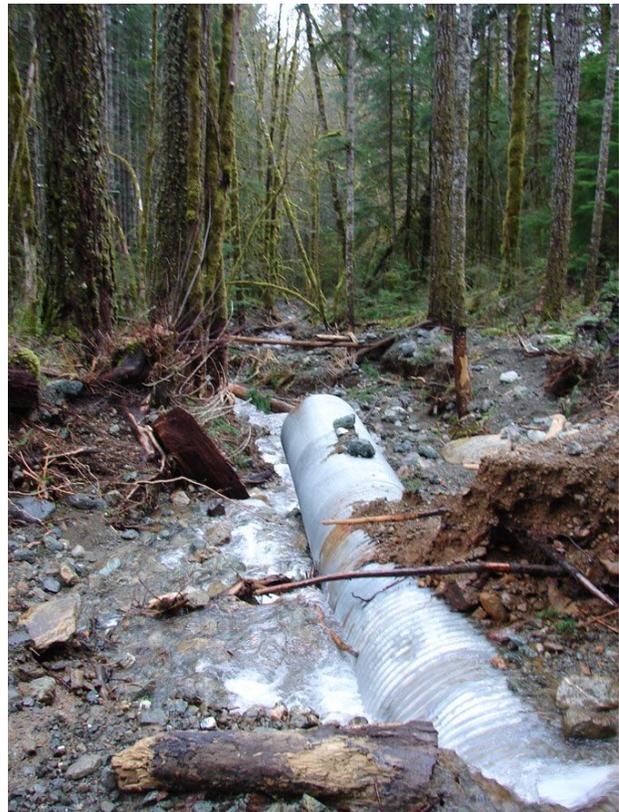
Photos 7 and 8 (below). Looking immediately above and below photo 6. Shows the amount of debris that came cascading down cutblock 141 into the second growth forest stream area, and onward onto Wayne Crowley's property.

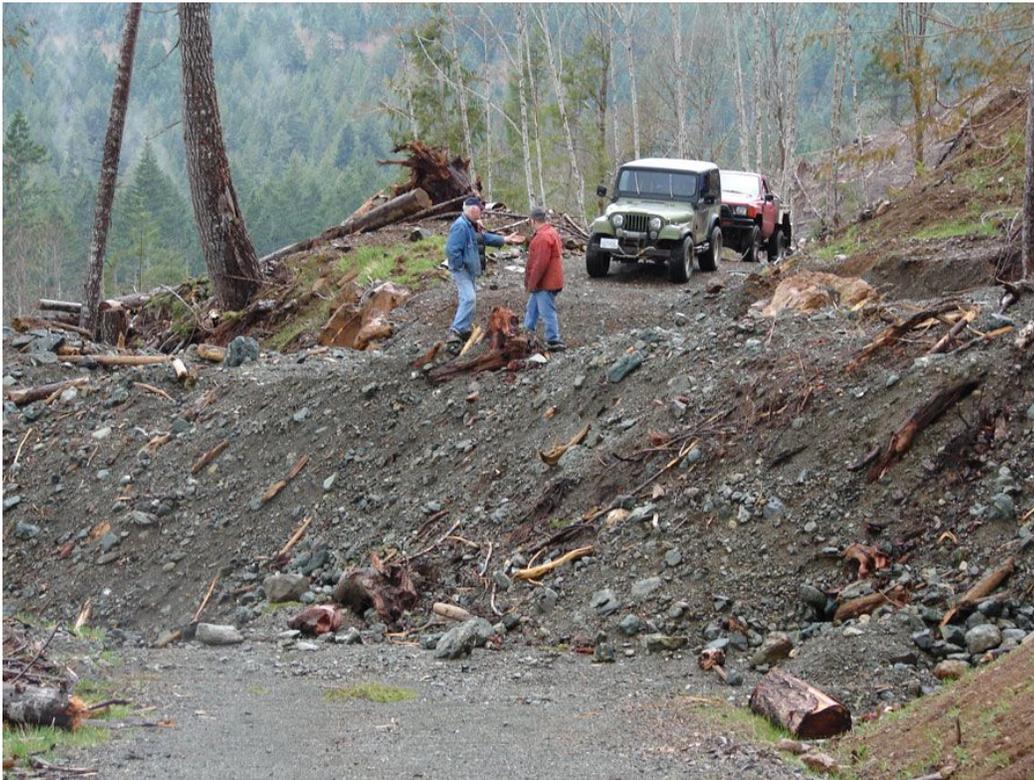
Photo 9: As far as the road goes in Block 141. Debris torrent remains some ten feet in height overtop logging road.

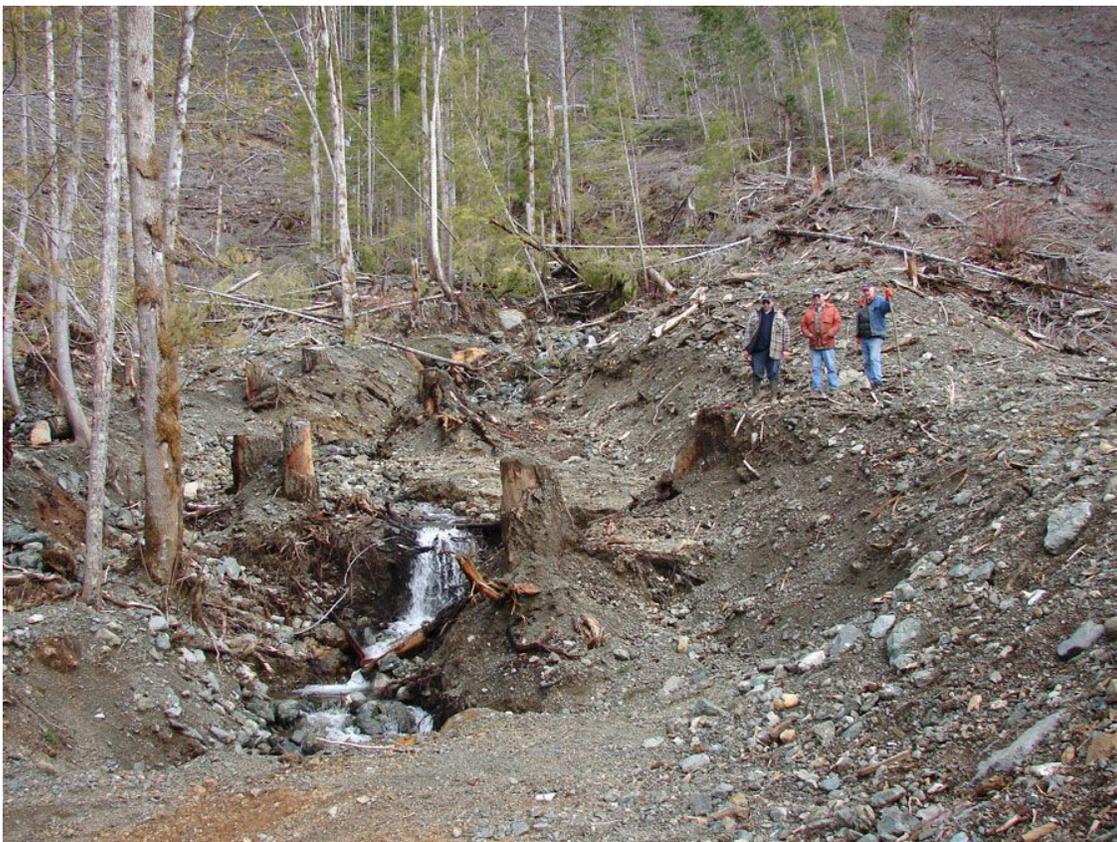
Photo 10: Below. Stream number 6 blow-out. What was once a “normal” looking narrow protected stream is now a scene of devastation.

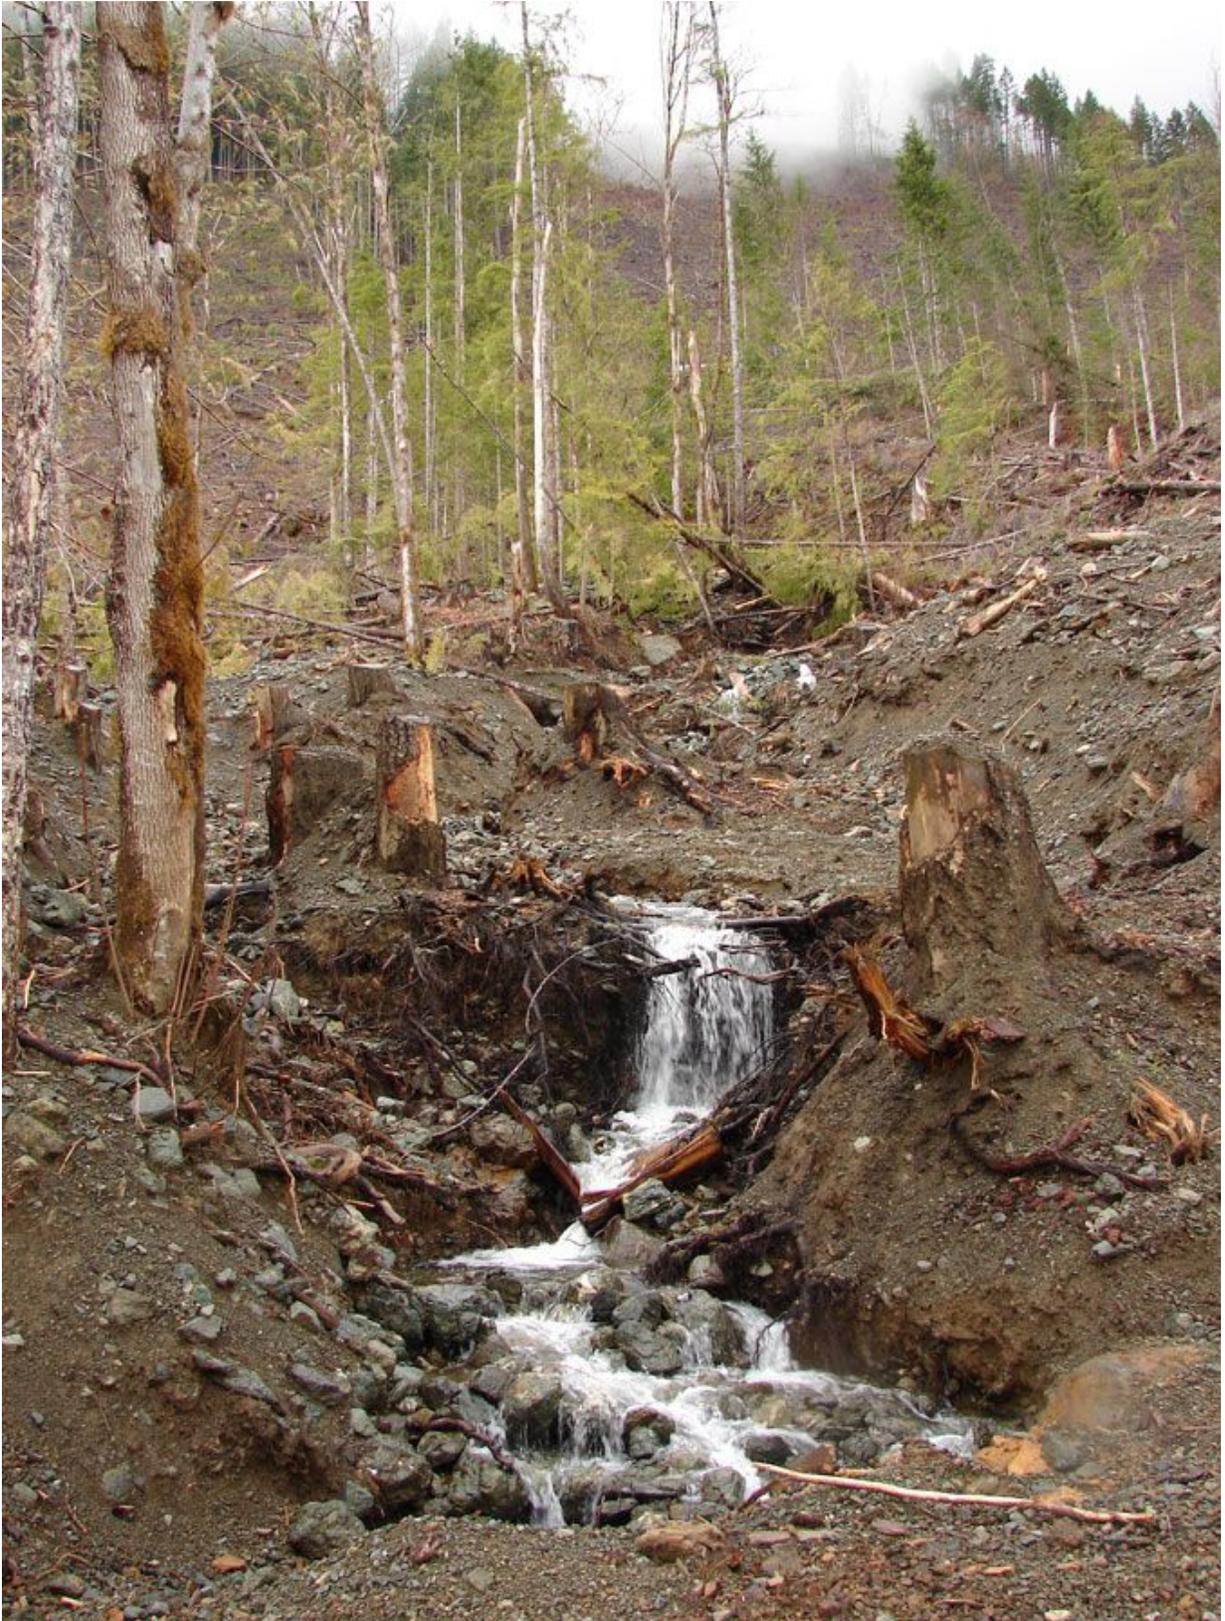
Photo 11. Close-up of blown-out creek number 6.

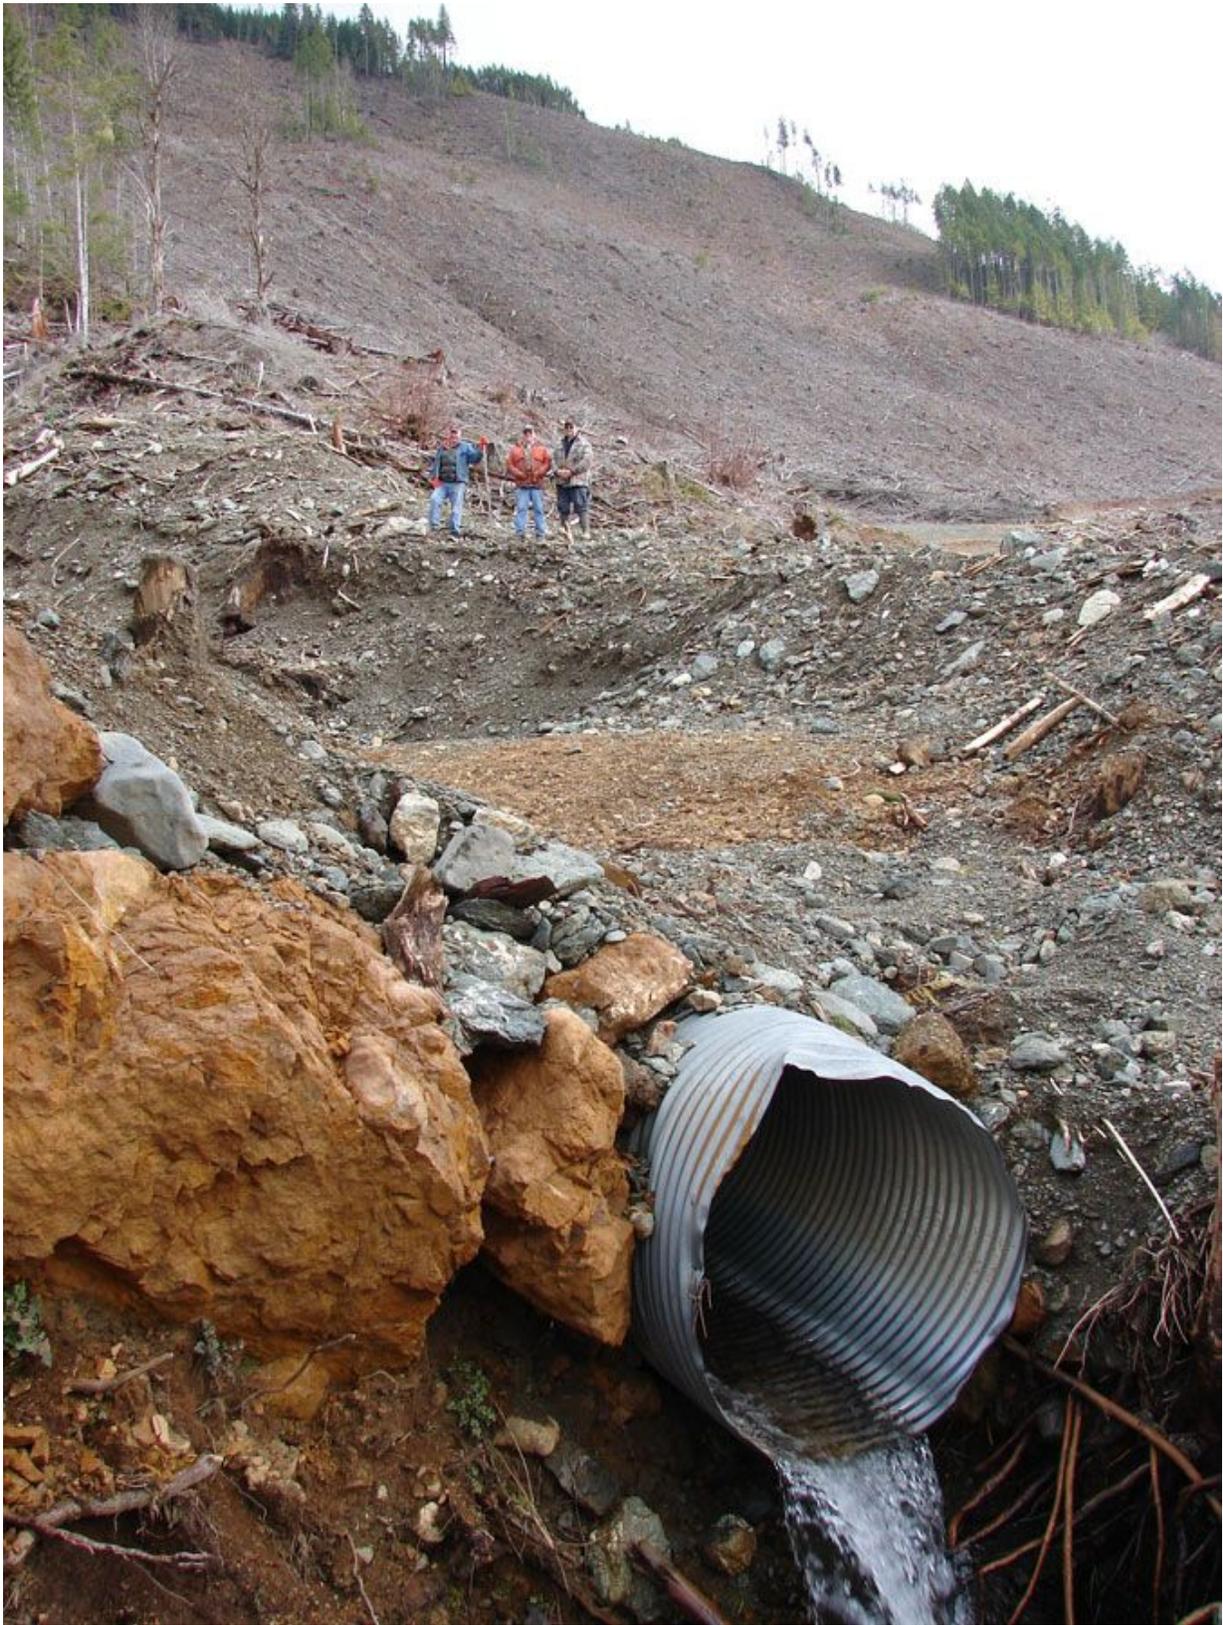
Photo 12. Another view of stream number 6.

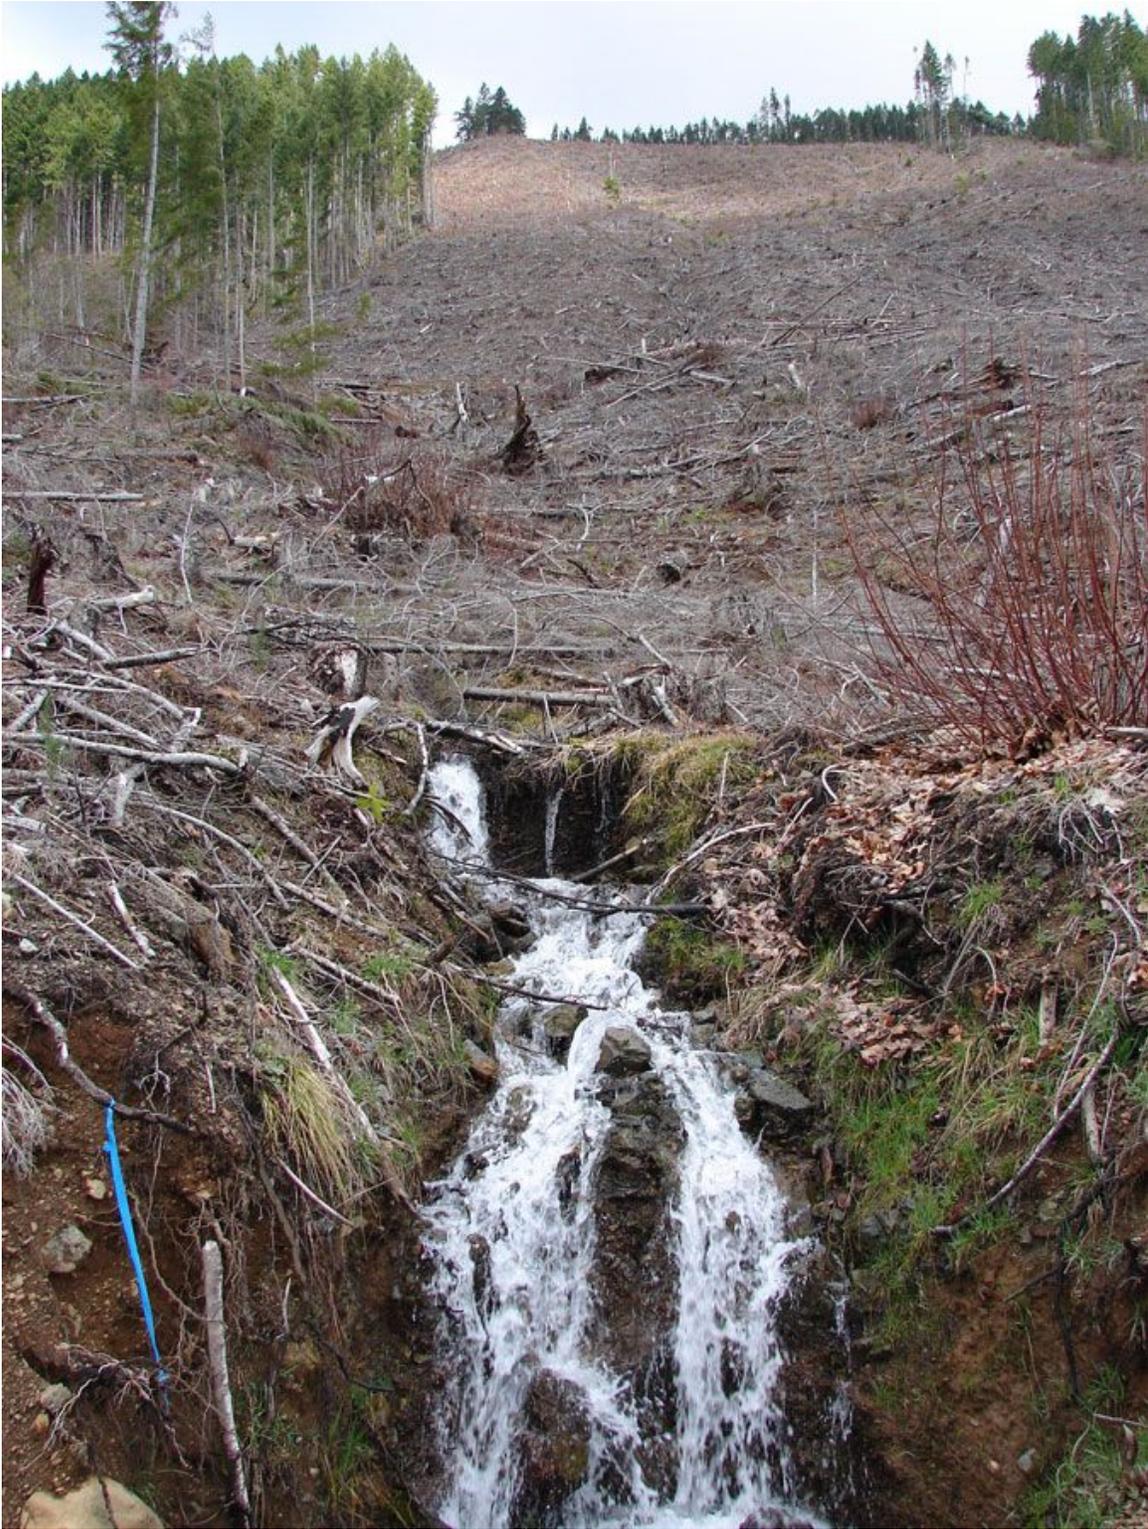
Photo 12. Stream number 7, just upslope on the road from photos above of stream number 6. When so many streams run parallel next to each other, and in close proximity, it is not wise to clearcut the forest.

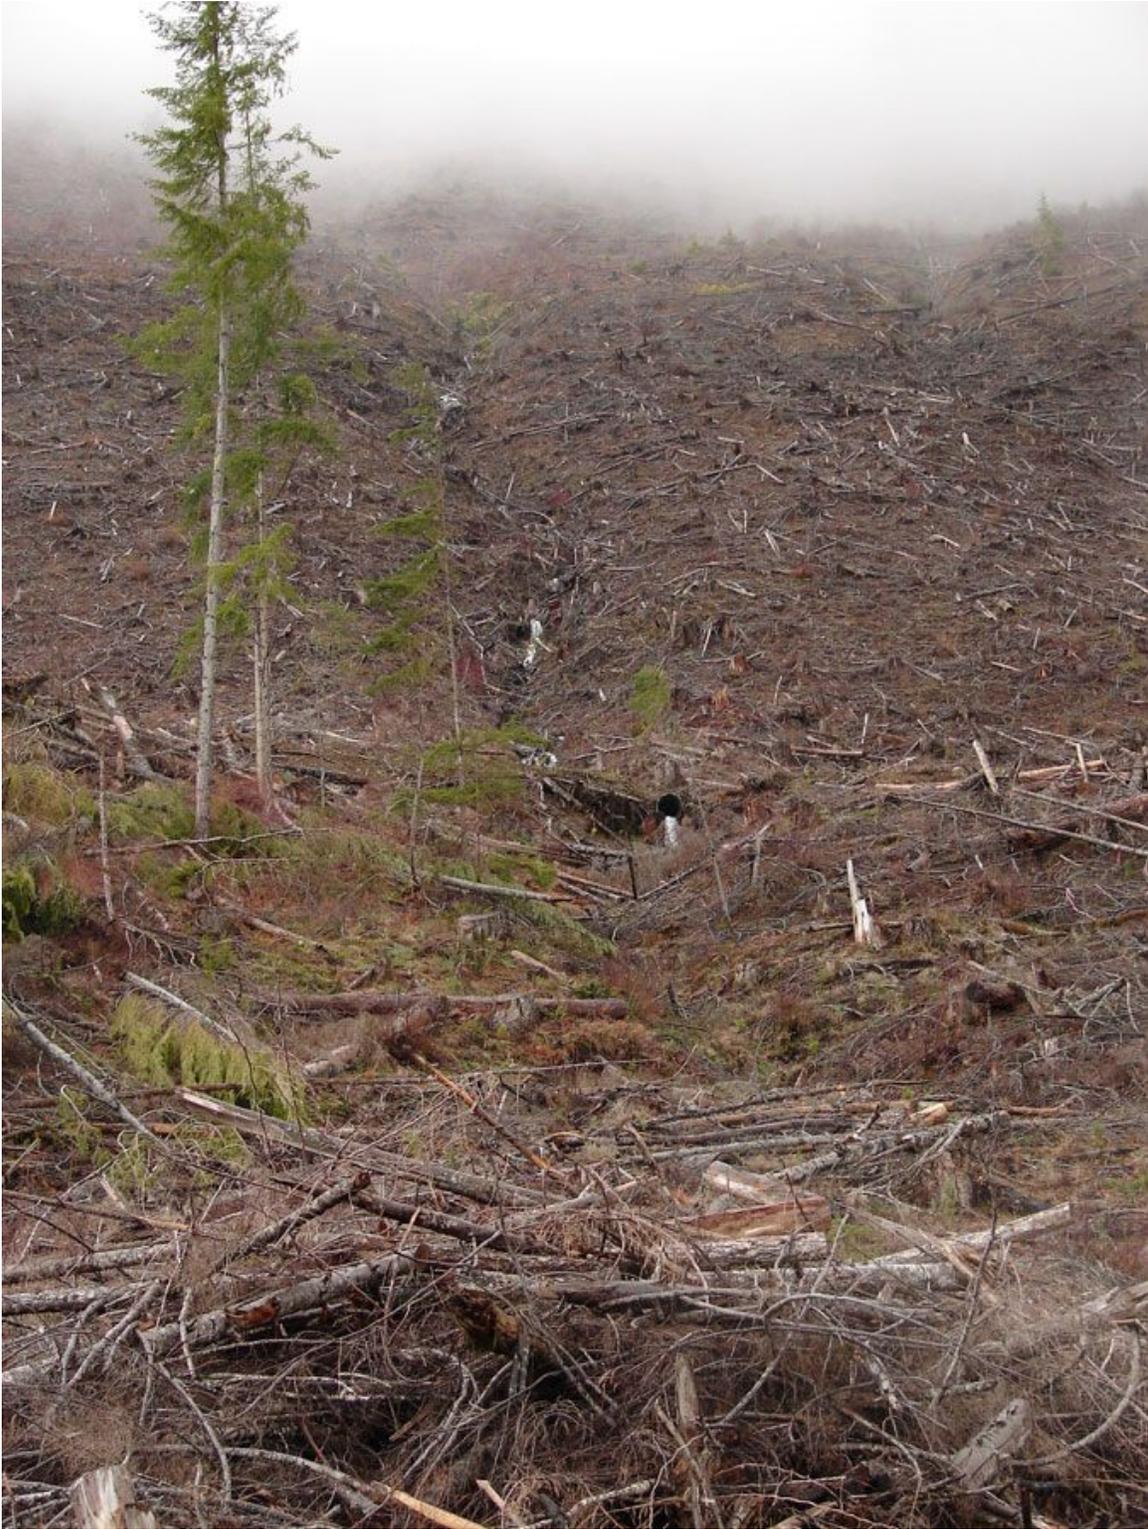
Photo 13. Looking up at stream number 8. The culvert (number 25) is just visible in middle right of photo.

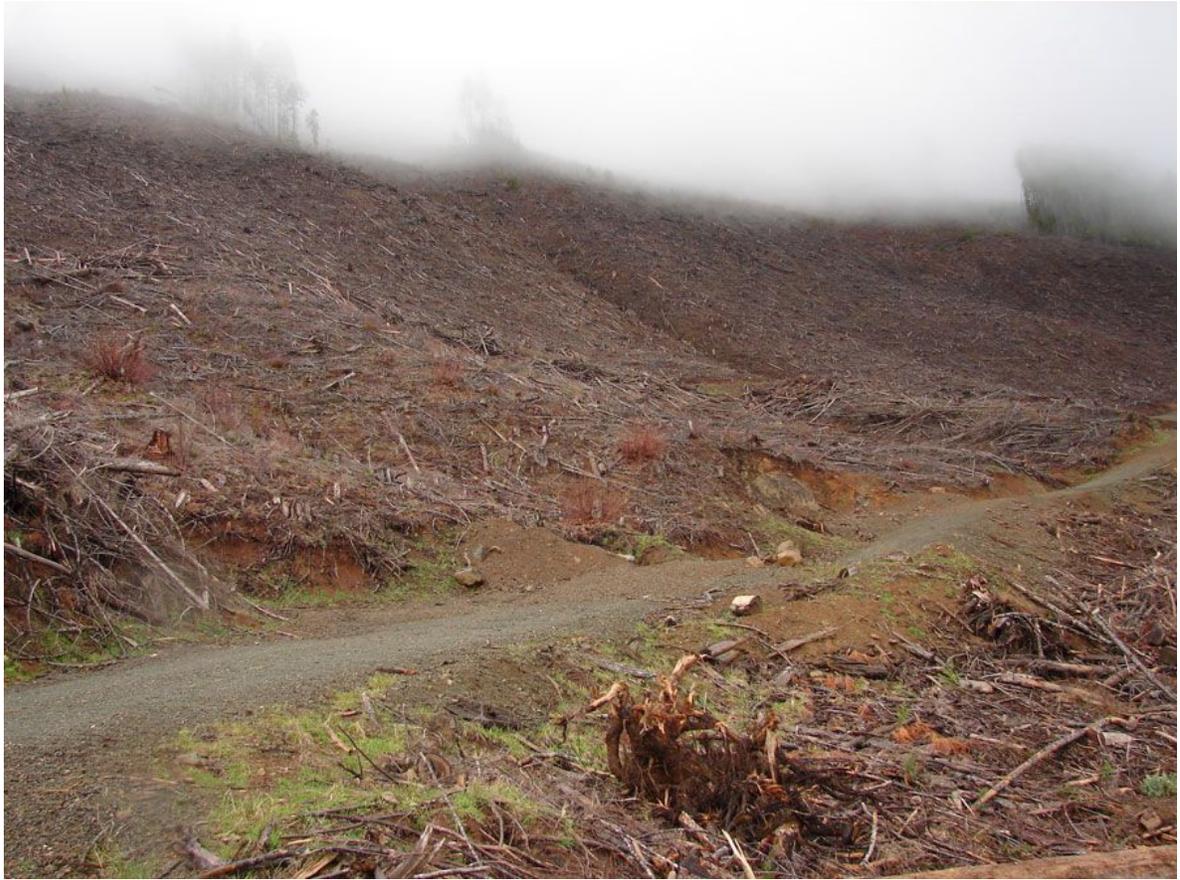
Photo 14 (above). Looking up and across at stream number 9 area (middle of photo). On the original logging plan, there was to be a buffer on this stream.

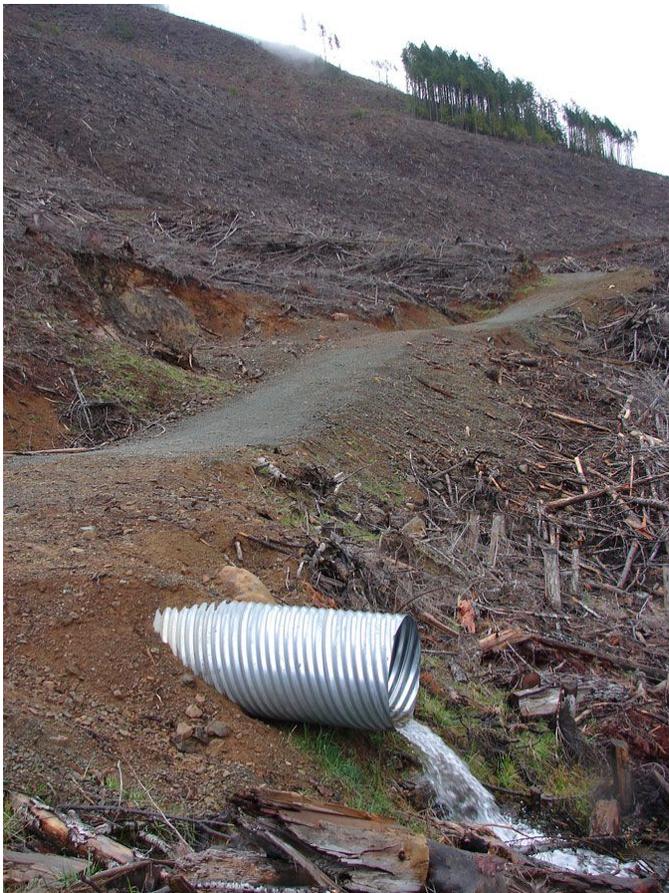
Photo 15 (left). Looking from culvert on stream number 8 up towards stream number 9.

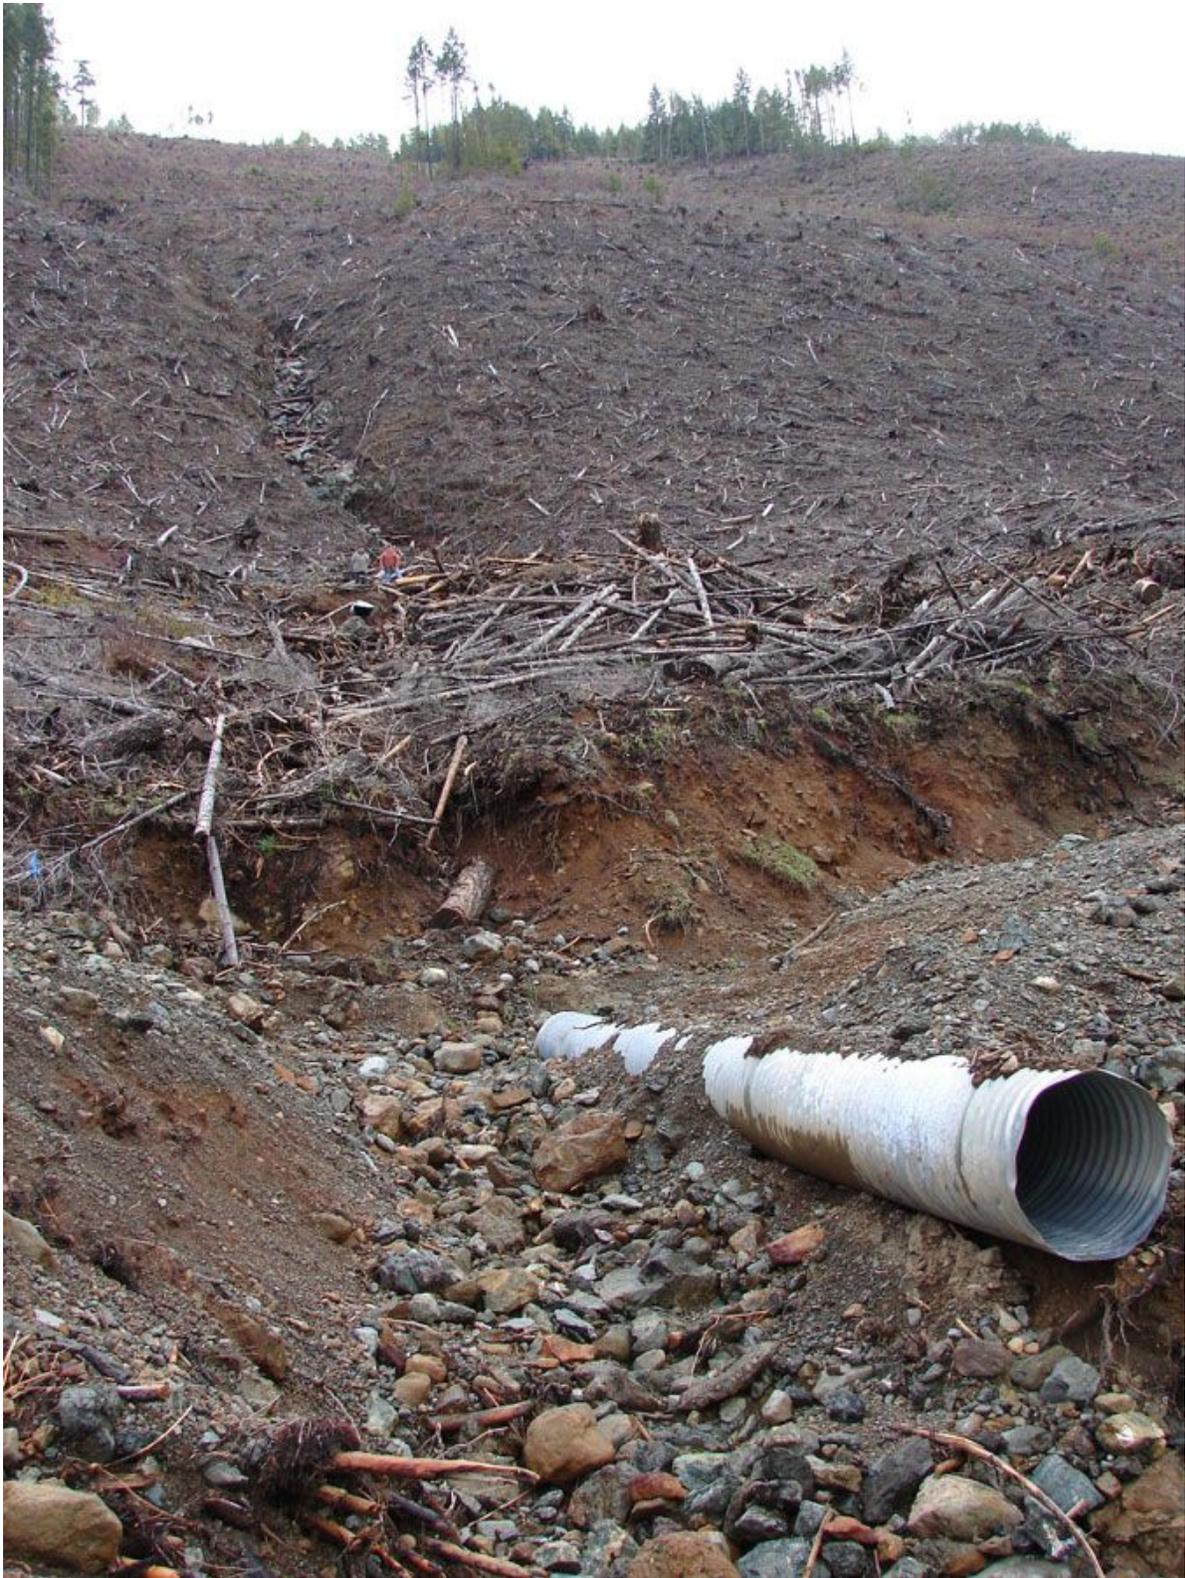
Photo 16. Dysfunctional culvert (number 23) on road along now dry bed of stream number 9.
