**ON MARCH 24, 2007 – BC TAP WATER ALLIANCE
PRESENTATION IN PORT ALBERNI TO SOVA
(SAVE OUR VALLEY ALLIANCE)
COMPLAINTS ABOUT TIMBERWEST LOGGING AND
DRINKING WATER
- Compilation of Photos (by Will Koop) on March 25, 2007**

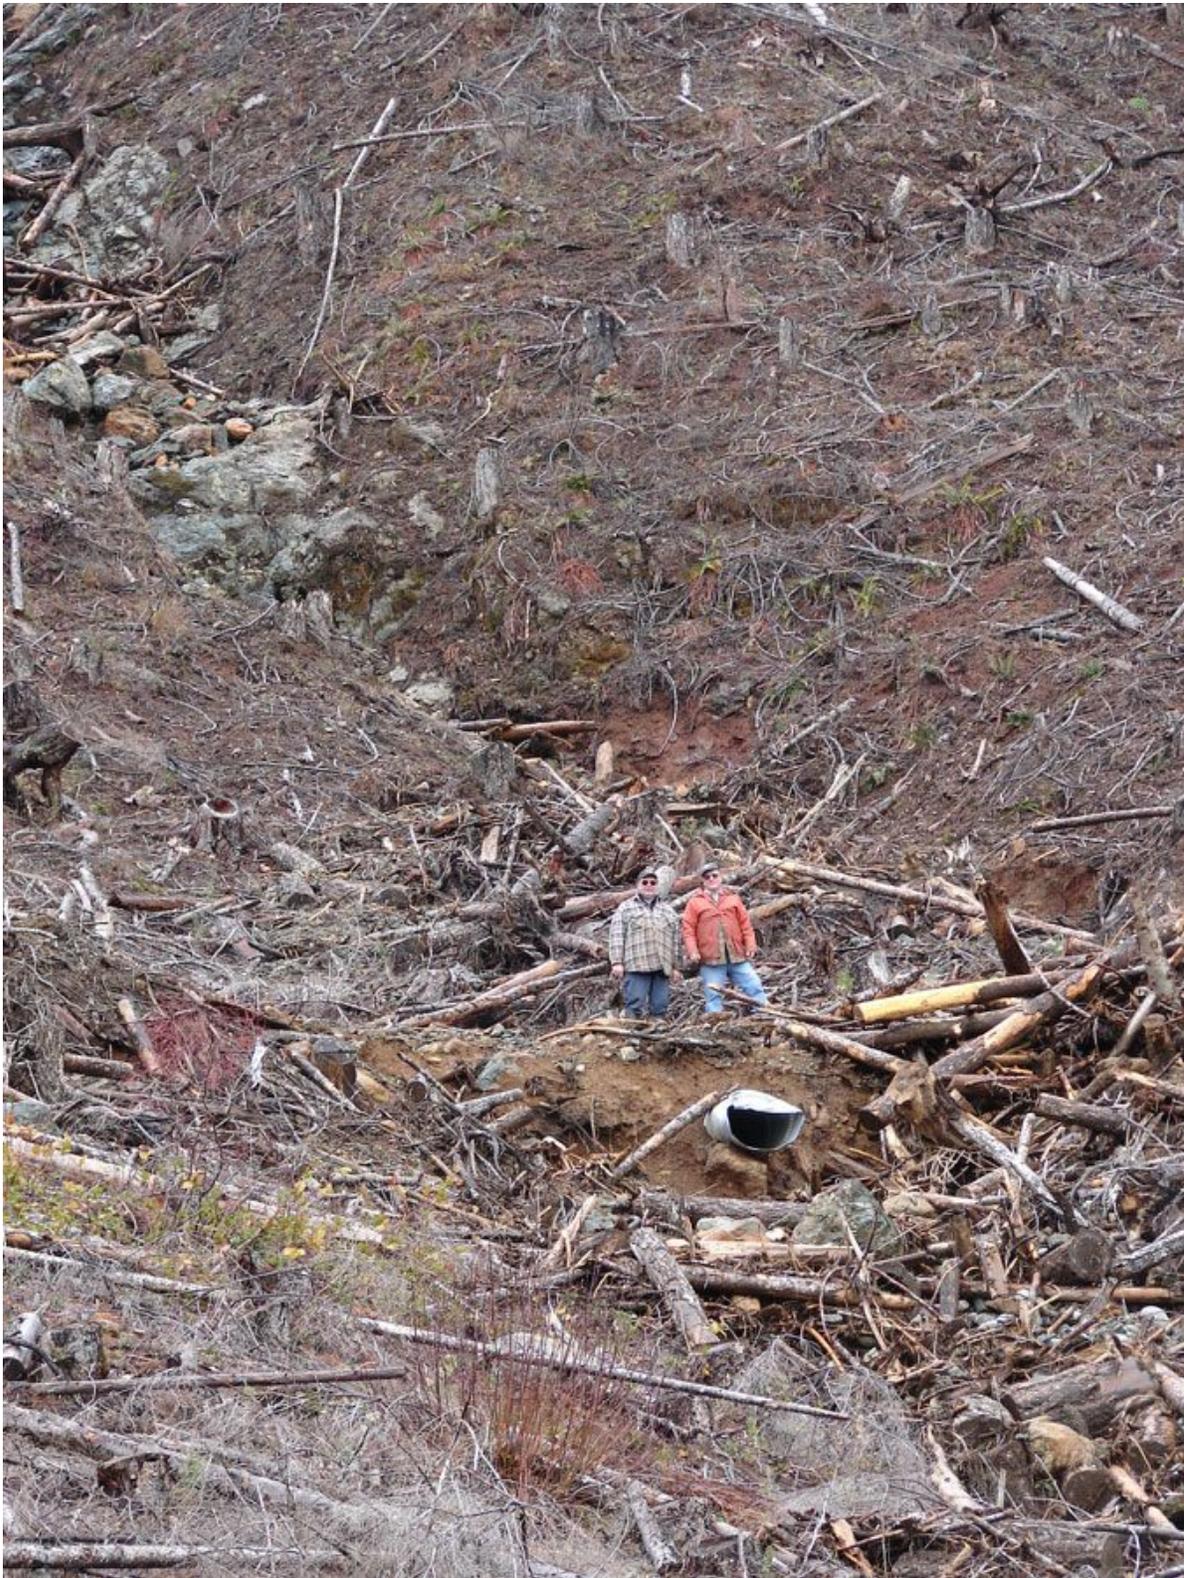
Photo 17. Plugged culvert (number 24) directly above culvert number 23 on stream number 9.

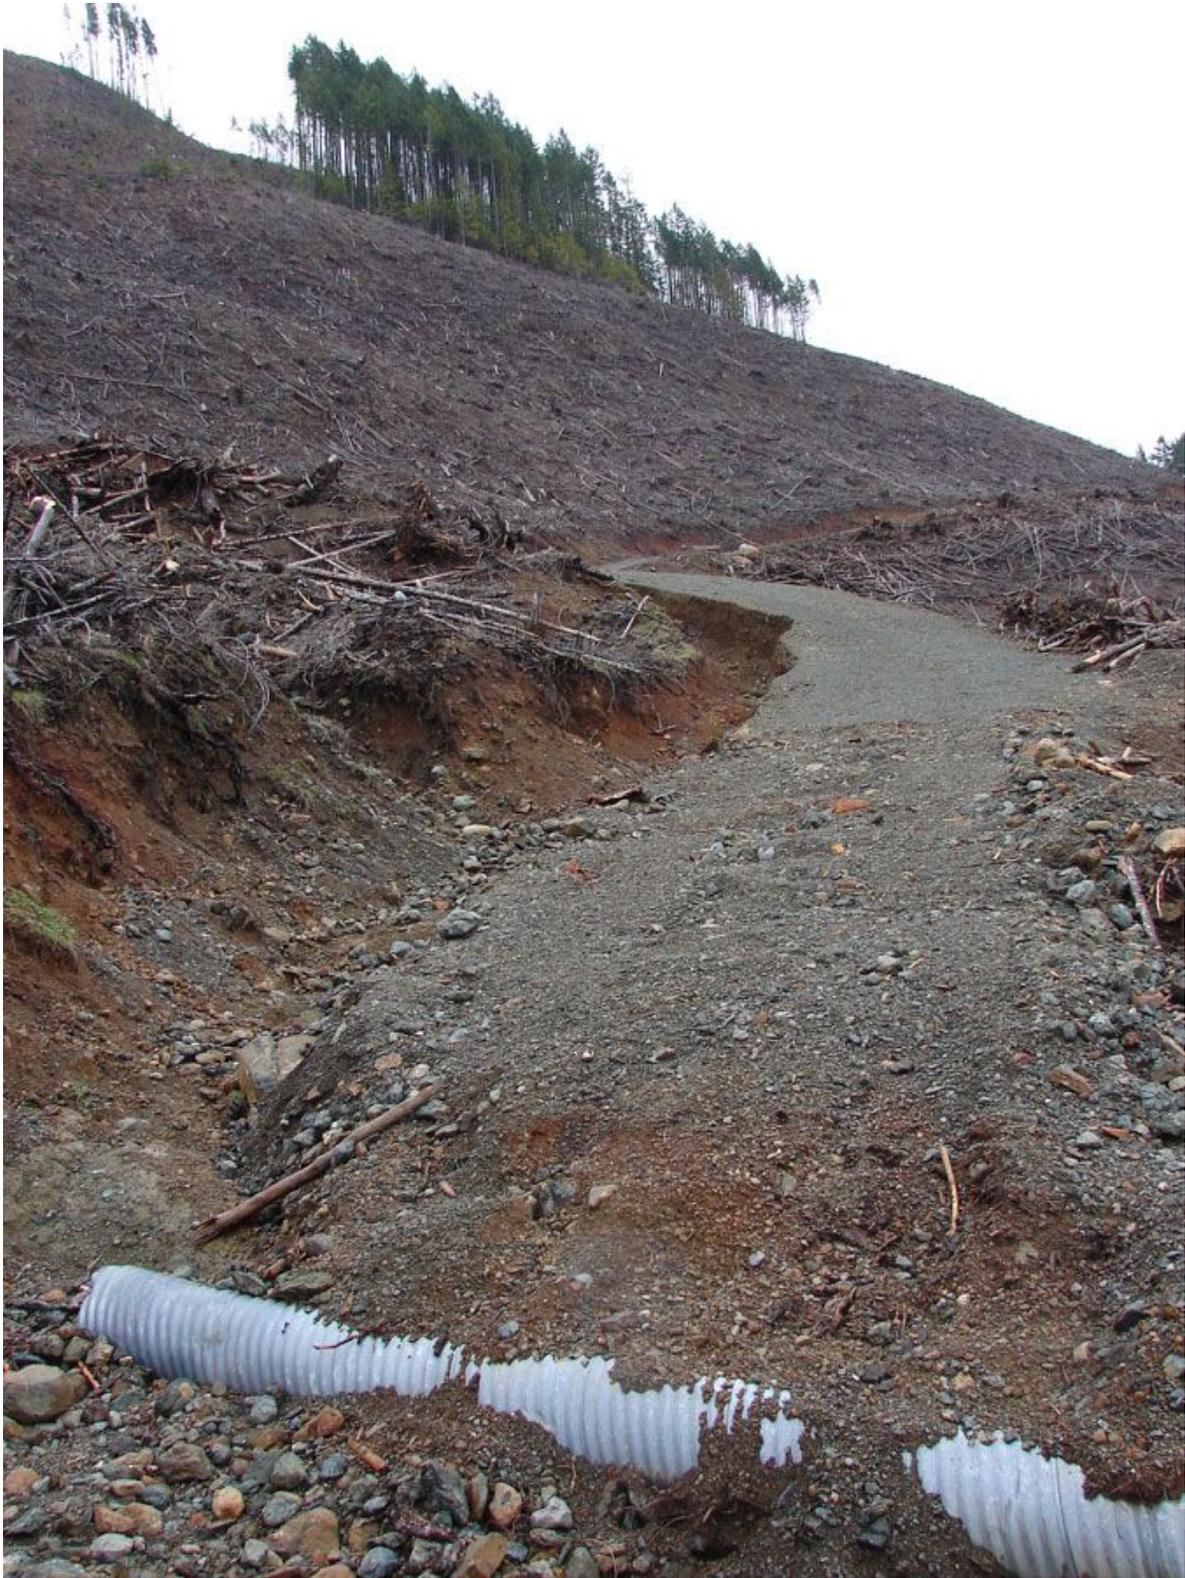
Photo 18. Looking up the road from culvert number 23 to switchback entrance (middle of photo) and ditch erosion on logging road.

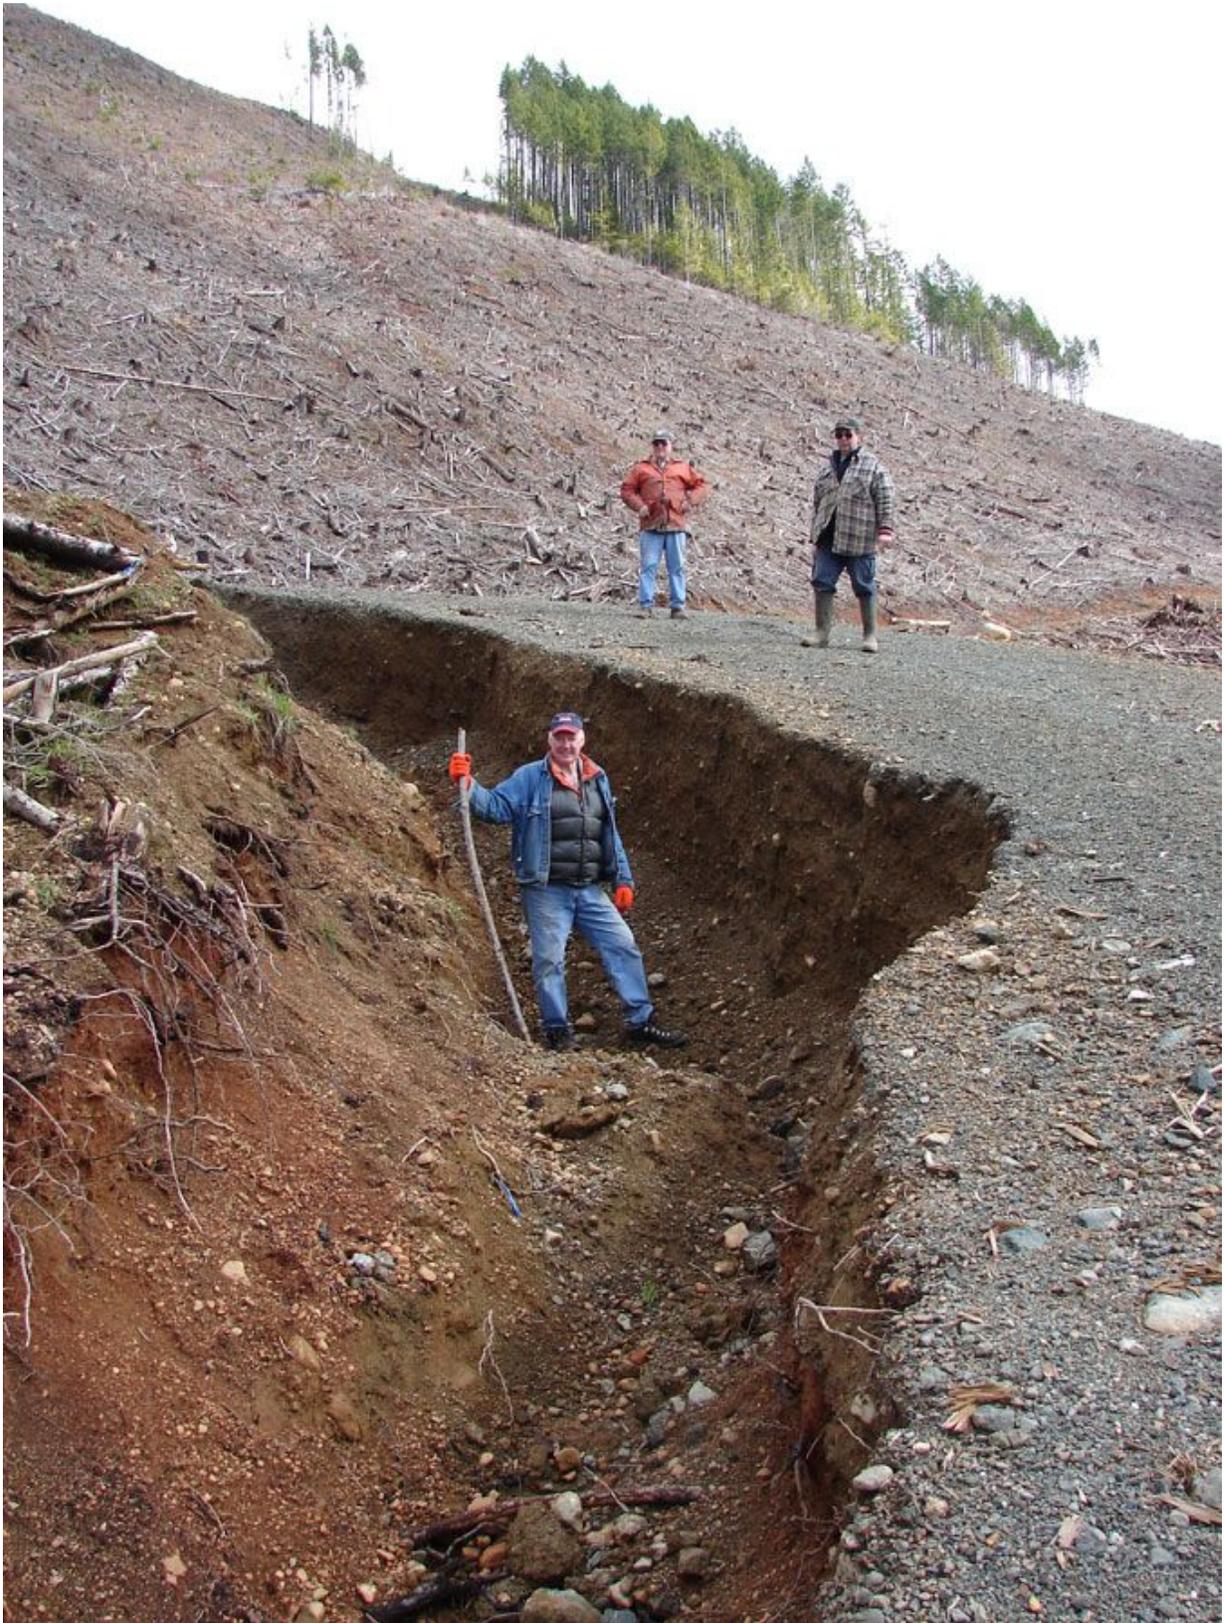
Photo 19. Extent of erosion in ditch as a result of diversion of stream number 9 above and around corner to left of photo.

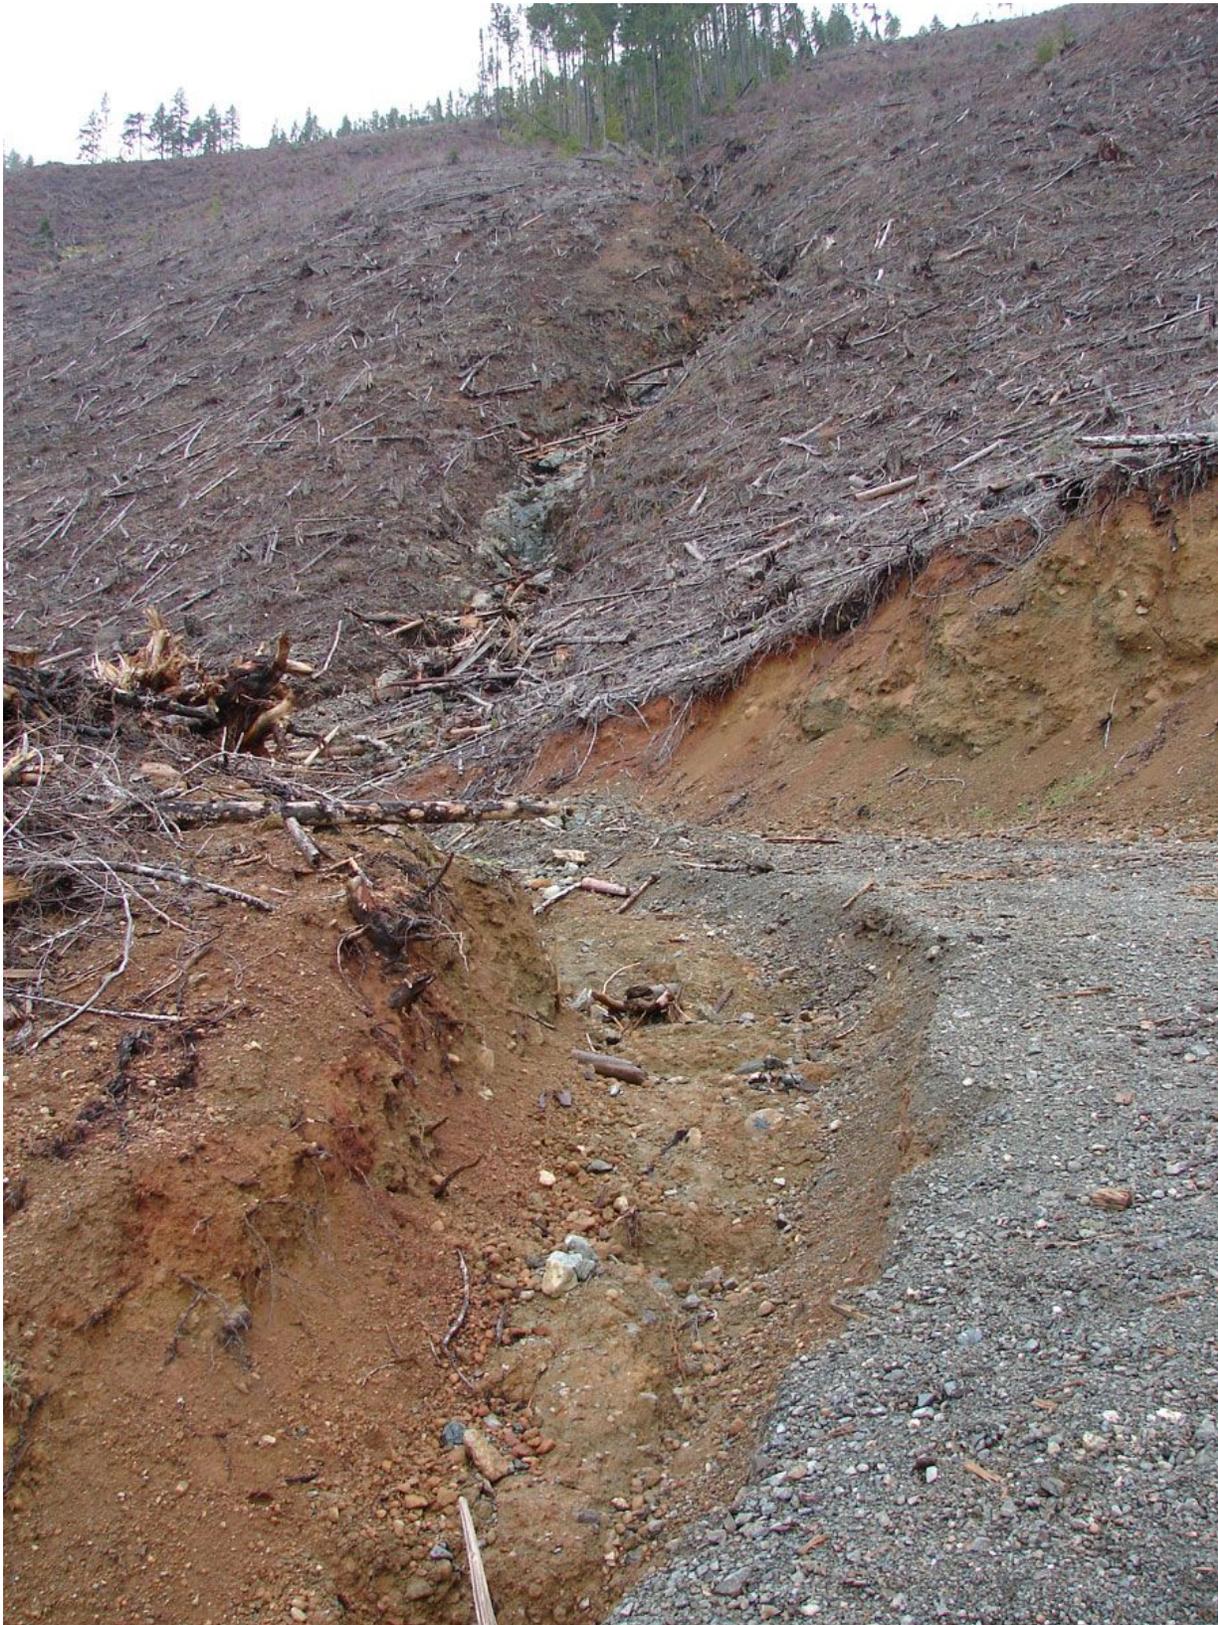
Photo 20. Diversion from stream number 9 as a result of blocked culvert (number 24), down onto the road, around corner, and over blocked culvert number 23.

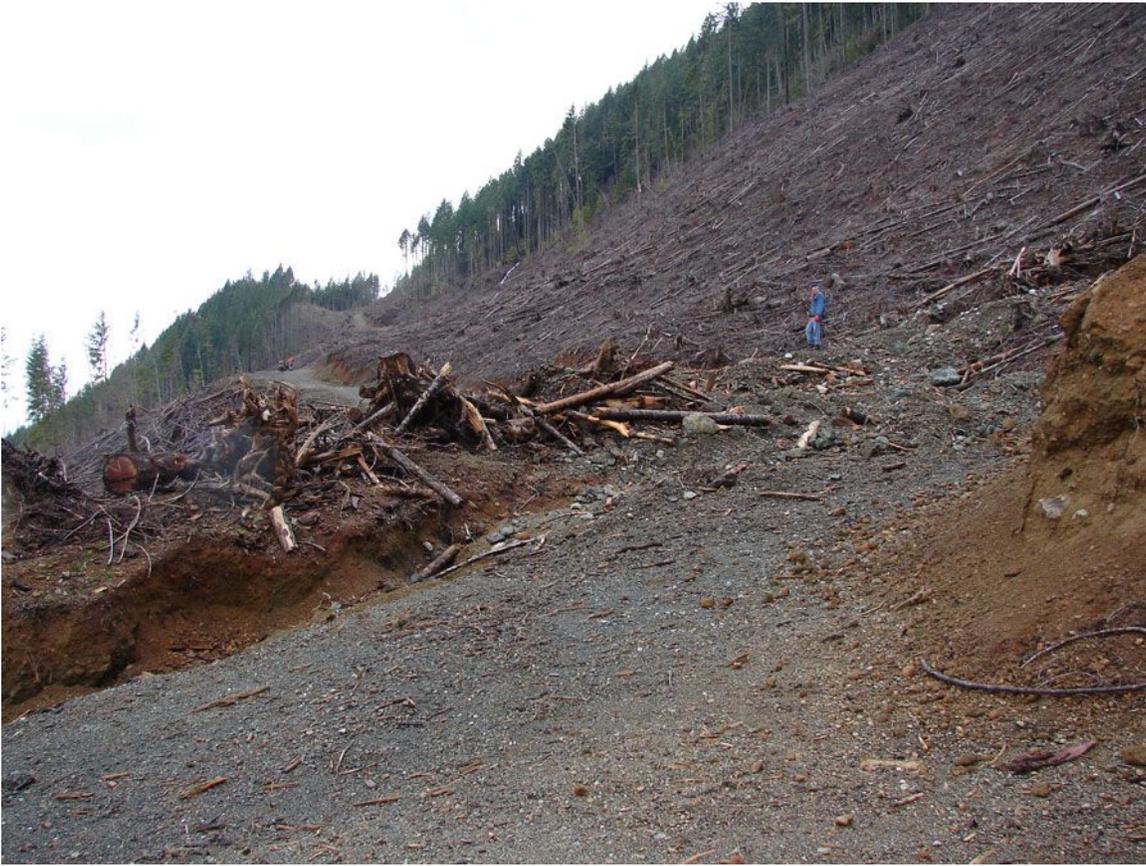
Photo 21 (above). Beginning of switchback toward upper part of stream number 6. Erosion debris of stumps, small logs, rocks and soil across road deposited from debris torrent on stream number 9 at culvert number 24. Debris height is about 8 feet or so above top level of road.

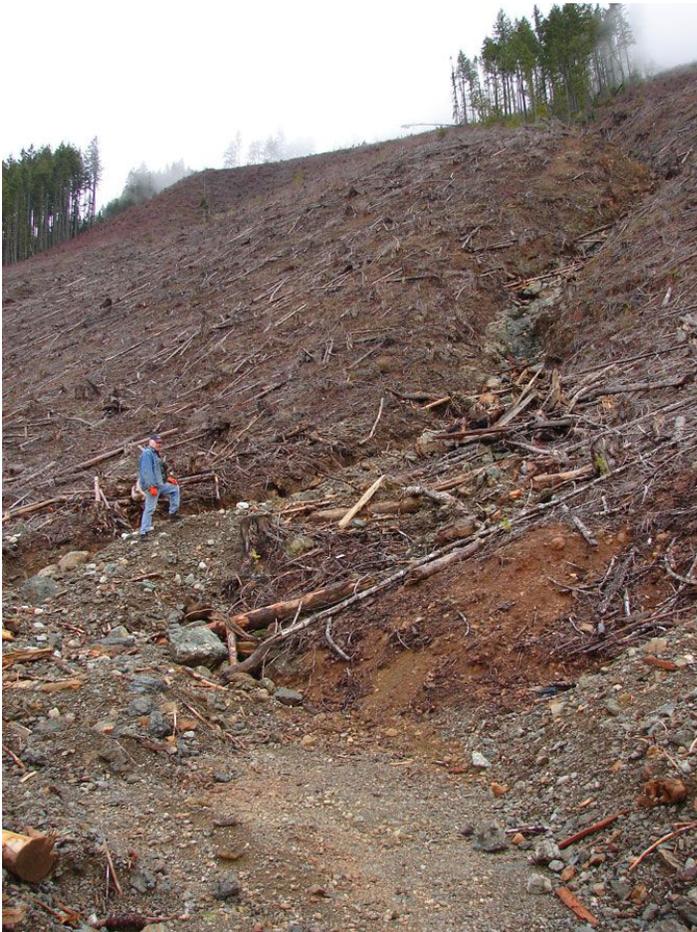
Photo 22 (left). Another view of photo 21 area, looking uphill.

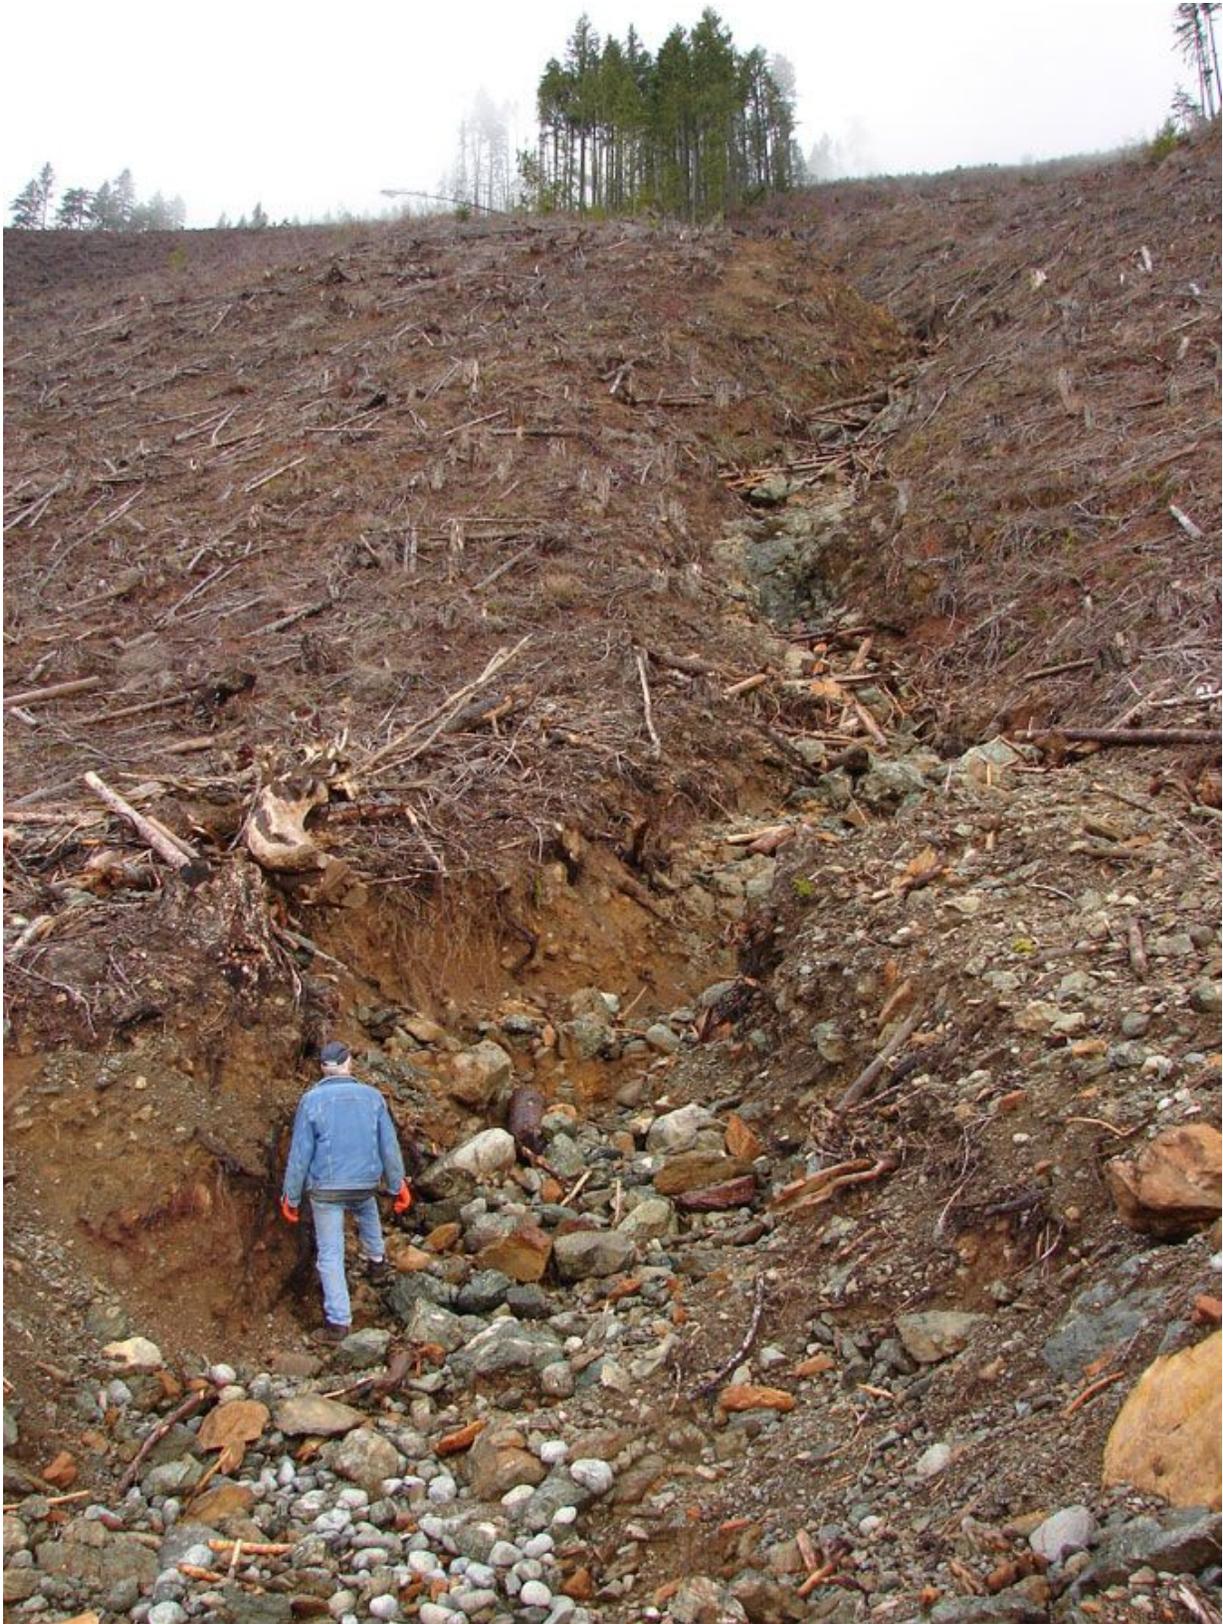
Photo 23. Erosion and widening of banks on denuded stream number 9.

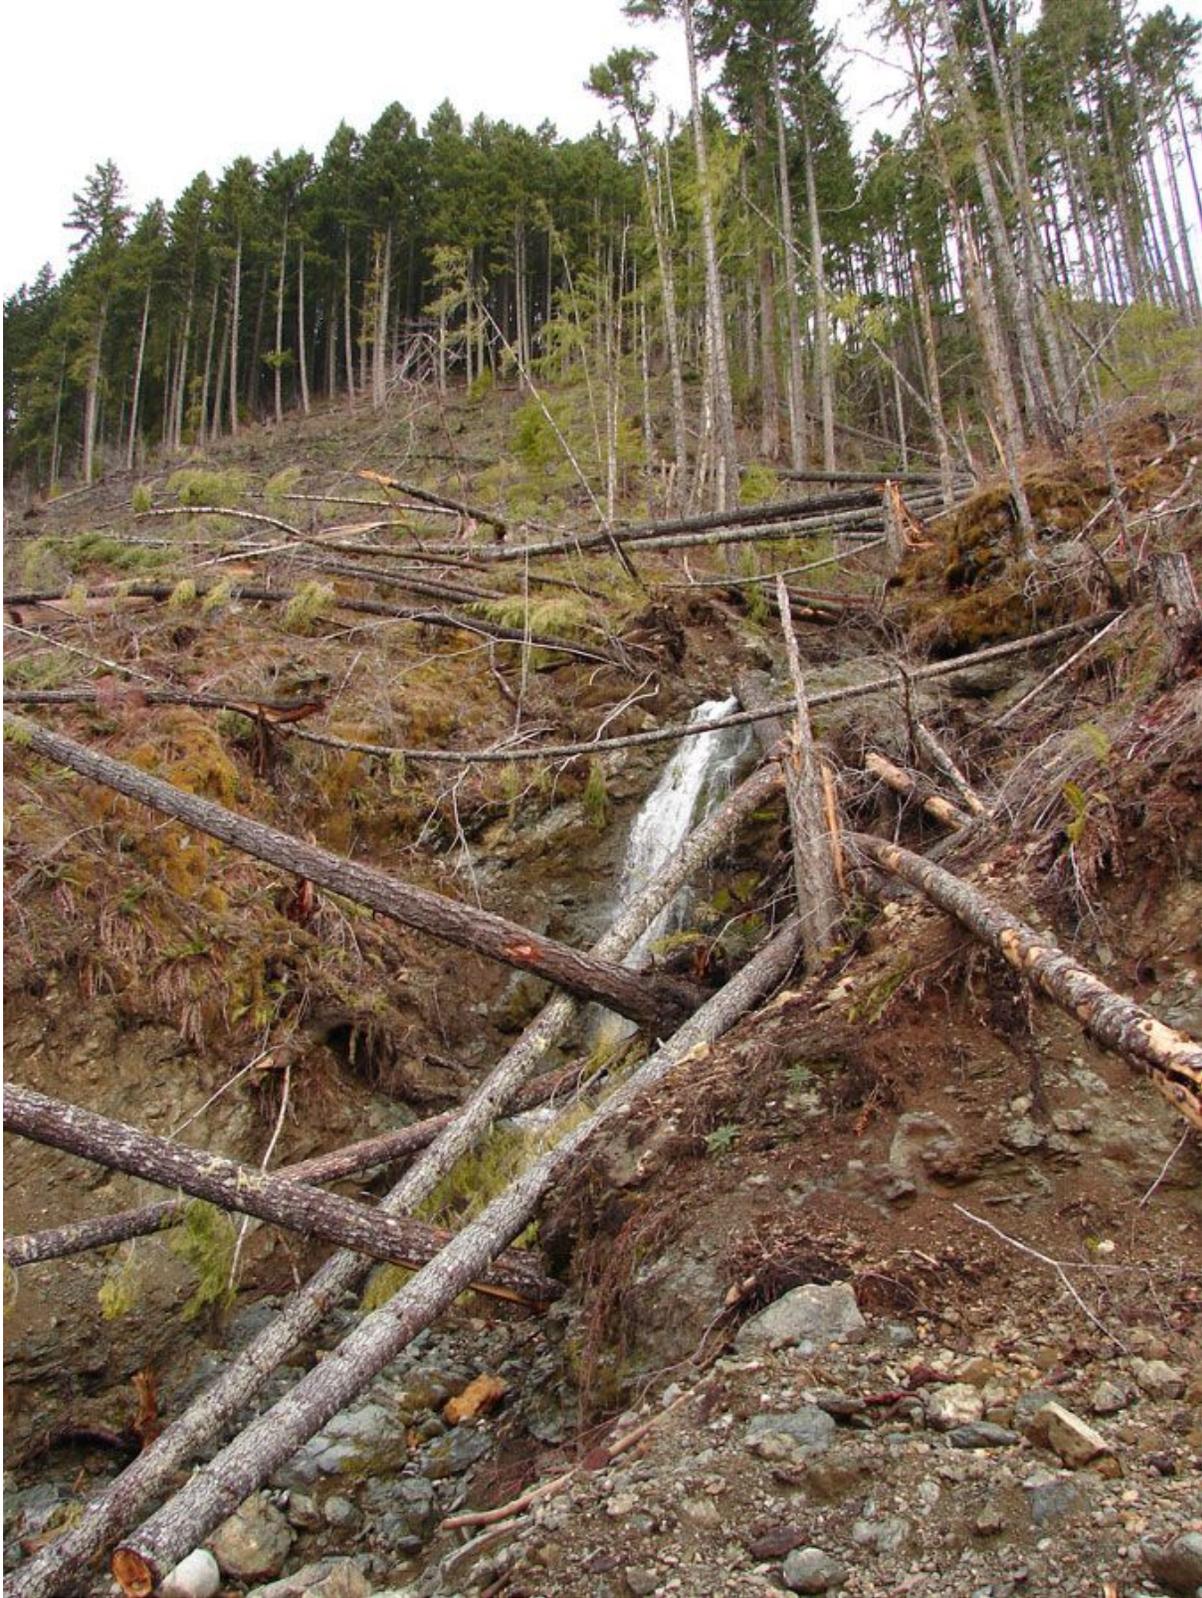
Photo 24. Just above culvert 27 on stream number 6. The extremely narrow buffer (shown in photo two) was blown down, causing uprooting on the edge of the stream, upheaving materials and boulders into the stream, which then plugged the culvert below causing a small dam to form.

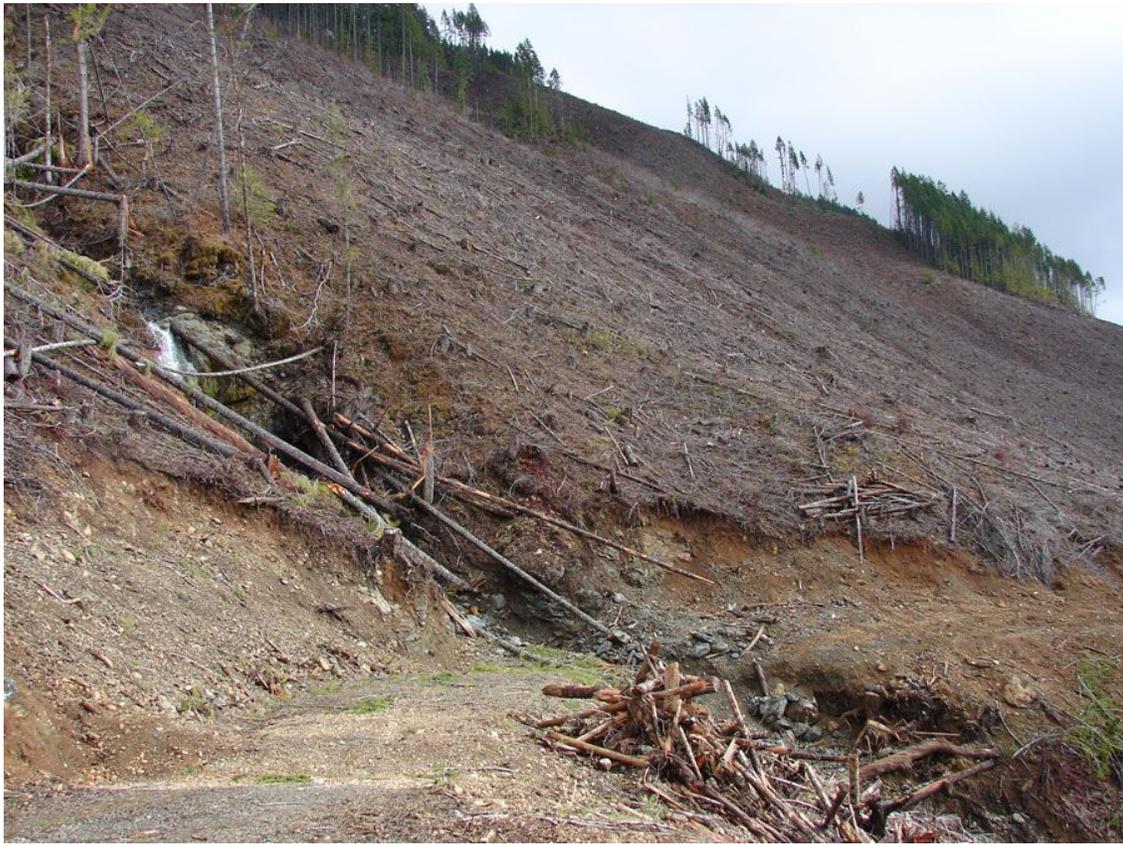
Photo 25 (above). Stream number 6 at culvert number 27. Location just below photo 24, where a dam formed, and then burst, causing a debris torrent to rush downward. Culvert was completely blown out and torn apart with the torrent.

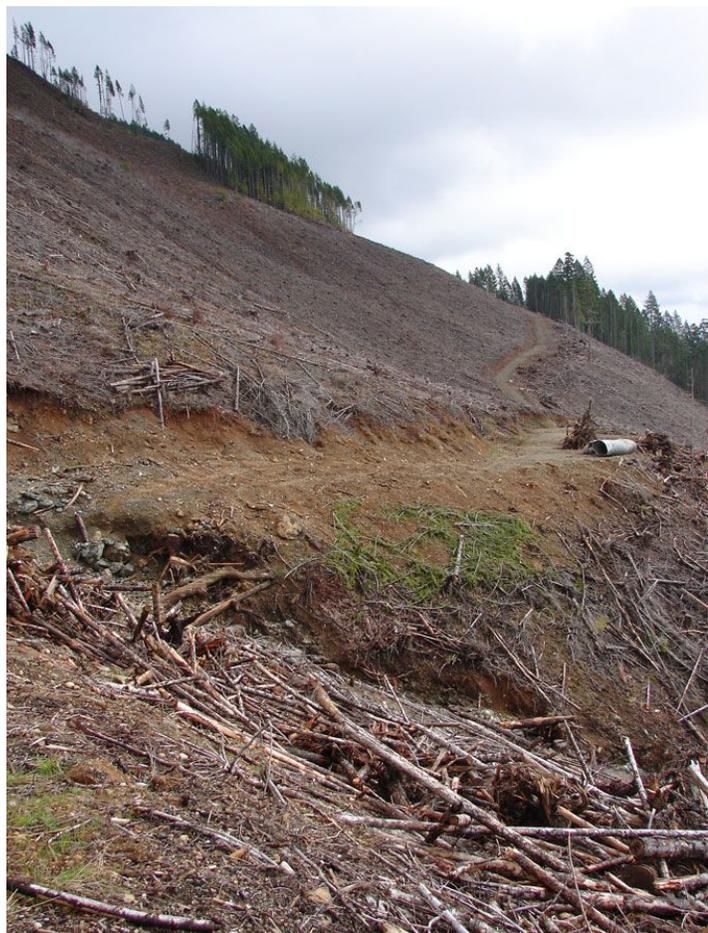
Photo 26 (right). Looking slightly the right and downslope of photo 25. Note the old culvert to the middle right of photo (shown below in photo 27). This culvert was removed before after a similar incident the previous year.

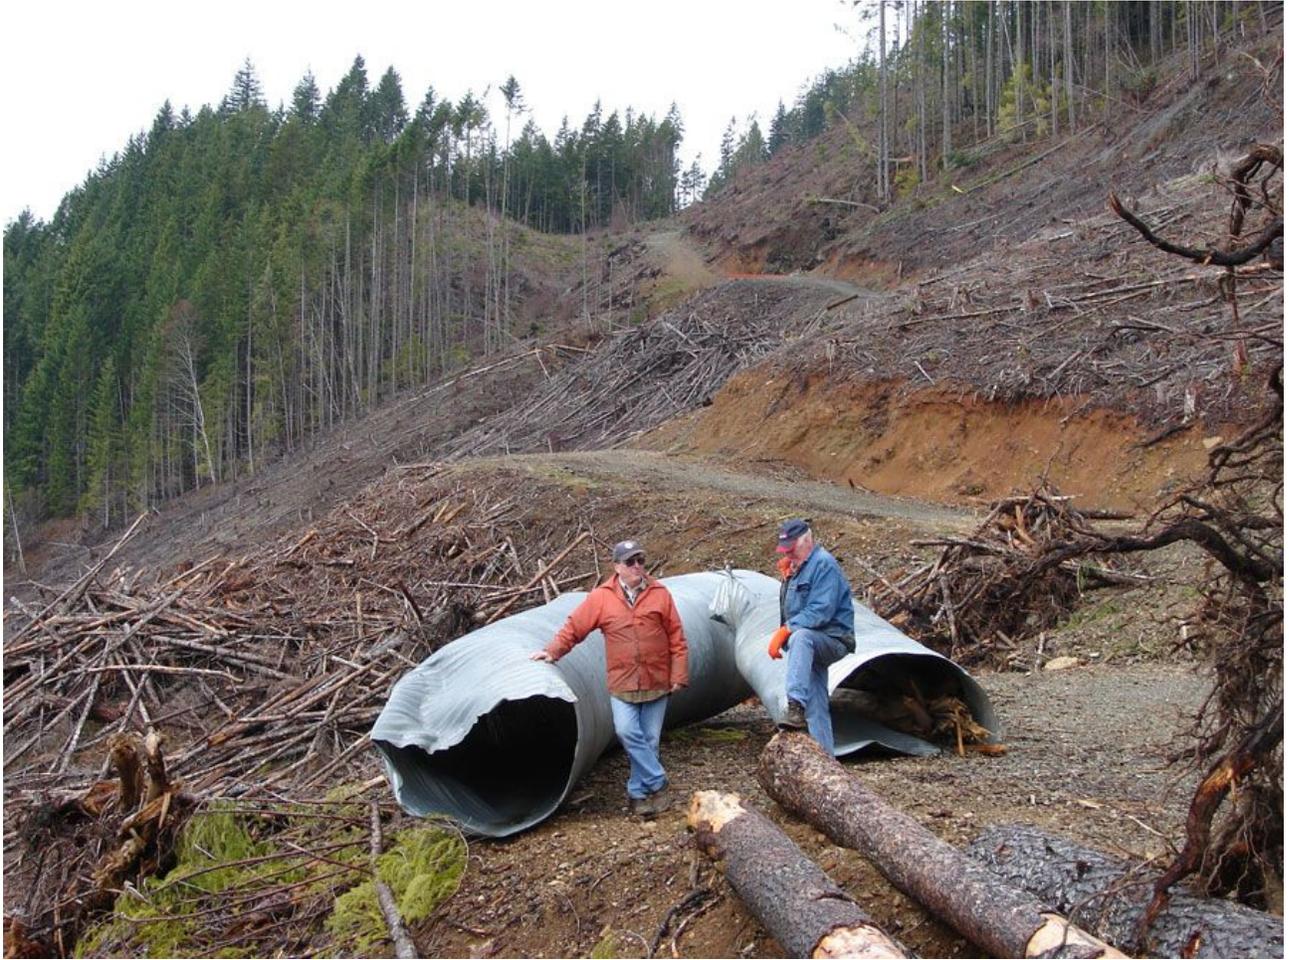
Photo 27. Former valley loggers and critics, Wayne Crowley (left) and Jack Klock (right), posing by former crumpled culvert number 27 removed by TimberWest in 2006 after a blow out. Port Alberni politicians were flown to this sight by TimberWest when the road was first built (before the blow-outs), and were shown a beautiful pool of water immediately above the newly placed culvert. Note all the logging debris (pecker pole waste) left in the distance.

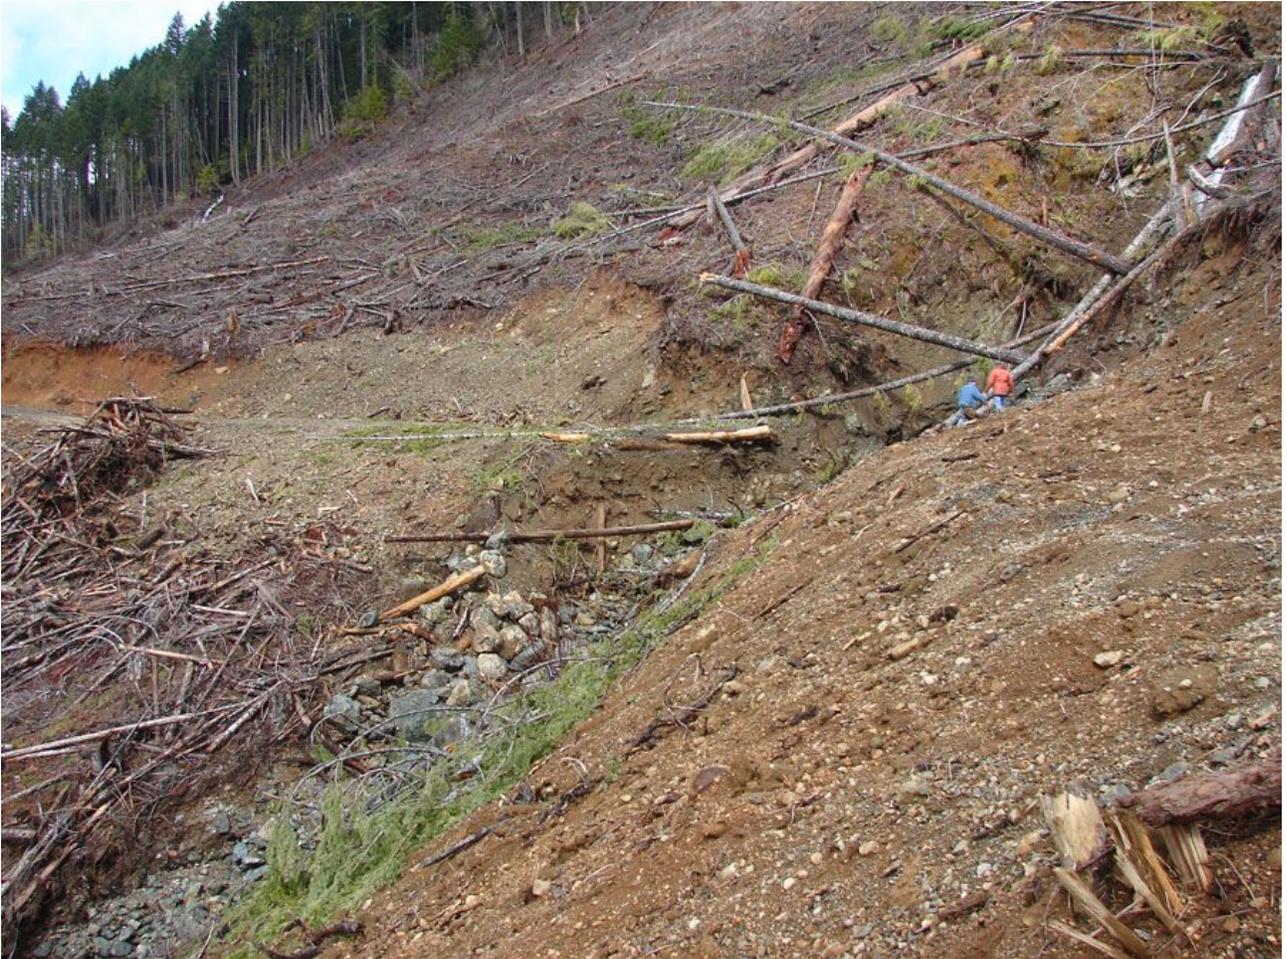
Photo 28. Looking at the blowout area on stream number 6 at former culvert number 27. Note the size perspective by two people at middle right.

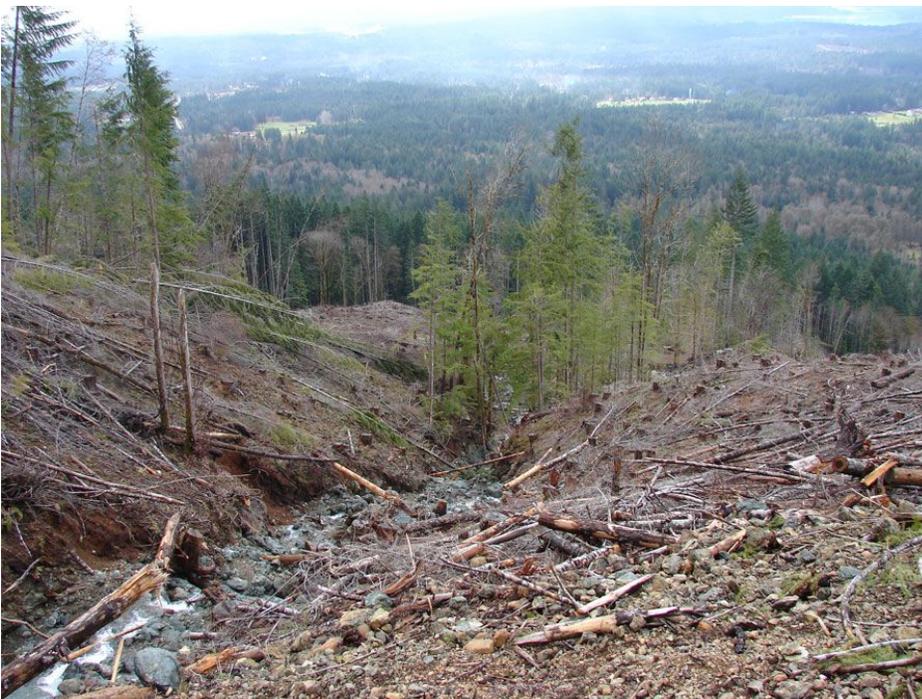
Photo 29. Looking downstream from former culvert number 27, along debris torrent path. Note no buffer, the widening of the creek bed.

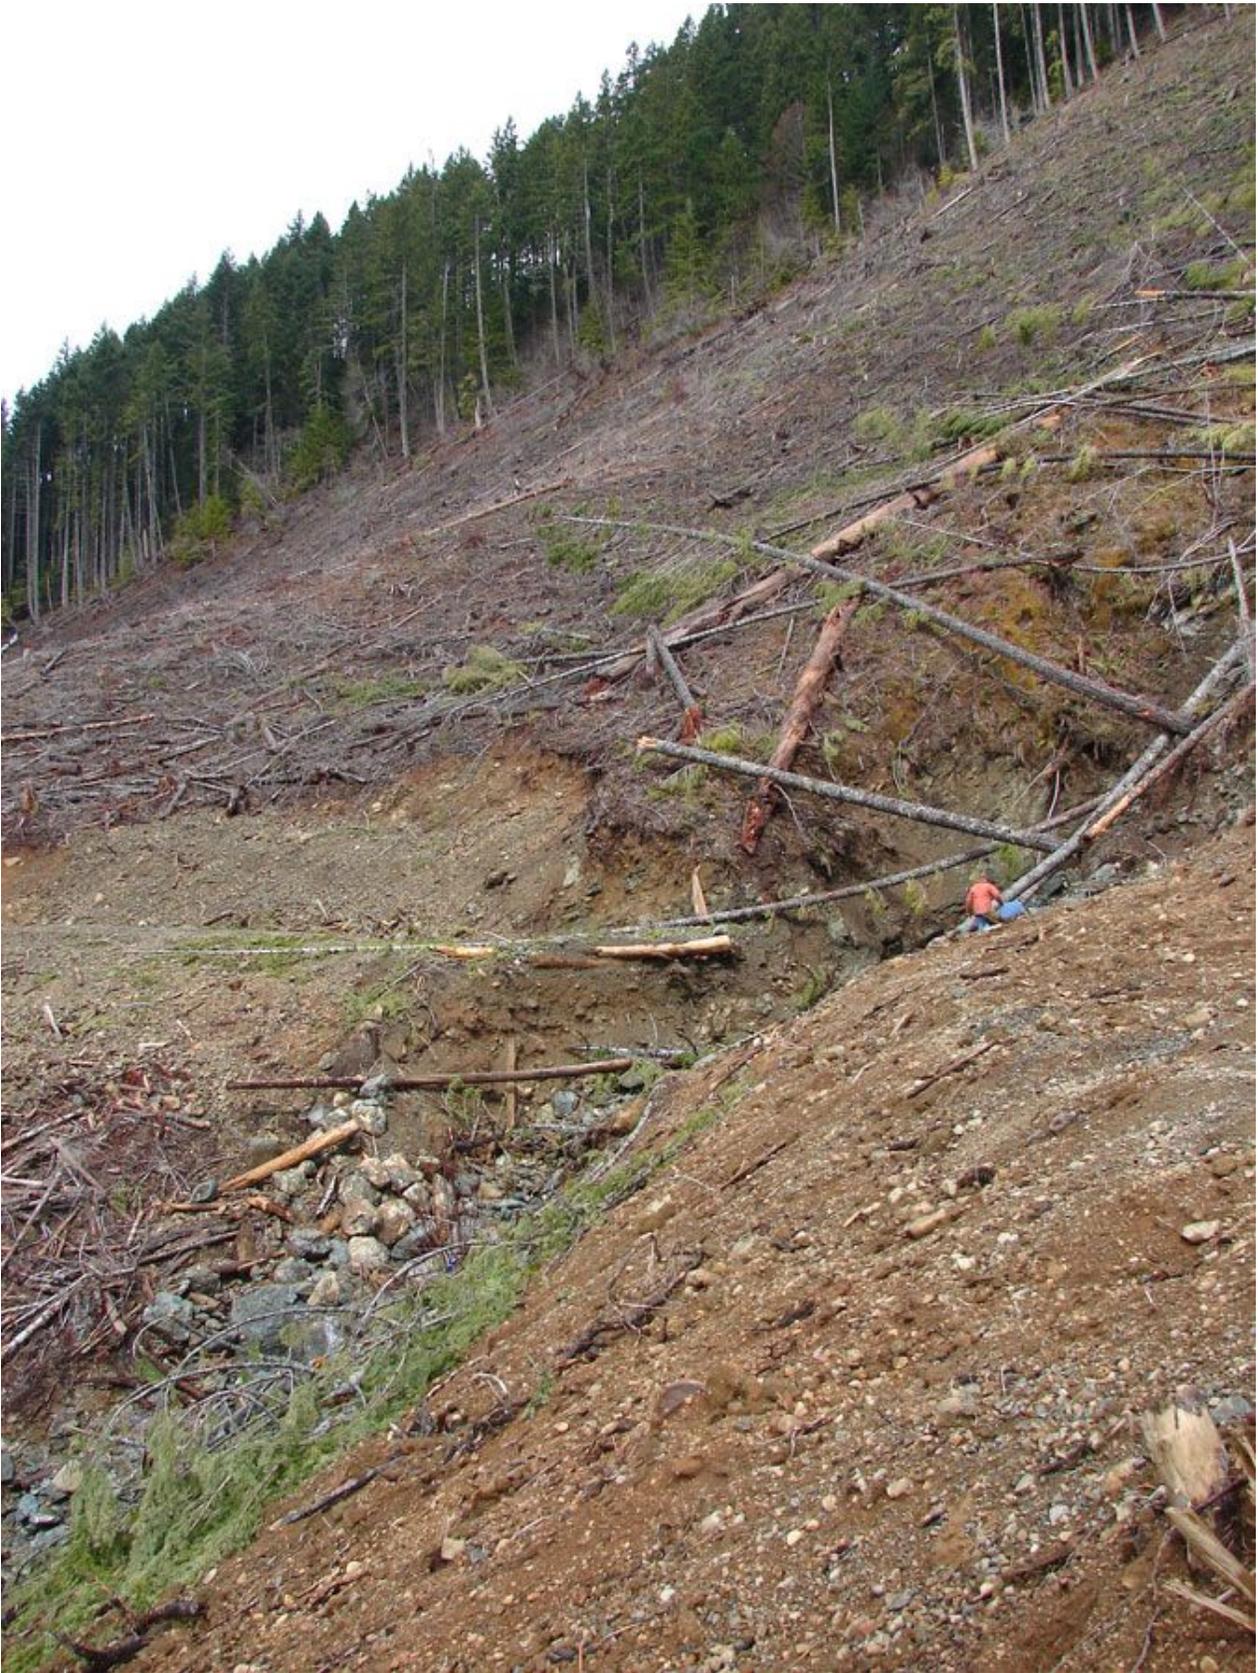
Photo 30. Same photo as photo 28, with more vertical profile.

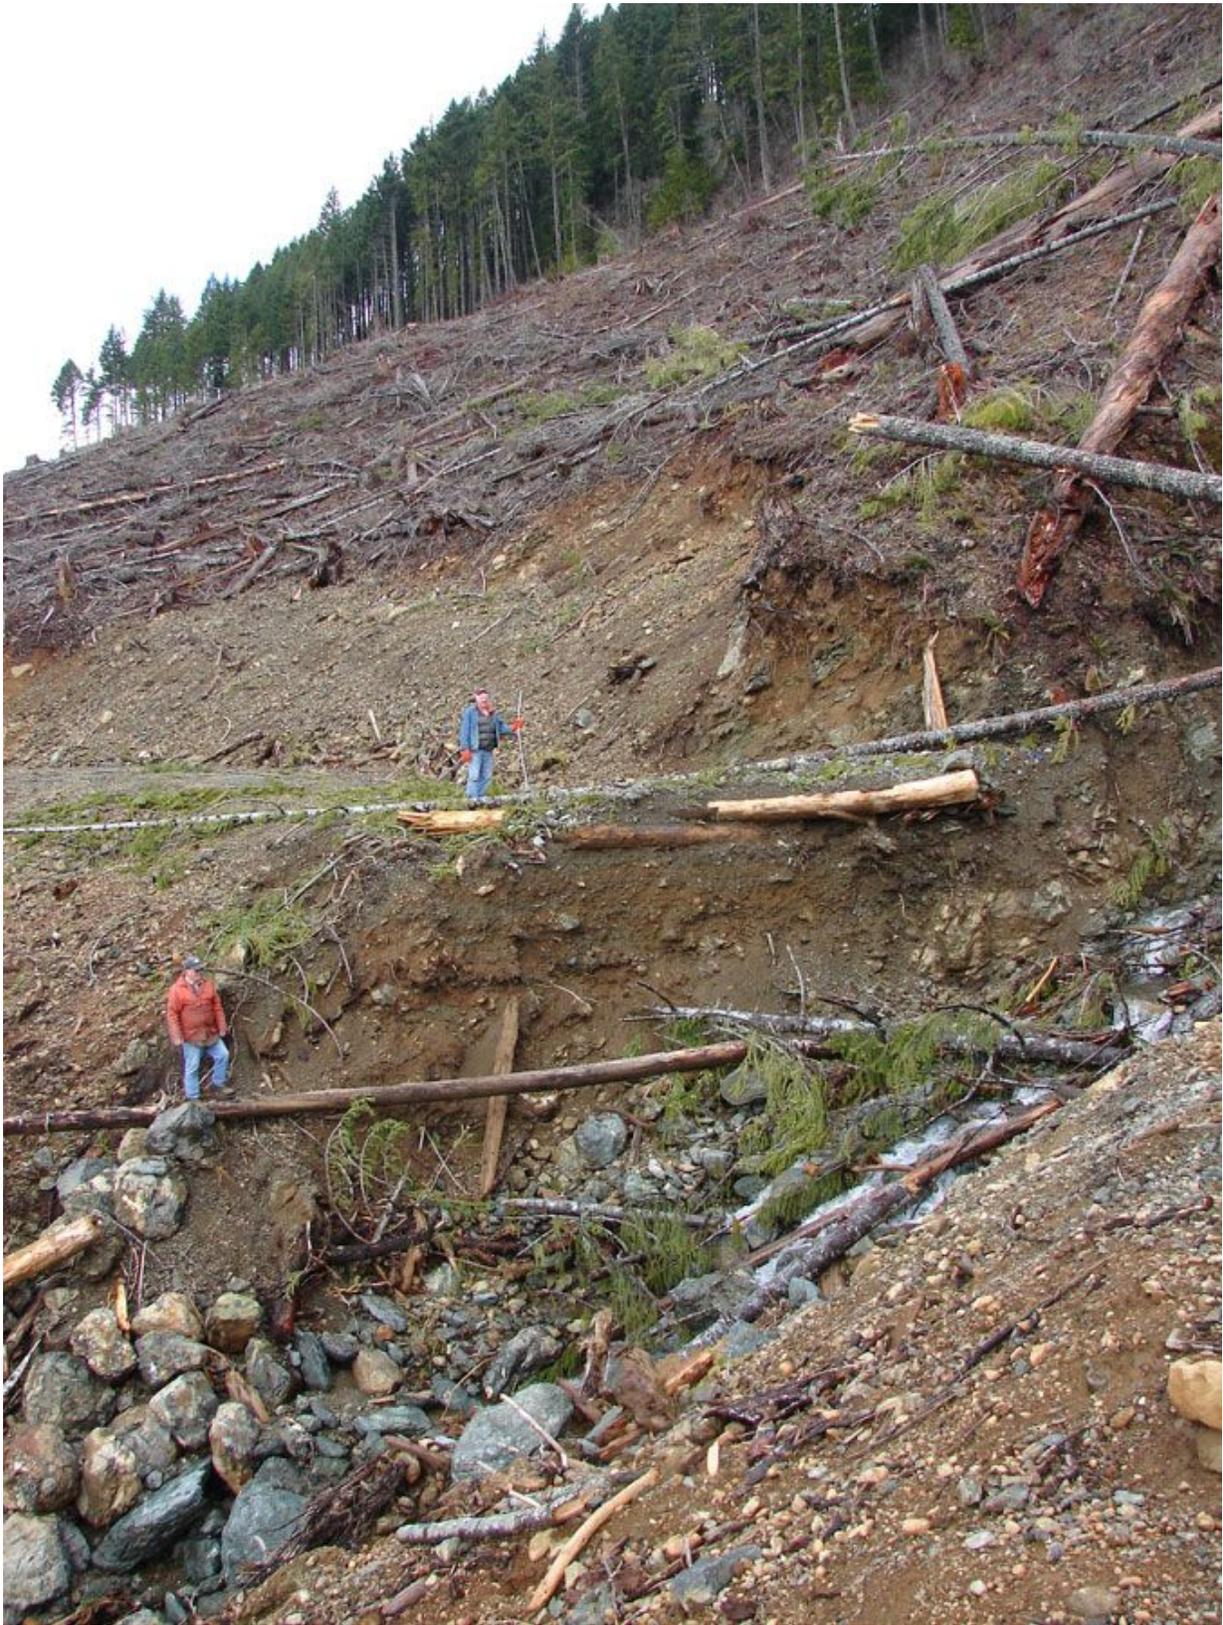
Photo 31. Showing profile of road area blowout on stream number 6, by former culvert number 27. Note the two people for scale. The road used to come across even with the person near the middle of the photo, who is standing on the road.
