**ON MARCH 24, 2007 – BC TAP WATER ALLIANCE
PRESENTATION IN PORT ALBERNI TO SOVA
(SAVE OUR VALLEY ALLIANCE)
COMPLAINTS ABOUT TIMBERWEST LOGGING AND
DRINKING WATER
- Compilation of Photos (by Will Koop) on March 25, 2007**

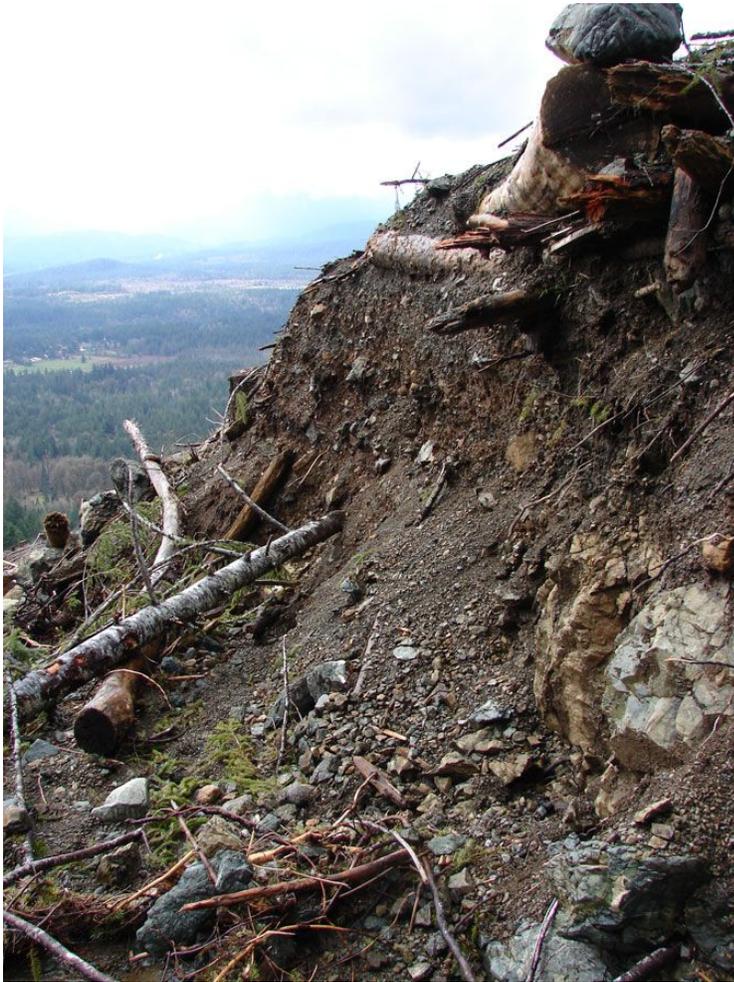
Photo 32 (left). Profile of depth of road height material remaining after the blow out on north side of road.

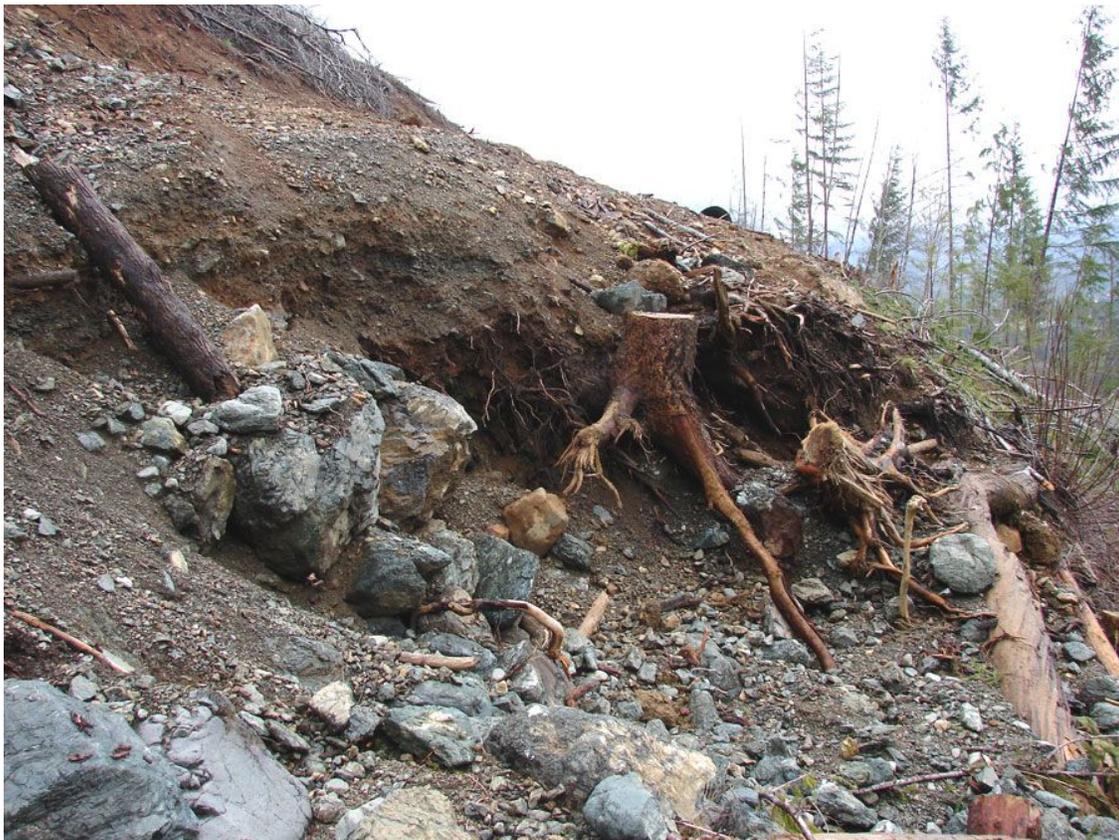
Photo 33 (below). Profile of depth of road height material remaining after the blow out on south side of road. Note the naked stump roots remaining.

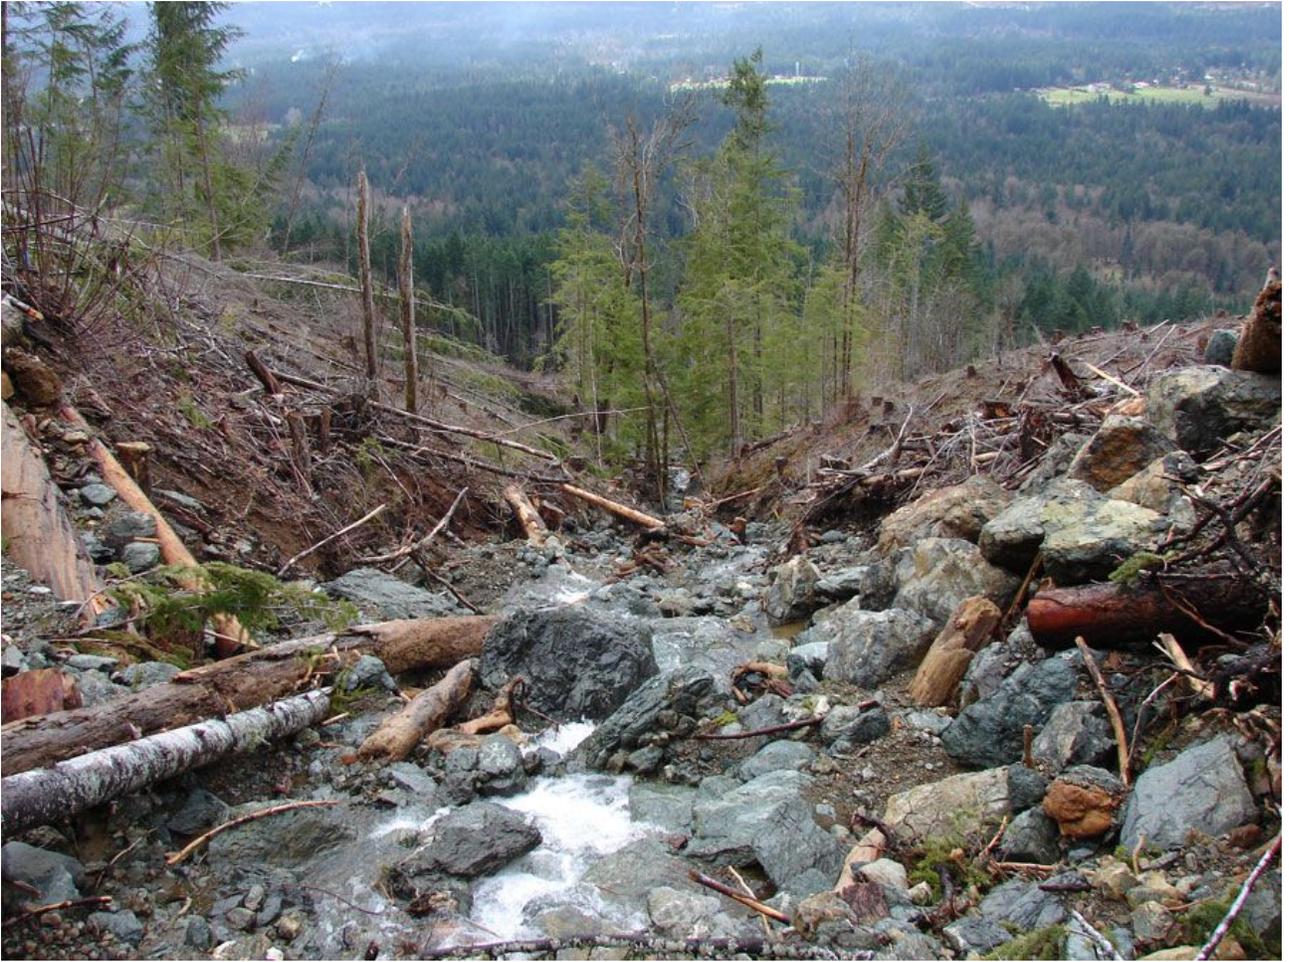
Photo 34. Looking immediately downstream from former culvert number 27. Note the extreme scouring of the former small stream channel down to top of boulders from the debris torrent event. No tree buffer for quite some distance.

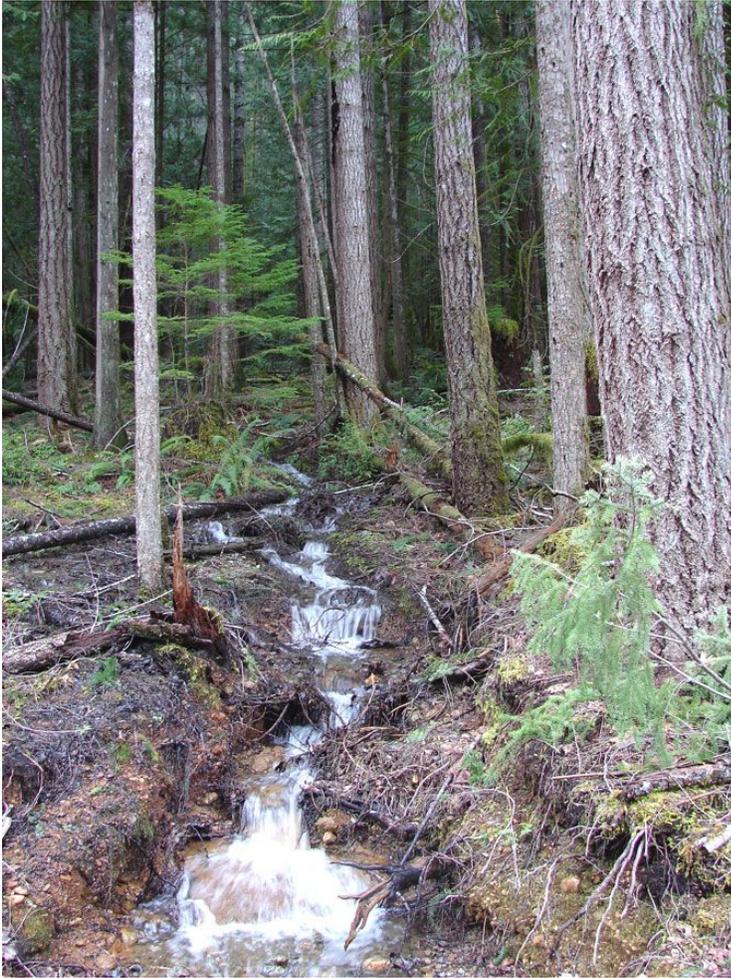
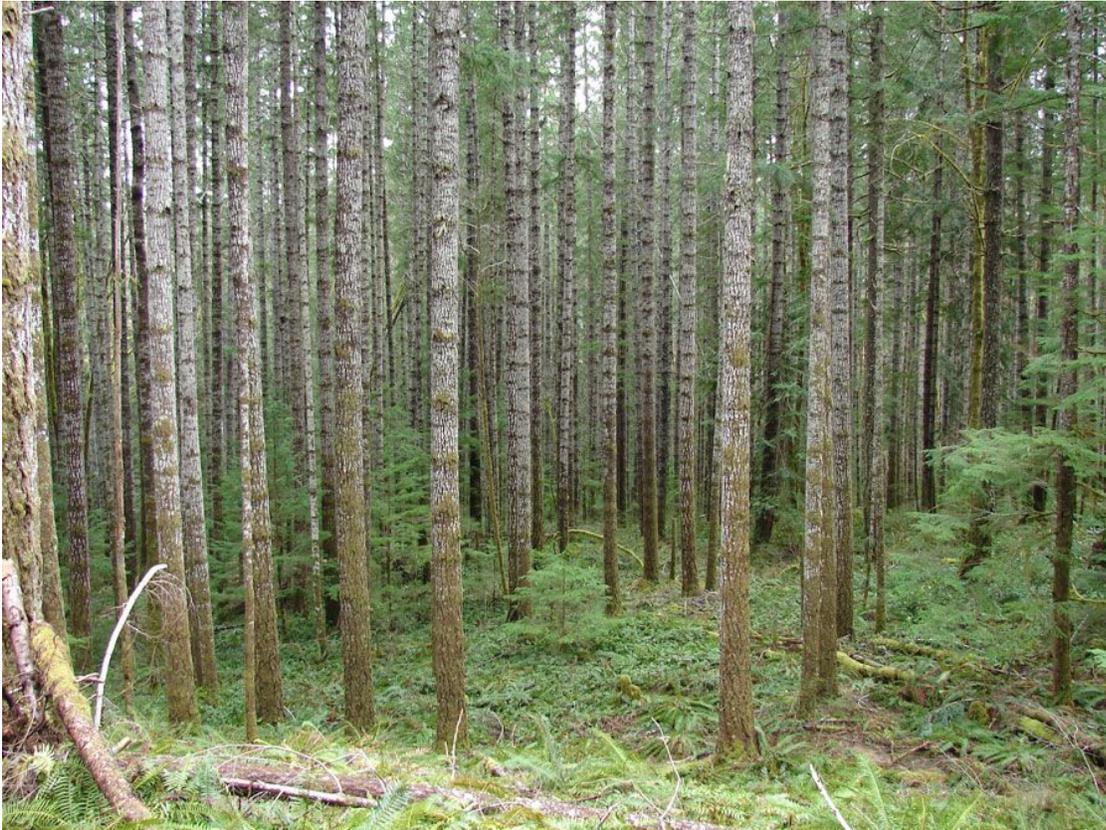
Photos 35 and 36. The way things were just over a year ago. A young, adolescent forest, which is just recovering, hydrologically, from former logging by MacMillan Bloedel.
