**A CRITIQUE OP THE LANDSLIDE REPORT
FROM JOHN MORSE TO THE WATER COMMITTEE,
BEING ITEM 2(D) OF THE FEBRUARY 10TH, 1995
WATER COMMITTEE AGENDA,
AN OVERVIEW OF OTHER RELEVANT DETAILS
WHICH WERE NOT REPORTED ON,
AND SOME GENERAL OBSERVATIONS**

By Will Koop,
March 10th, 1995.

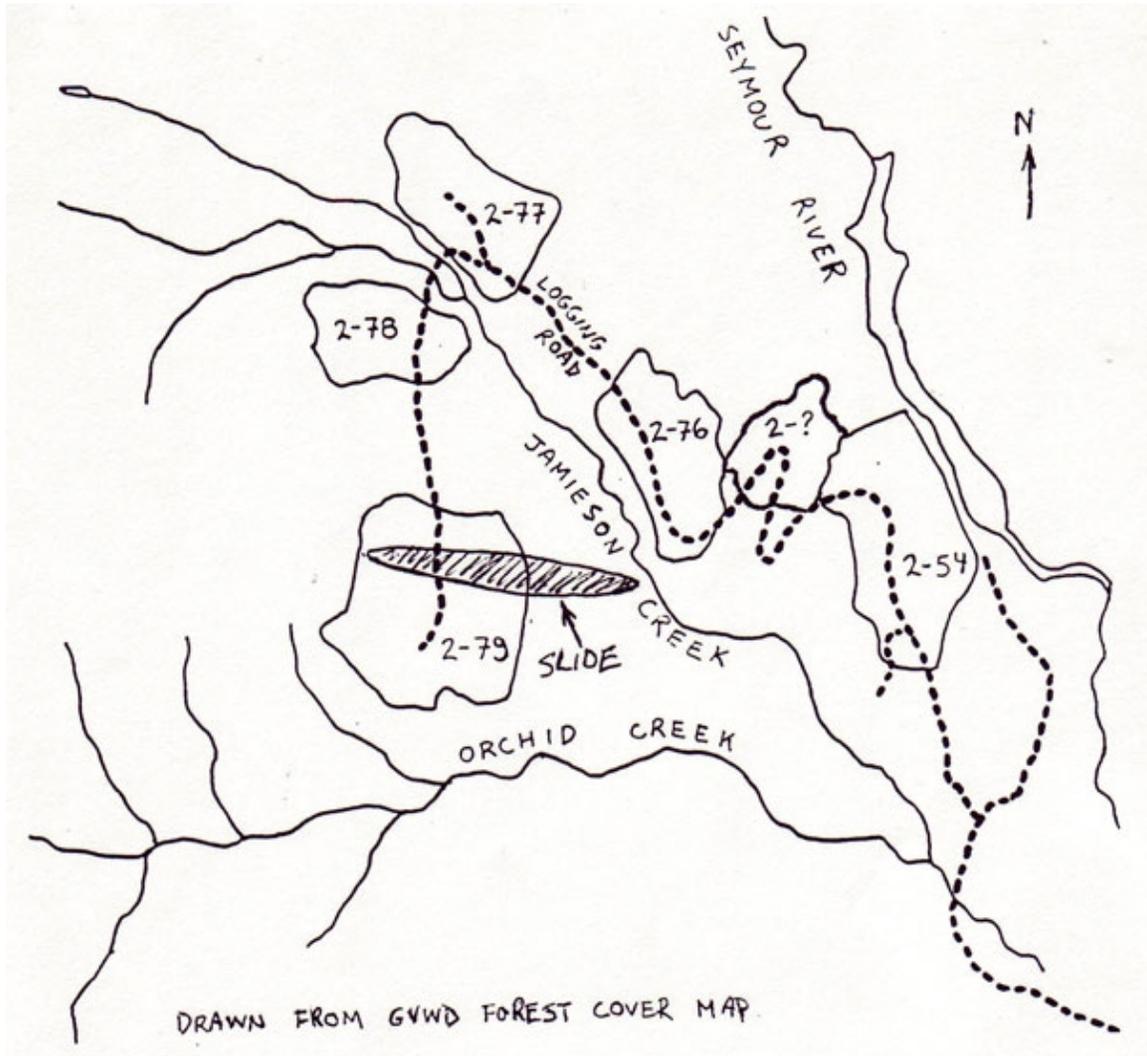
The Thurber report (cited above) mentioned the November 1990 rain storm which triggered a major slope failure in the experimental Jamieson drainage in cutblock 2-79, clearcut in 1984 (see below). The steeply inclined area destabilized due to forestry practices. One of the important and most likely contributing factors of this failure was the disintegration of tree roots over an eight year period, roots which once stabilized this slope. The result was a sudden and continuous concentration of sediments to Jamieson Creek, turbidity which eventually reached the Seymour water supply system. The point here is that the experimental model has provided plain and simple evidence of the effects of the GVRD's forestry practices to our water quality, an incident which became rapidly problematic for the GVRD, after which they hired the consulting firm, Thurber Engineering.

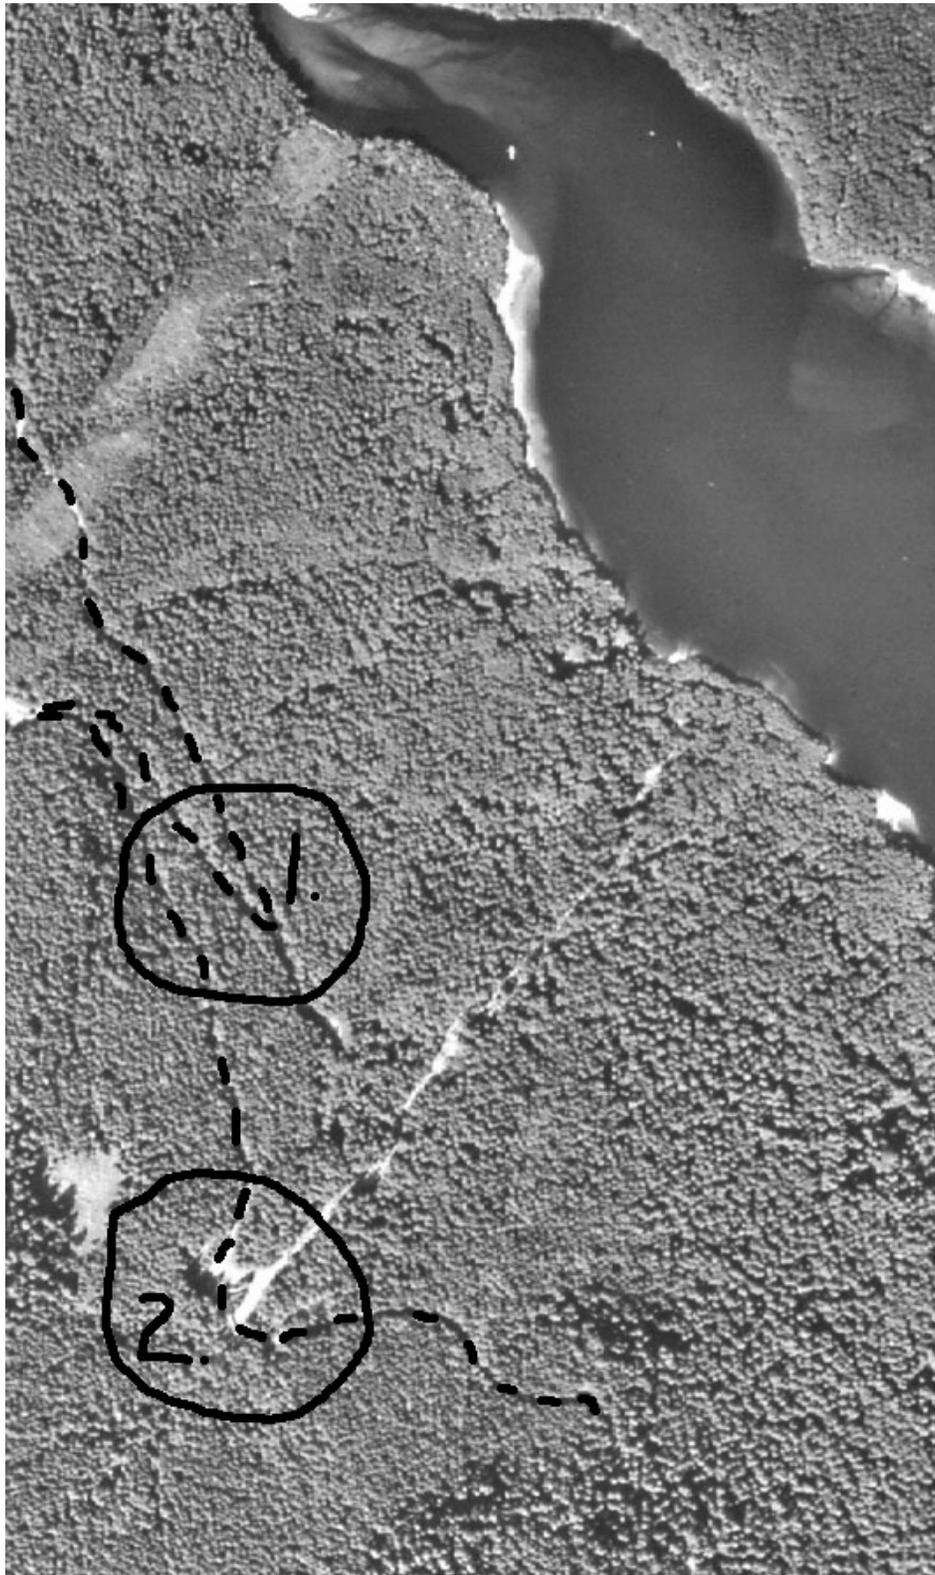
Aerial photograph showing west side forest above Capilano Reservoir, and Hollyburn logging road switchback. Area 1 (in top circle) is the location of Diagrams 1-2, and photos 1-6. Area 2 (bottom circle) is the location of photos 7-11.

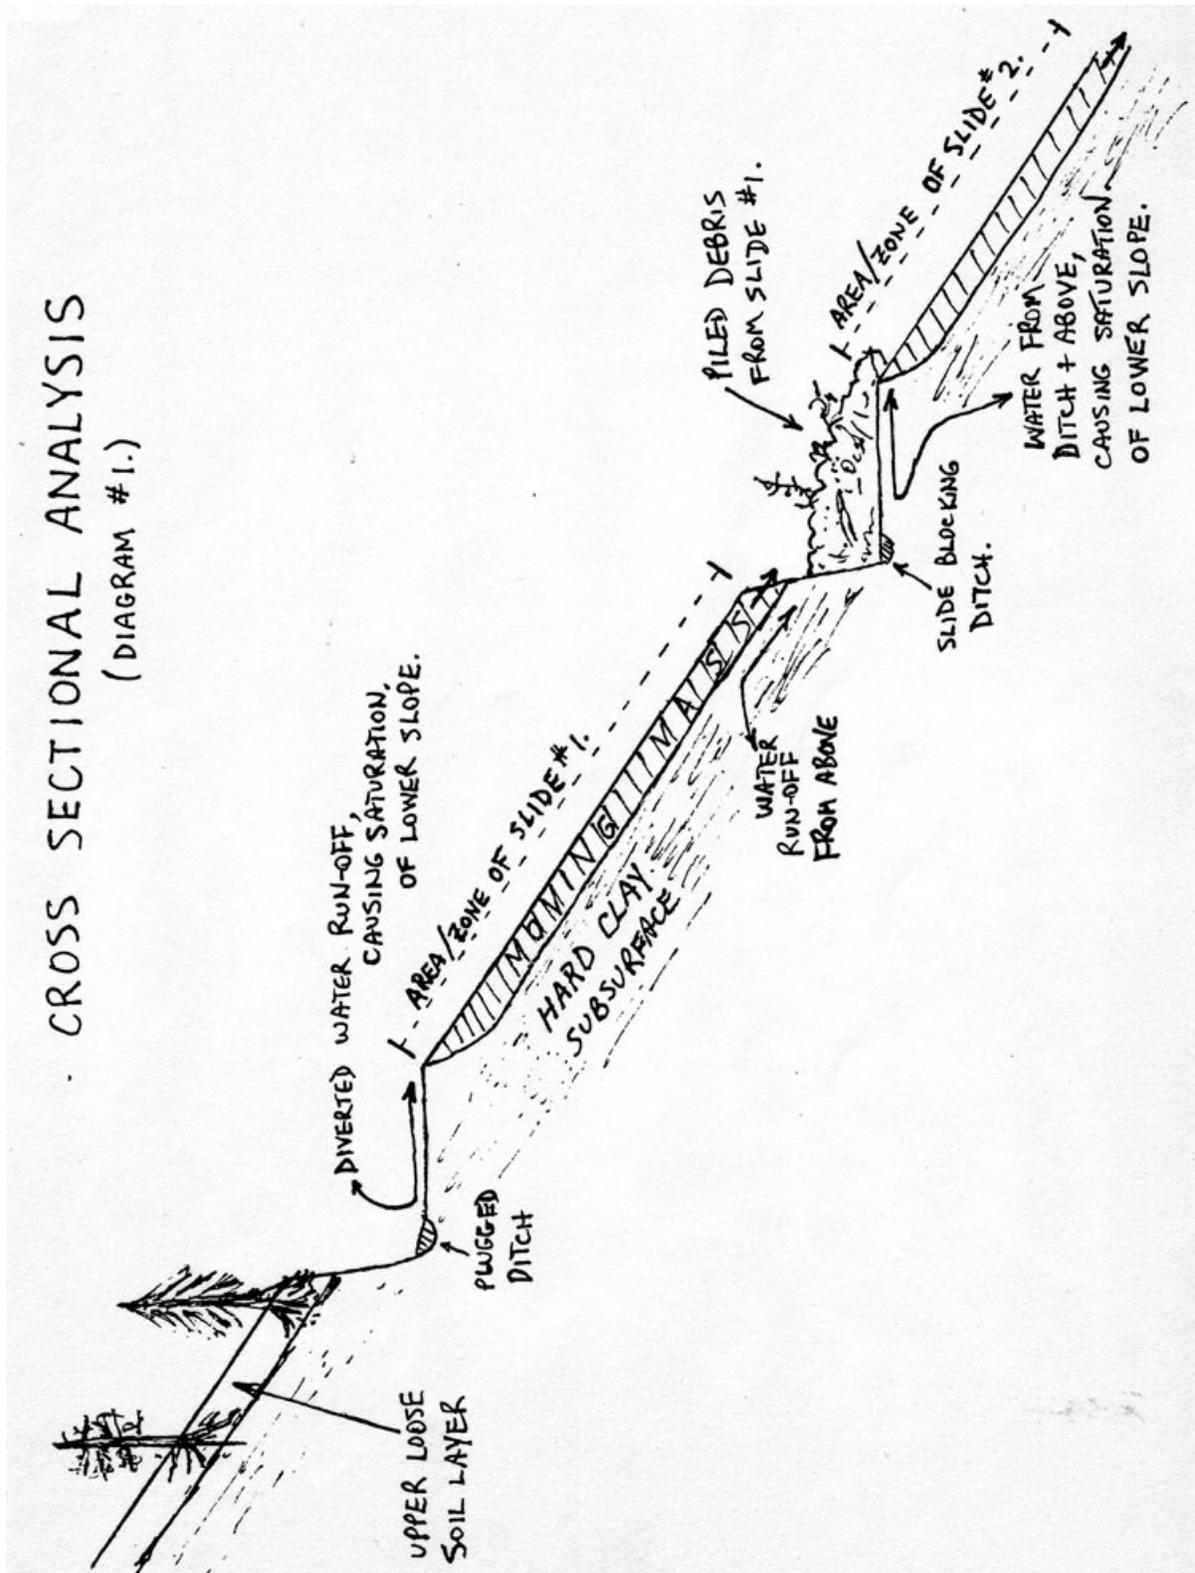
CROSS SECTIONAL ANALYSIS (DIAGRAM #1.)

An example of such a case was recently discovered after the storm events along the Hollyburn road branch, directly above the Capilano reservoir. Contrary to the Morse report, this slide did not originate in high elevation forest (diagrams 1 and 2 on pages 11 and 12). Water had been moving down along a shallow ditch. The water bypassed a damaged, narrow, and now functionless culvert, which should have intercepted some of the storm water's volume. Not much farther down the ditch from this culvert location, a number of long branches had fallen diagonally into the ditch area, slowly trapping forest litter and creating a small dam. The dam then deflected the stream onto the road and rushed down the middle of the road, carving out the fine road gravels (photos 1-2). About one hundred feet down from the diversion point the water spilled over and down the road bank, eventually saturating the slope. This young aged forested slope, which lay above a road immediately below it, eventually collapsed (photos 3-5), and a section about thirty feet wide and one hundred feet long slid across the road directly below (photos 5-6). This slope failure resulted in three more events:

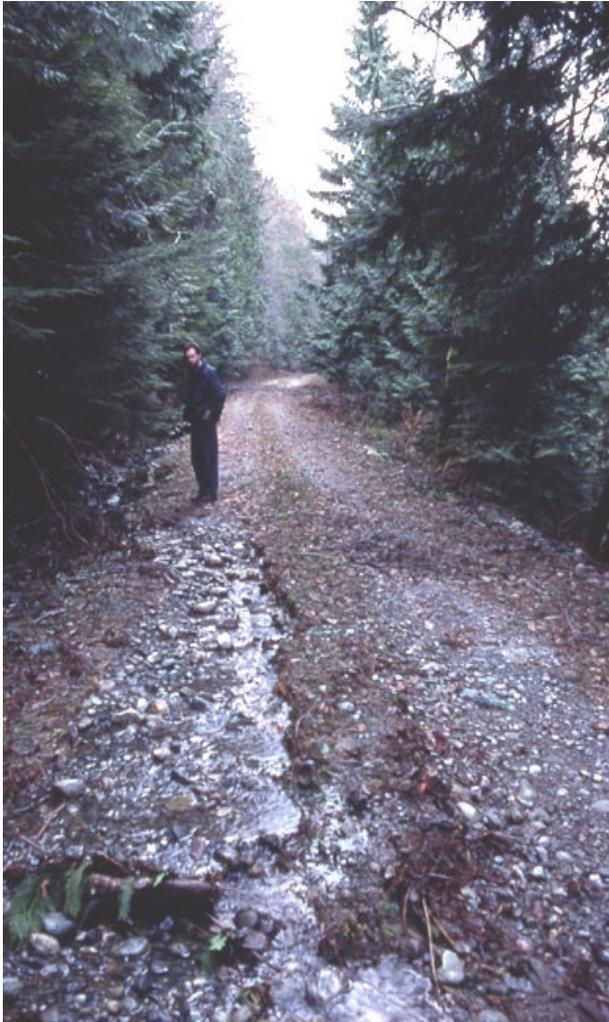
Photo 1 (left). Runoff water diverted onto road due to blockage in ditch. Road grade is about 20 percent.

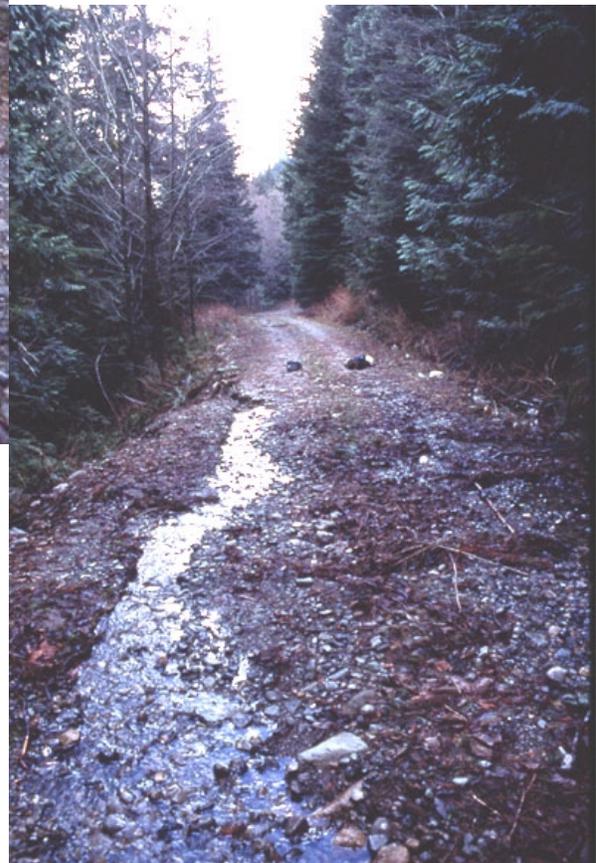
Photo 2 (below). Shows the path of the diverted water channel on road directly below photo 1, crossing the middle of the road, and then over the downslope where it caused a small landslide.

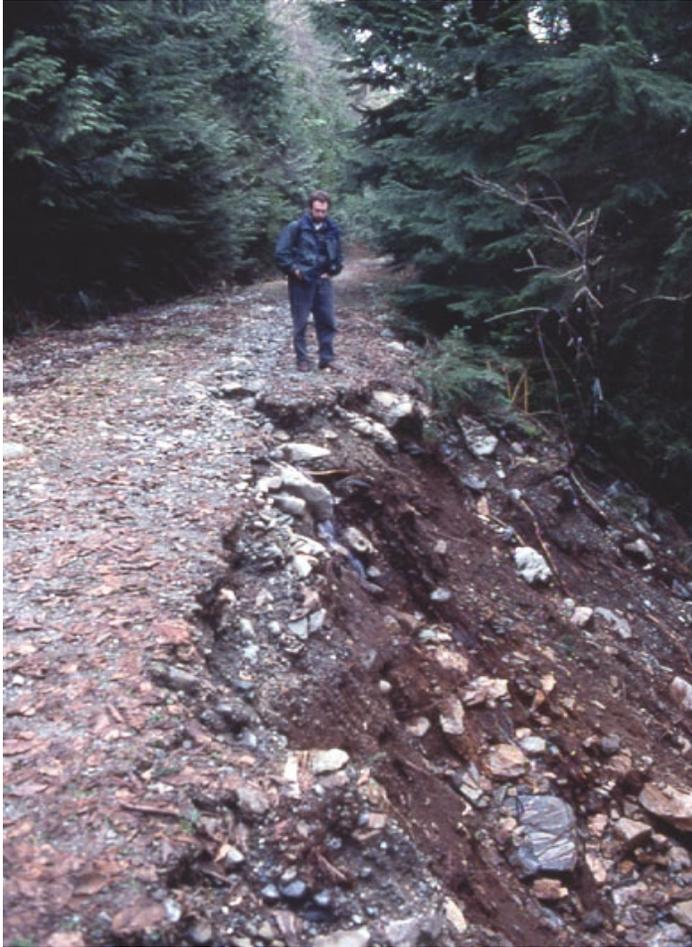
Photo 3 (left). Directly to left of person standing is the point where the diverted water runoff went down the slope, supersaturating the soil, and causing a small landslide.

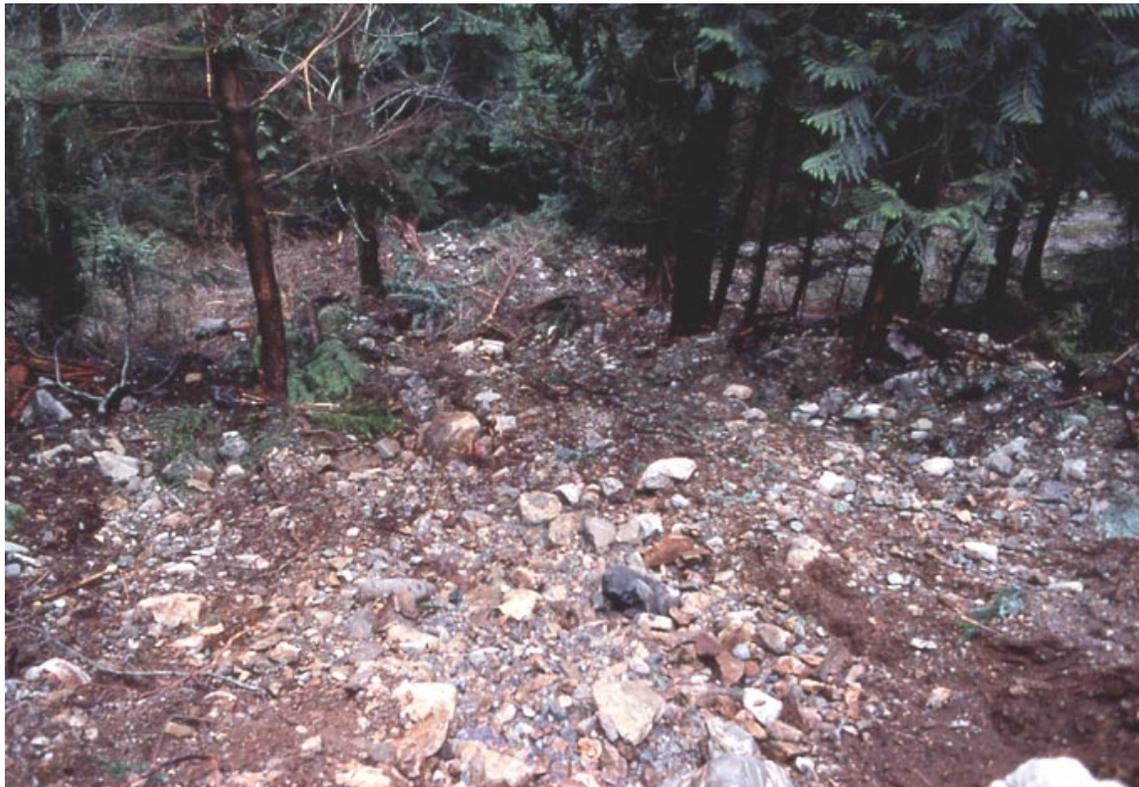
Photo 4 (below). Looking down the slope from photo 3. Small landslide has fallen across the lower road in the switchback. Water runoff was diverted in two directions, to left, and down the road, and to right of slide, across the road, and down the slope, causing another small slide.

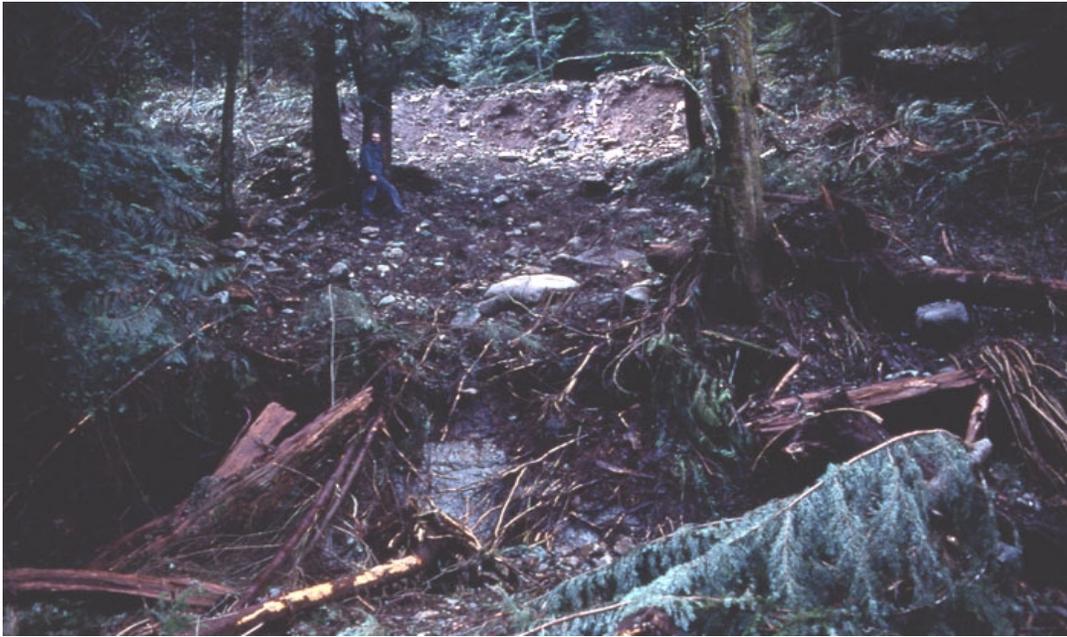
1. The water which had caused the slope failure was continuing to come down from the road over the now exposed slope and was diverted to the downward right hand side of the slide (examine diagram #2), which happened to be the up-slope portion of the road which the slide now lay across.
2. The water which had been traveling down the lower road ditch was blocked by the slide, and this water, joining with the other water just mentioned, flowed across the road, parallel to the slide material, and the combined waters then saturated the slope below this road.
3. This over-saturation of the road bank below the road caused another slope failure (photo 6), roughly the same size as the slide above.

Photo 5 (above). Shows the upper landslide area from lower road. For scale, note person in upper middle area. Water runoff diverted to right and left of photo, and down road ditch to right.

As a result, more taxpayer's maintenance costs are involved to restore the damaged road, to re-stabilize the two slopes, to remove the slide material, to replace and perhaps add another culvert, and more sediment may have accumulated in the Capilano reservoir.

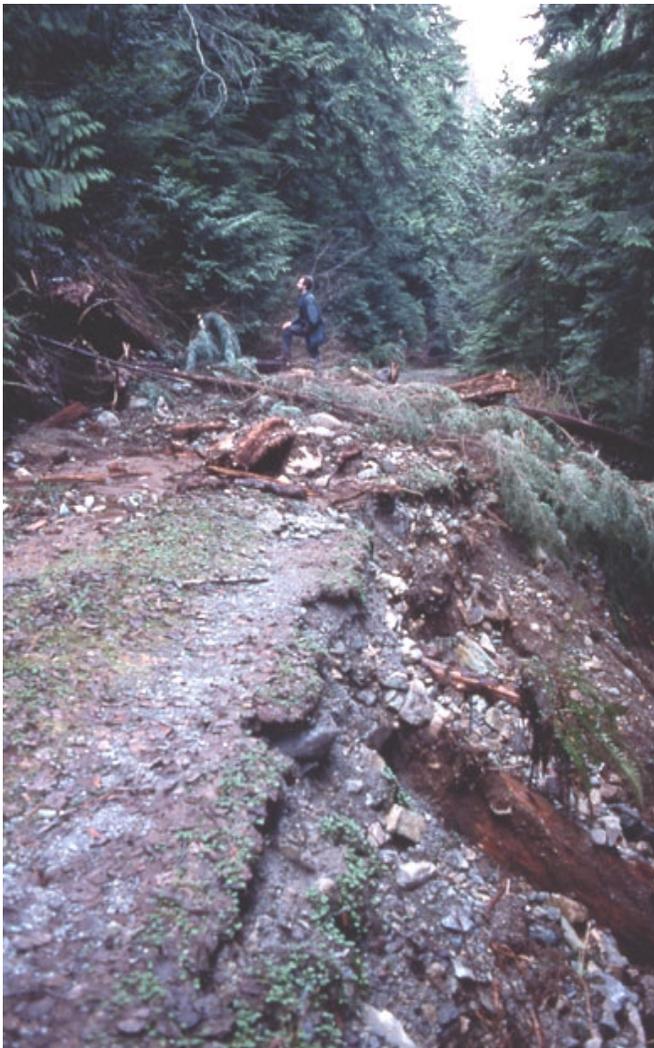
Photo 6 (left). Slide debris across lower road. Note man in middle of slide for scale. Some of the water runoff which caused this slide came down the slope and was diverted to this side of slide and over the road, combined with ditch runoff immediately to lower left of photo, to cause another slide to lower right of photo. Size of slide similar to slide above it.

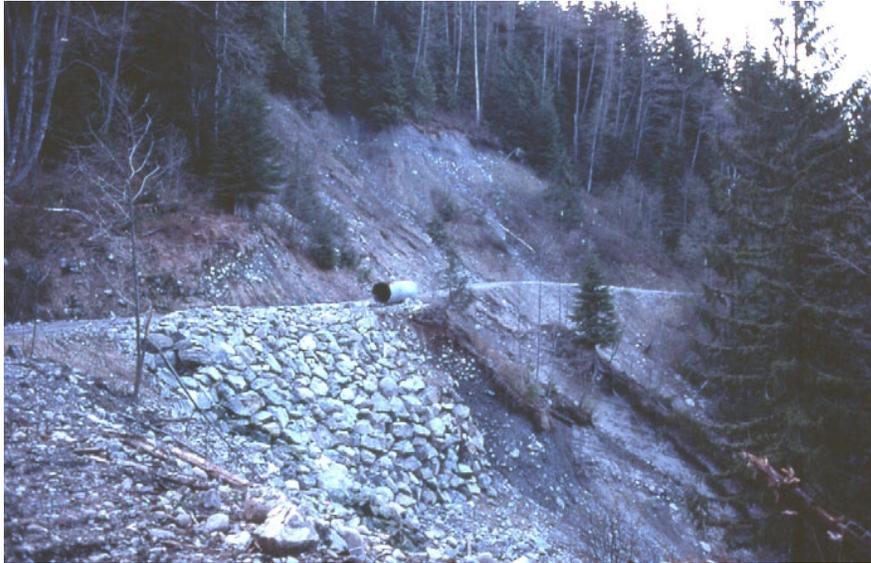
An example of the long-term effects from roadbuilding, and the source of recent fine clay turbidity in the Capilano reservoir, can be found directly above the north-west portion of the reservoir itself. At the end of last February, 1994, during another dramatic rain-on-snow event, two u-shaped sections of loose clay soil, both about ten metres wide and about thirty or more metres long by about seven metres deep, slid off the downward portion of the Hollyburn spur road (photos 8-10). The debris which gave way filled a steep main creek gully directly below it, and the rushing waters carried the clay sediments directly into the reservoir (photo 11), causing a productive turbidity event. This problem was never properly addressed nor reported to the Water Committee. Another rather serious section of eroded upper road bank exists directly above and to the

Photo 7 (left). Large top and bottom cutslopes in area 2 (see page 10), the source of fine silt erosion and turbidity.

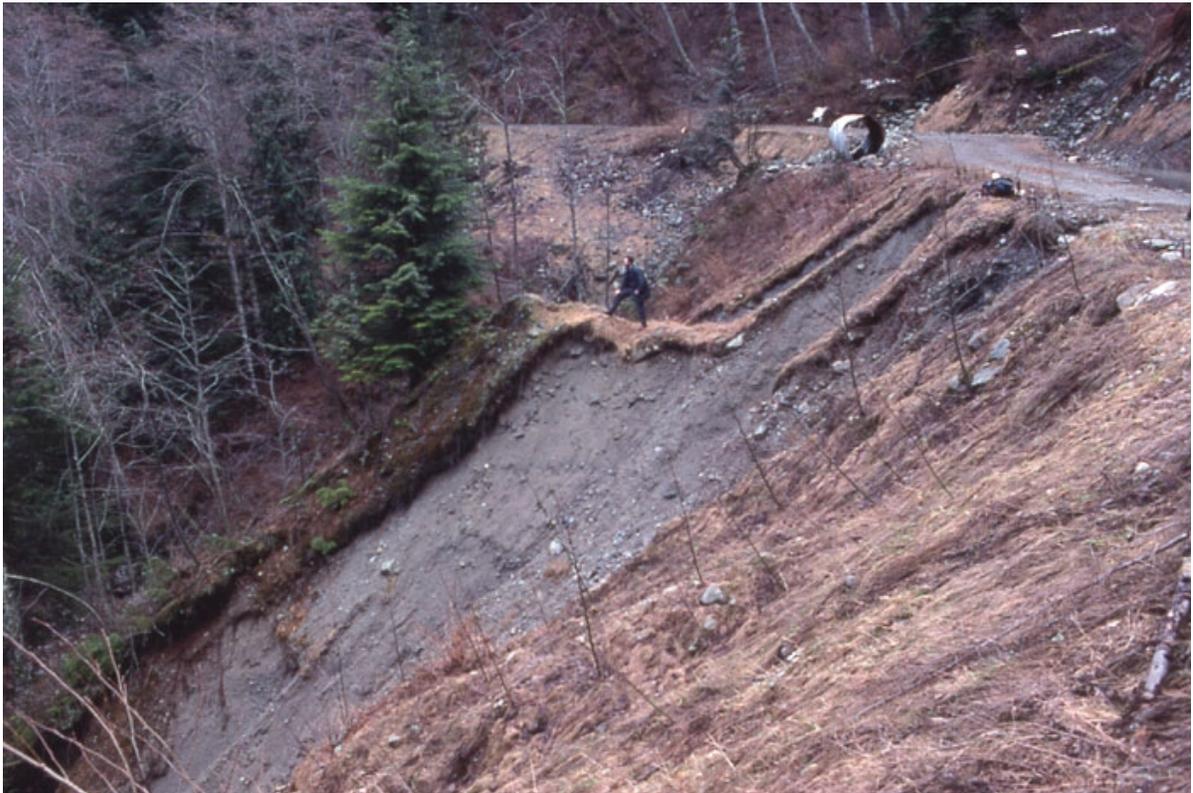
side of this site. A section from a very steep clay bank about fifty metres wide by about 40 metres high also slumped last February 1994. The upper bank slide material oozed across the road and the fine silt was funneled into the same creek channel below. The problem with both steep banks is that materials will continue to erode because of roadbuilding. The lower slope can be repaired, but at great cost. The upper slope may be almost impossible to correct, because of the length and inclination of the bank. It was a bad place to cut a road, and if that road location had been absolutely necessary, a very long bridge ought to have been built to properly protect such a sensitive area. Of course to construct a bridge in this location would have exorbitant costs.

Photo 8 (below). Reverse angle of photo 7, showing large slope failure below road. Note person in middle of photo for scale. Hurricane Creek is about 100 feet behind person.

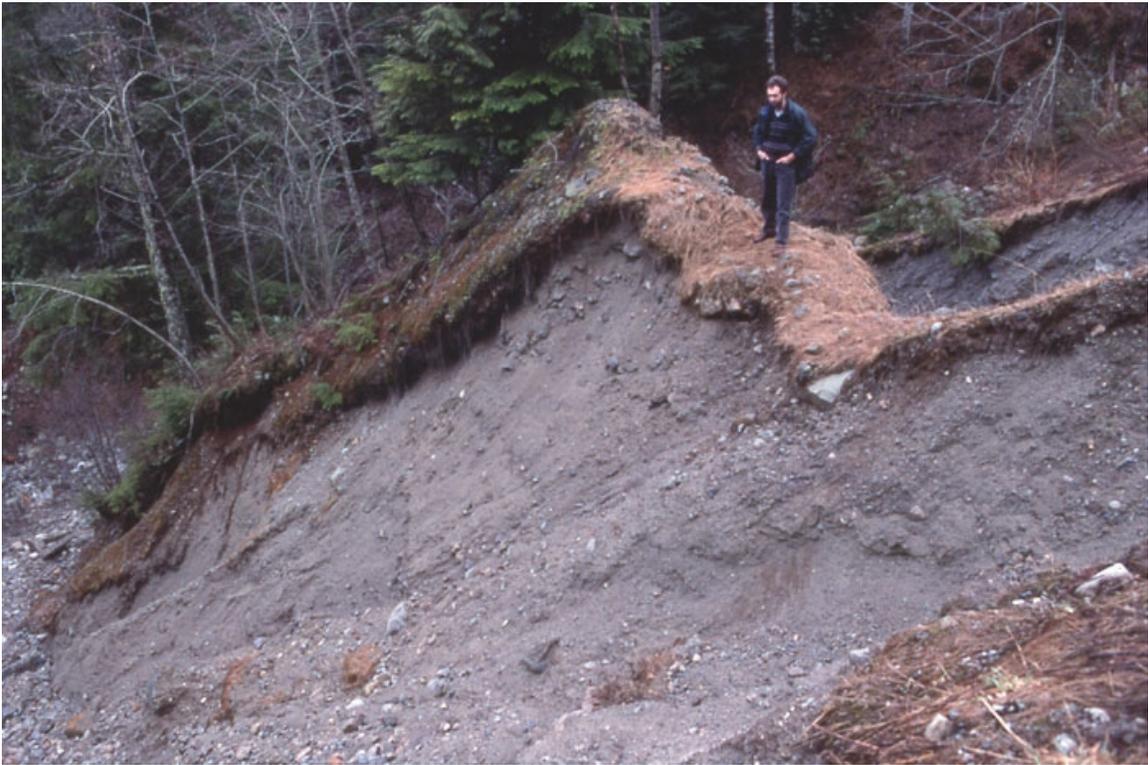
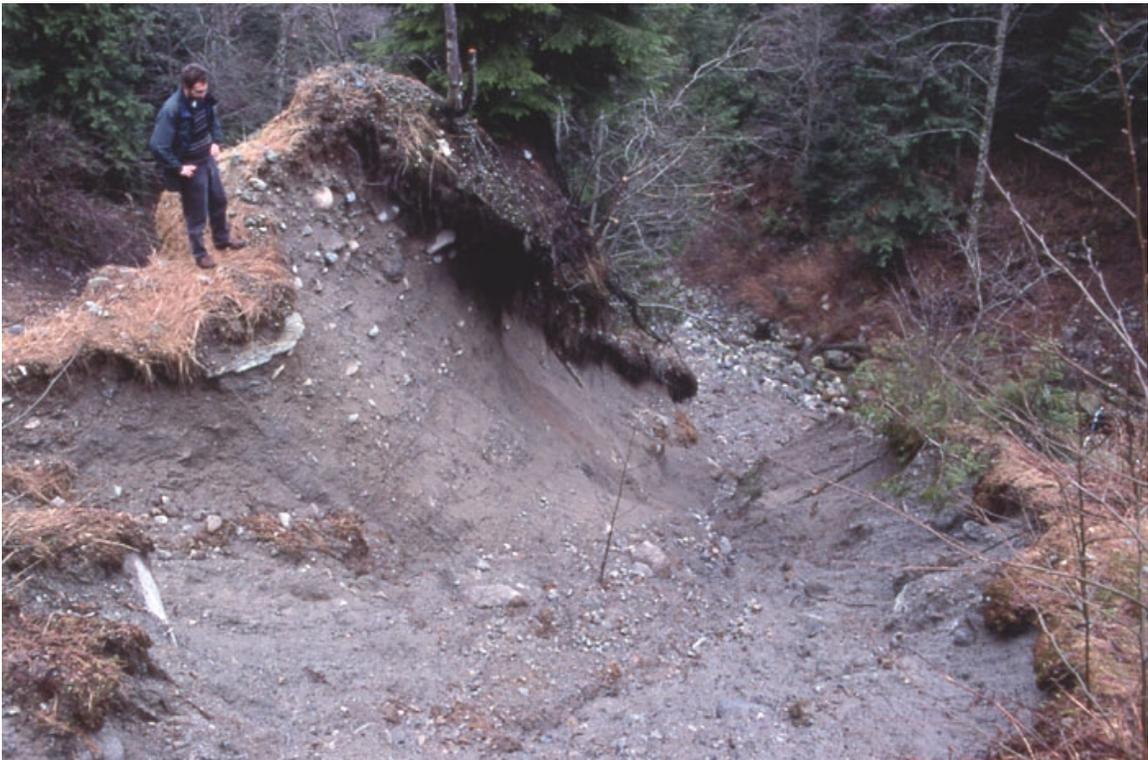
Photo 9 (above) and photo 10 (below). Photos looking downslope from road, showing deep erosion of fine silt slope material, on either side of remaining thin, erect island of material where person is standing. Note that the island is supported by tree roots. This island will let loose at any time, as slope is continuing to erode, and has considerably weakened as a support for the road directly above. Hurricane Creek is directly below, where washed silts from slide material, causes turbidity, and is transported directly into Capilano Reservoir.

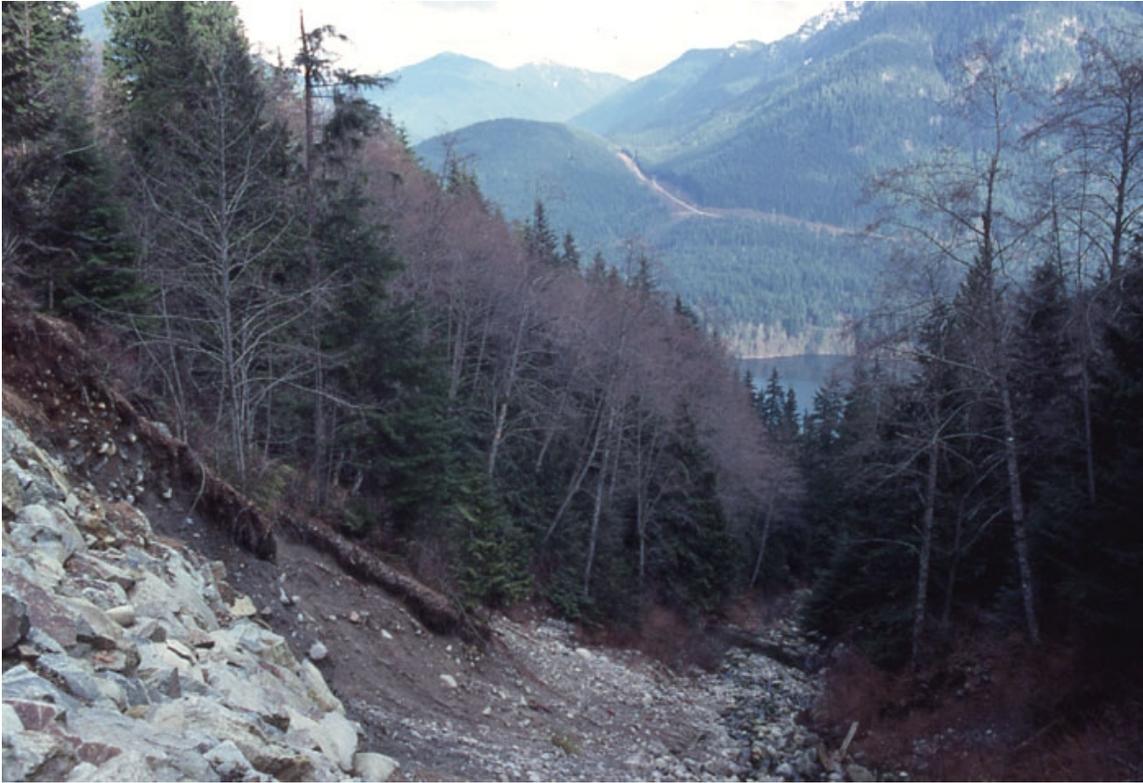
Photo 11. Looking down Hurricane Creek. Note Capilano Reservoir below. Note eroded banks to bottom left area. All debris washed into creek and down into reservoir. The Water District previously placed rip-rap (rock) on slope to support road and bank to bottom left..

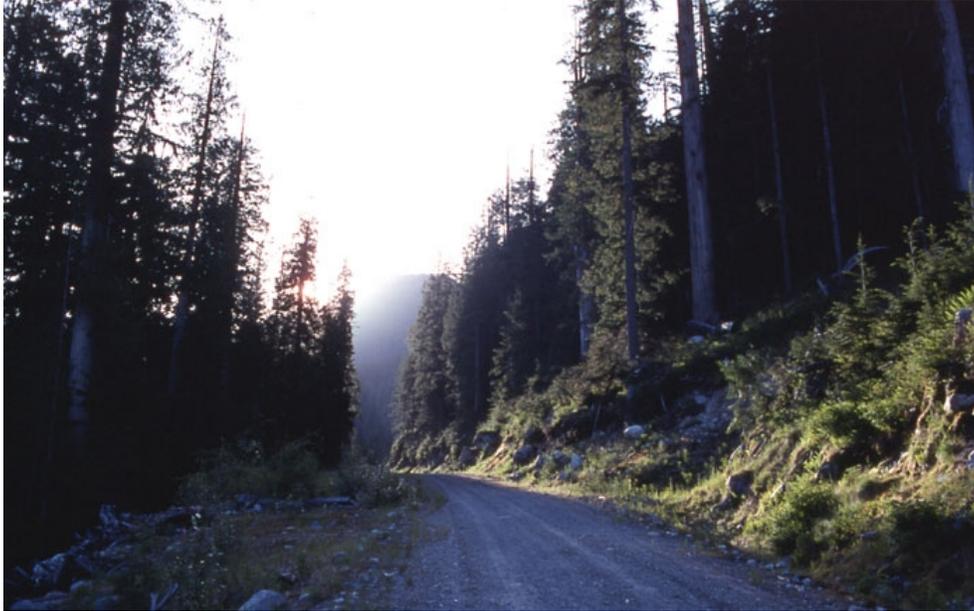
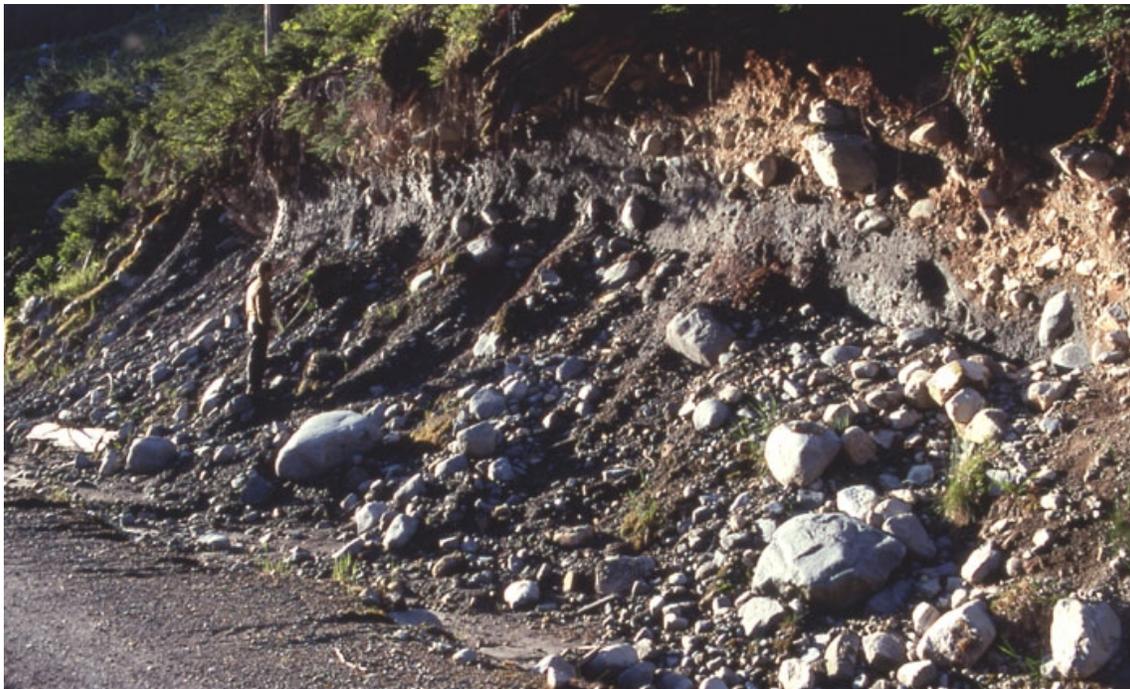
Photos showing logging road on south side of Eastcap Creek, Capilano Watershed. This logging road, built through ancient forests, and over-top of the old Eastcap Water District trail, has exposed a number of steep cutslope materials. Not person in bottom photo, to left, for scale.

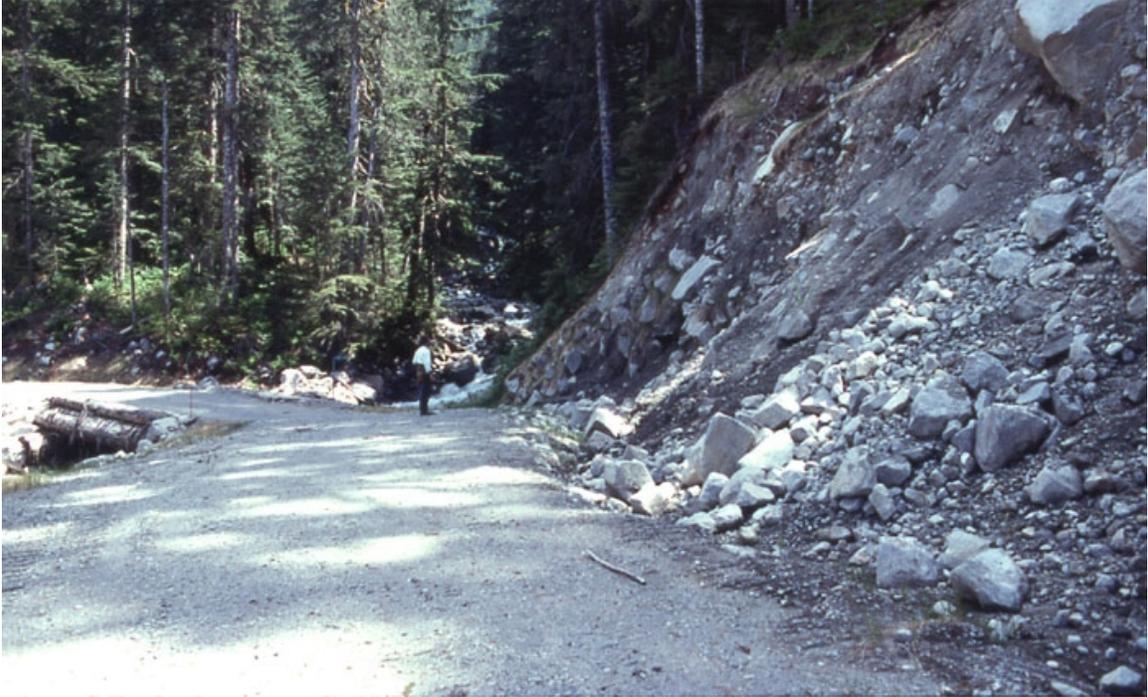
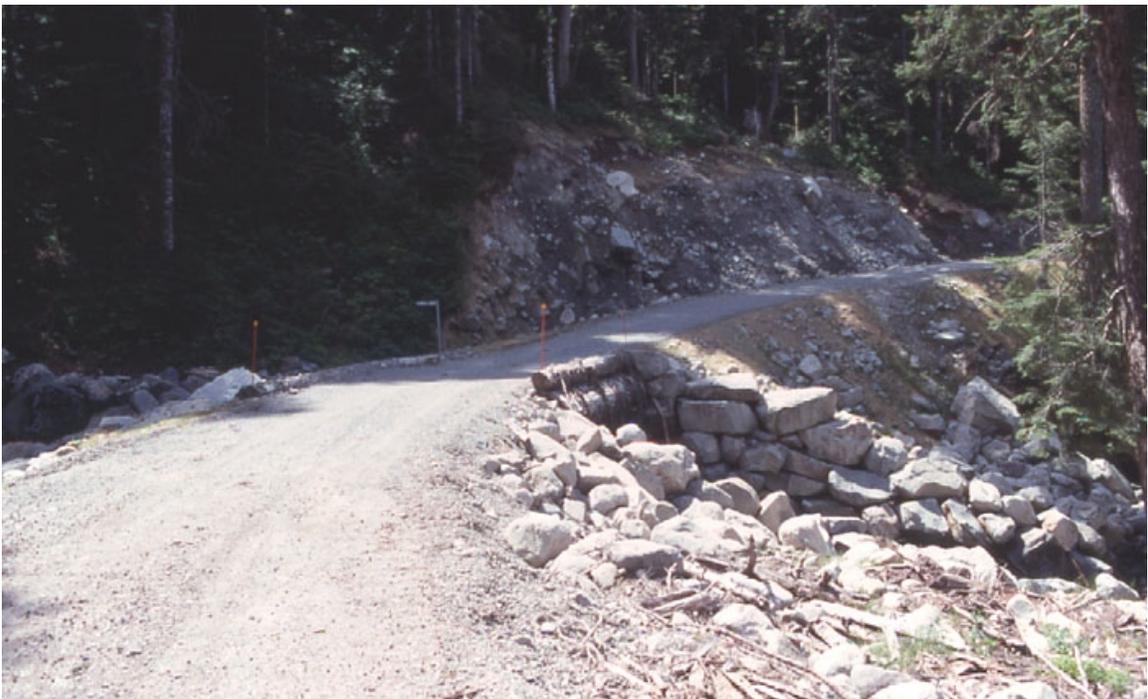
Another large cutslope at upper end of Eastcap logging road, next to Cypress Creek. Note person in upper photo, on logging road, for scale. These sediments are routinely washed into the Capilano River during heavy rainstorms. Photo below shows same area, but from another angle across Cypress Creek bridge.

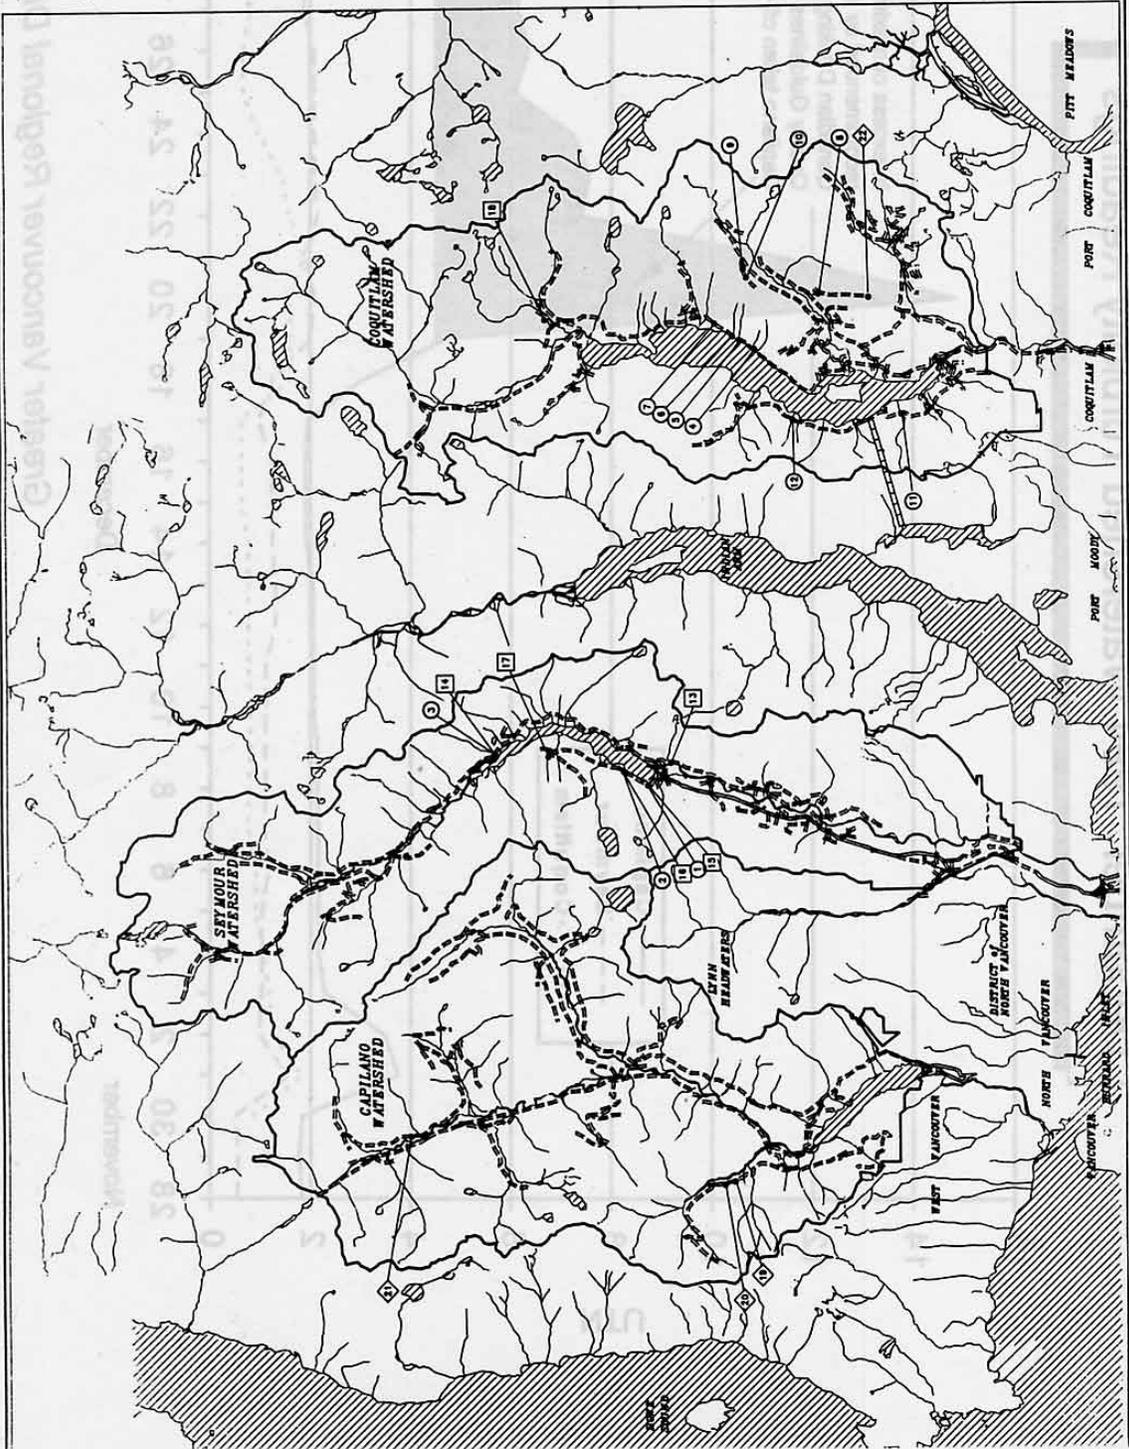
**GVWD WATERSHED MANAGEMENT
NOVEMBER and
DECEMBER 1994
LANDSLIDE LOCATIONS**

- November 25-30, 1994
- December 16-21, 1994
- ◇ December 26-28, 1994

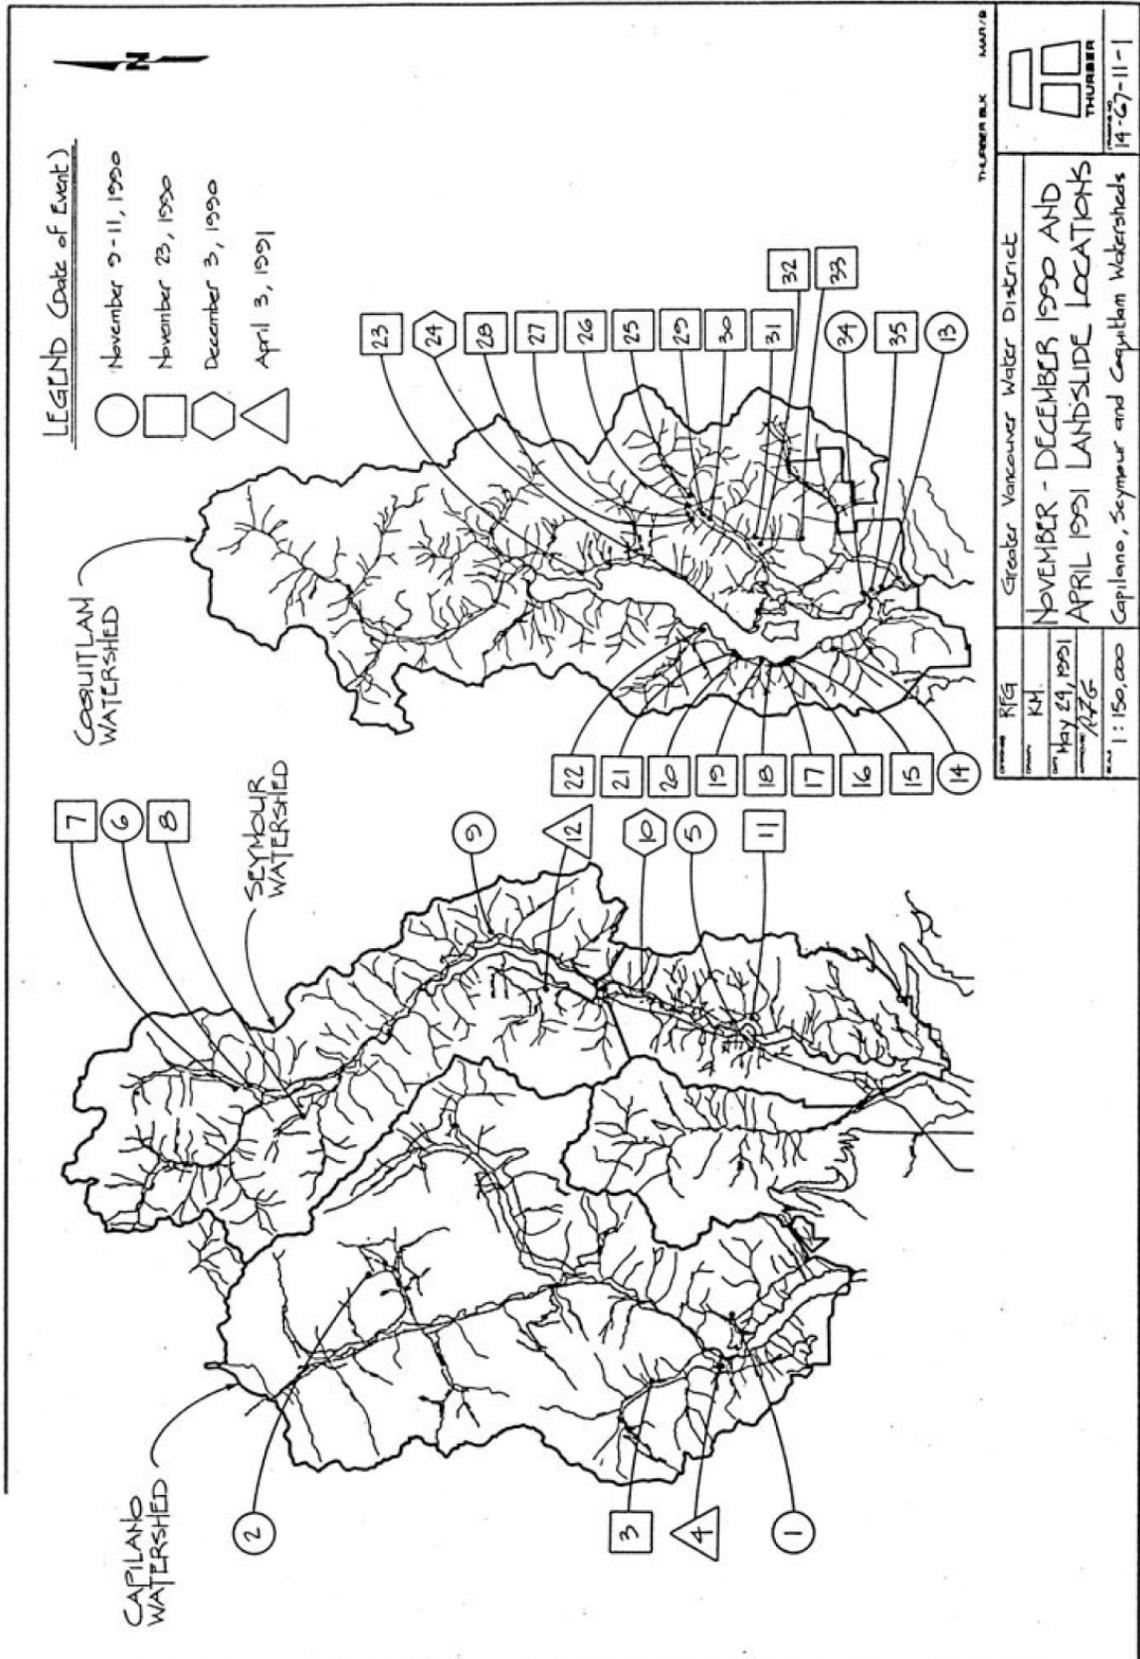
1990/1991 THURBER LANDSLIDE MAP

THURBER BLK	MAP 7/9
Greater Vancouver Water District	
NOVEMBER - DECEMBER 1990 AND	
APRIL 1991 LANDSLIDE LOCATIONS	
Capilano, Seymour and Coquitlam Watersheds	
Scale	1:150,000
Date	May 29, 1991
Author	RWG
Project	KM

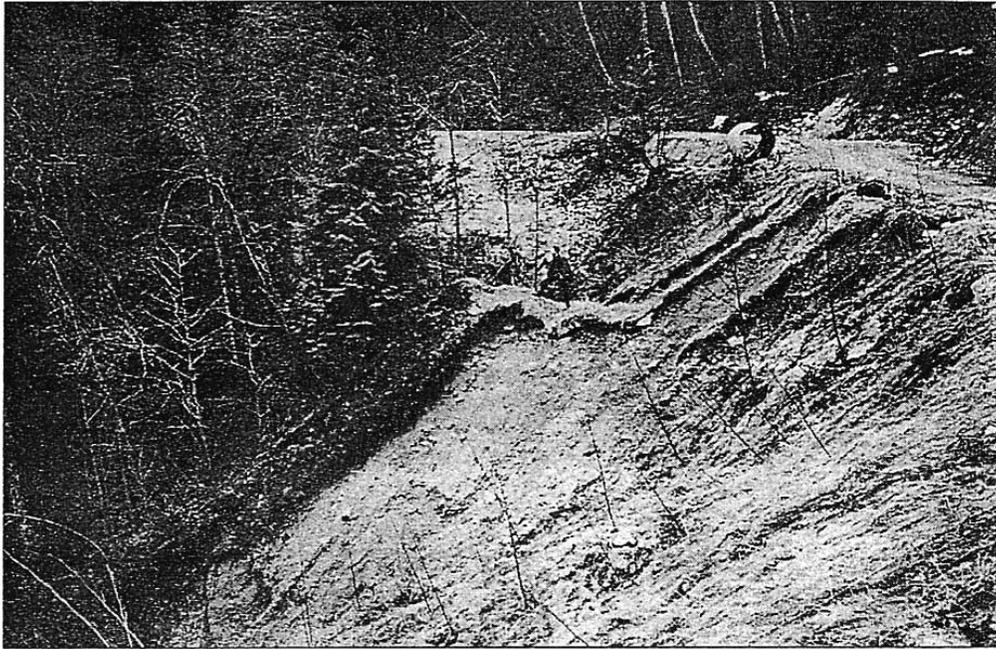
A SLIDE at the Hollyburn spur road last year brought debris down a creek feeding the Capilano reservoir, according to environmentalist Will Koop.

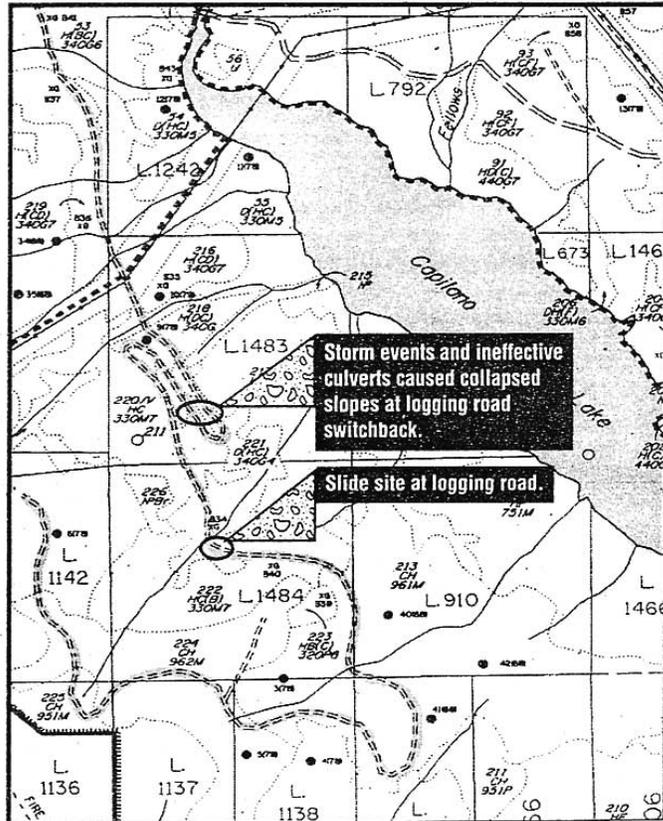
ENVIRONMENTALIST WILL Koop has identified numerous slides at a Capilano watershed logging road.
