The Chilcotin River Landslide: Potential Links to Commercial Logging

By Will Koop
August 6, 2024 (third update)

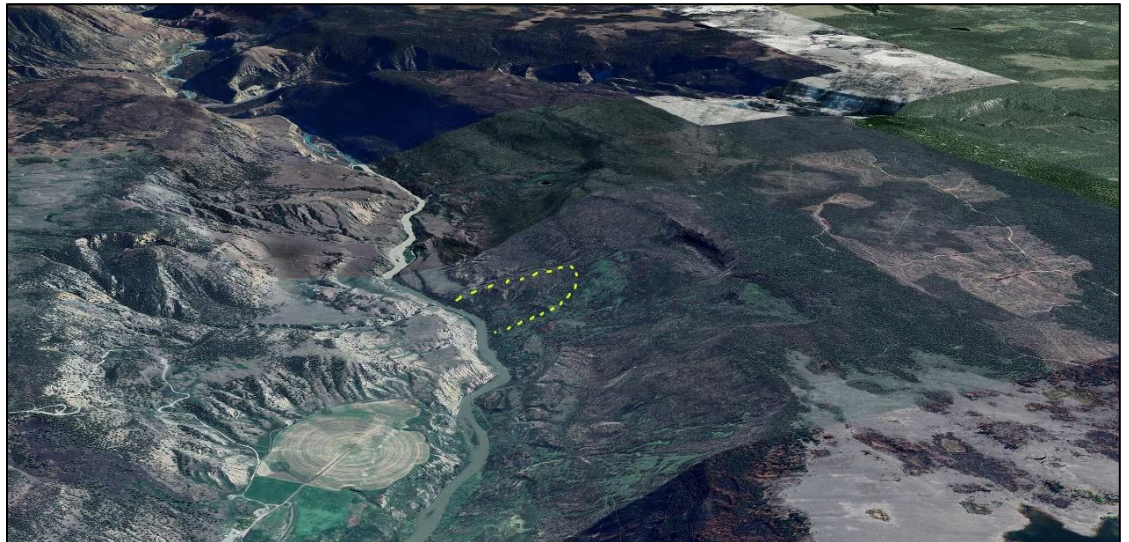
I then created four images from different perspectives from Google Earth online satellite data and plotted the zone of the landslide on each. I noted that the Google Earth imagery was dated from October 2021, and that the fresh logging taking place, showing multiple piles of fresh logs, was incomplete.

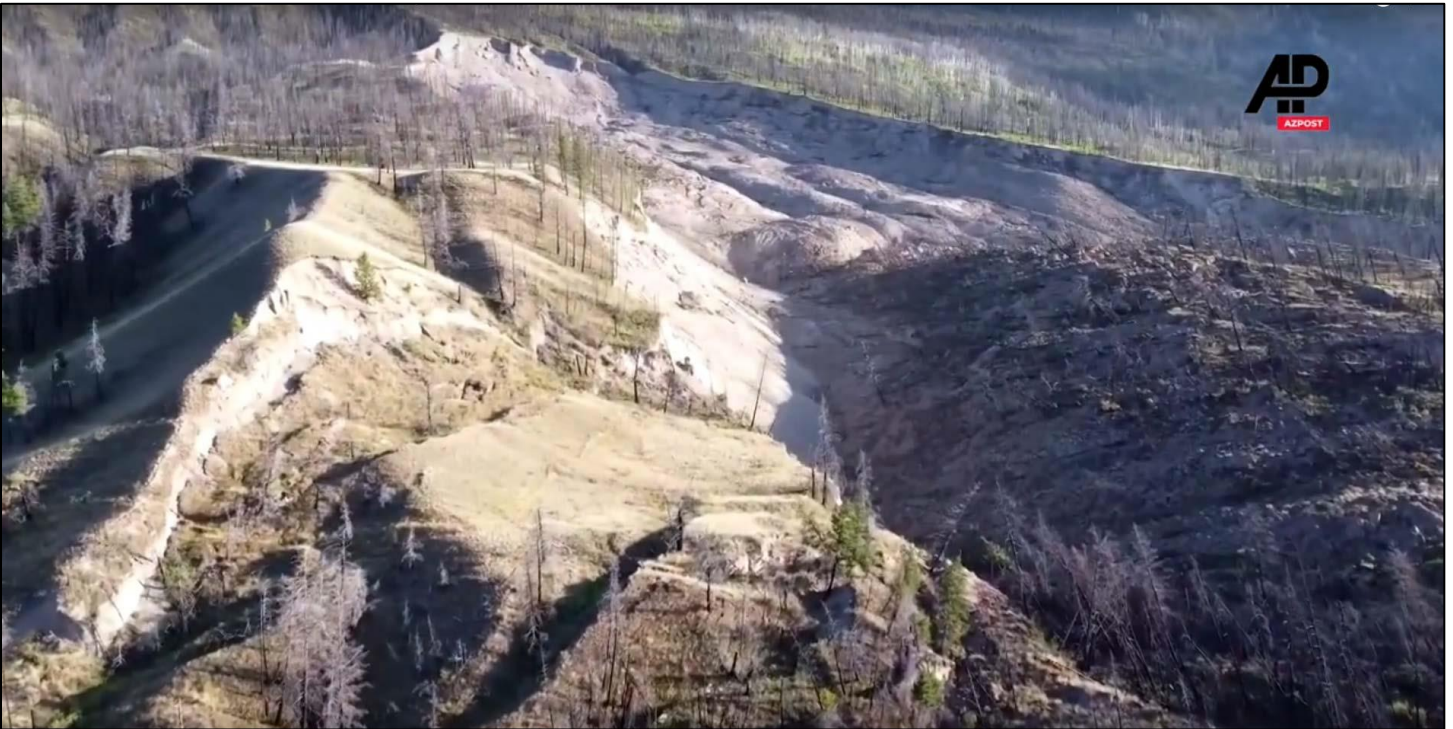
The above photo, and the photo below, are snapshots from a drone flight video. The top photo shows the slope profile, revealing that the slope is gentle to moderate, and not “steep” as reported in some news stories.

Given the fact that the slope is gentle to moderate, there was something in the upper profile area of the debris slide that induced the slope to fail.

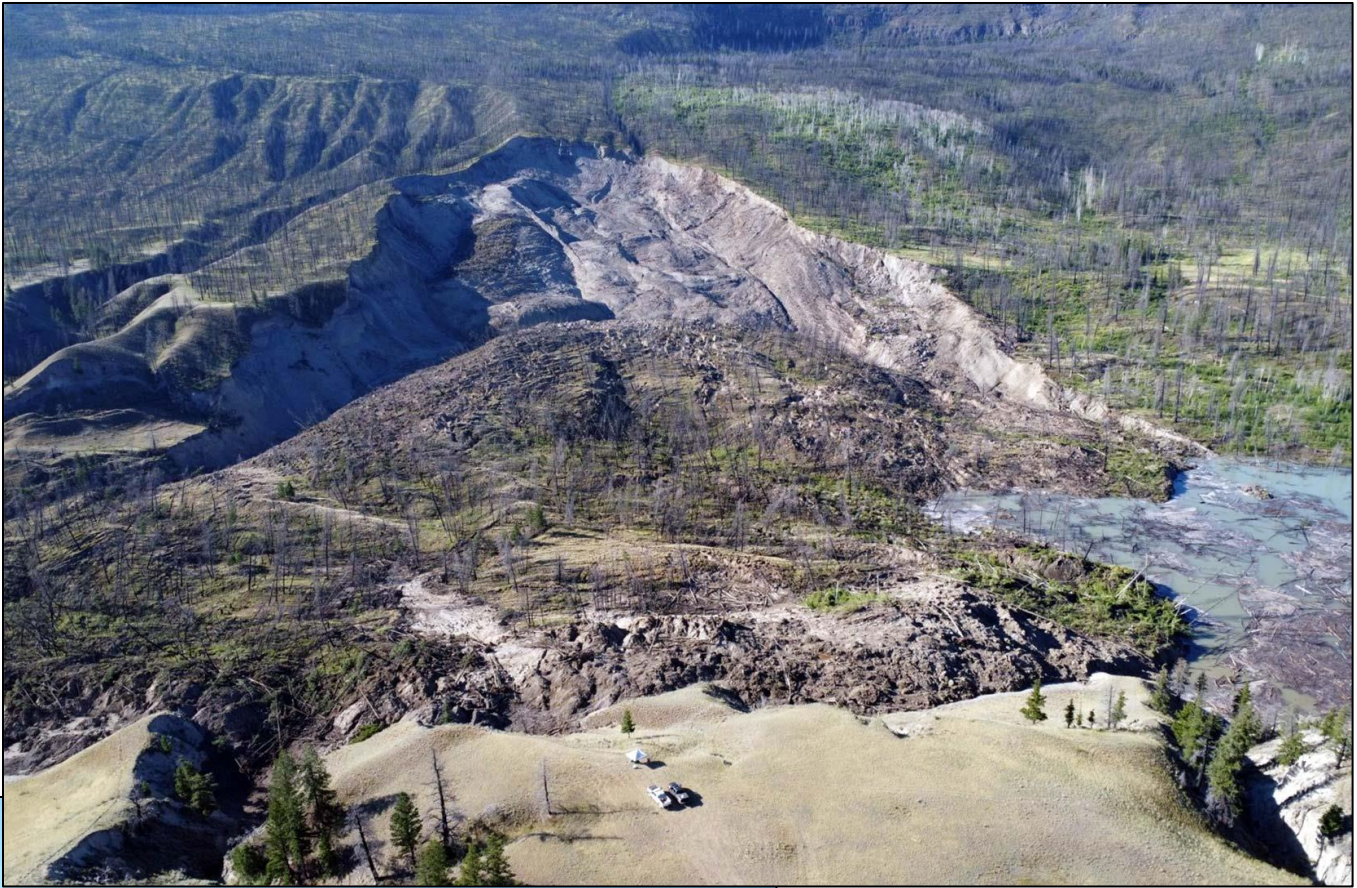
In the top photo, note the middle of the top of the slide area. You can see an entry channel of small stream (see close-up photos on next page). The stream channel curves back to the right onto the lower bench, situated below the rolling plateau where the clearcuts are located.

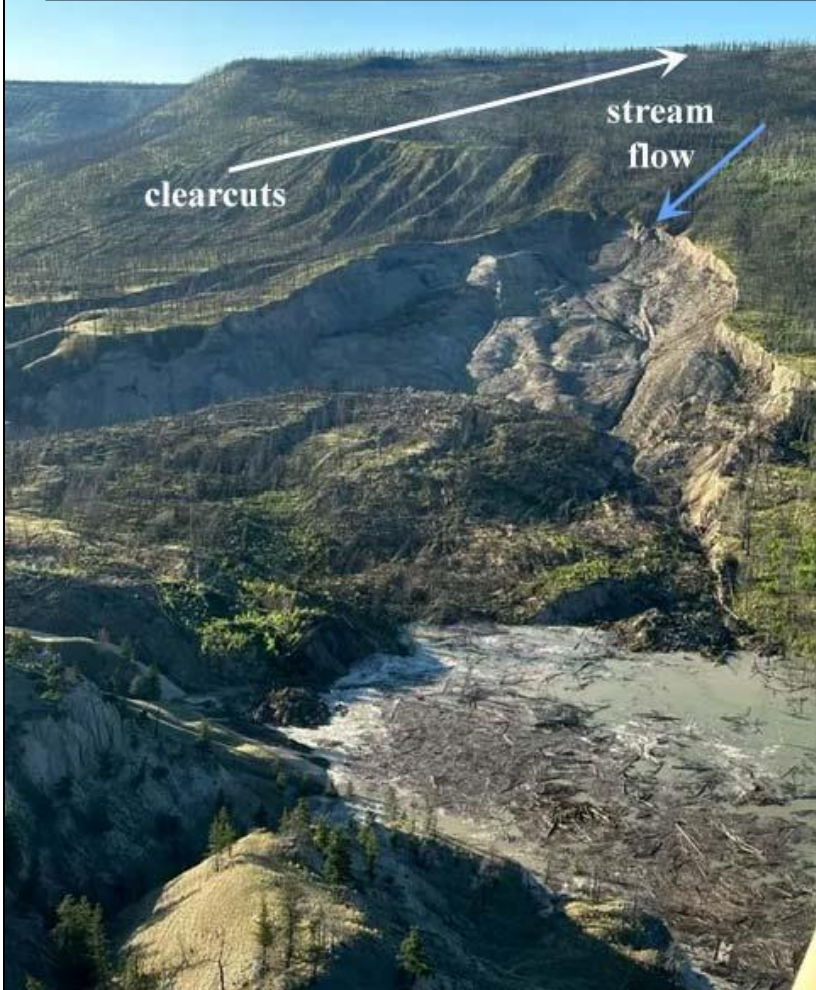
The photo on the left provides a closer view from a different angle. This photo also shows that not all the forest / forest canopy had been burned from the last fire(s). On the lower bench, above the top of the landslide area, are many standing live trees, and live trees are present in the debris slump.

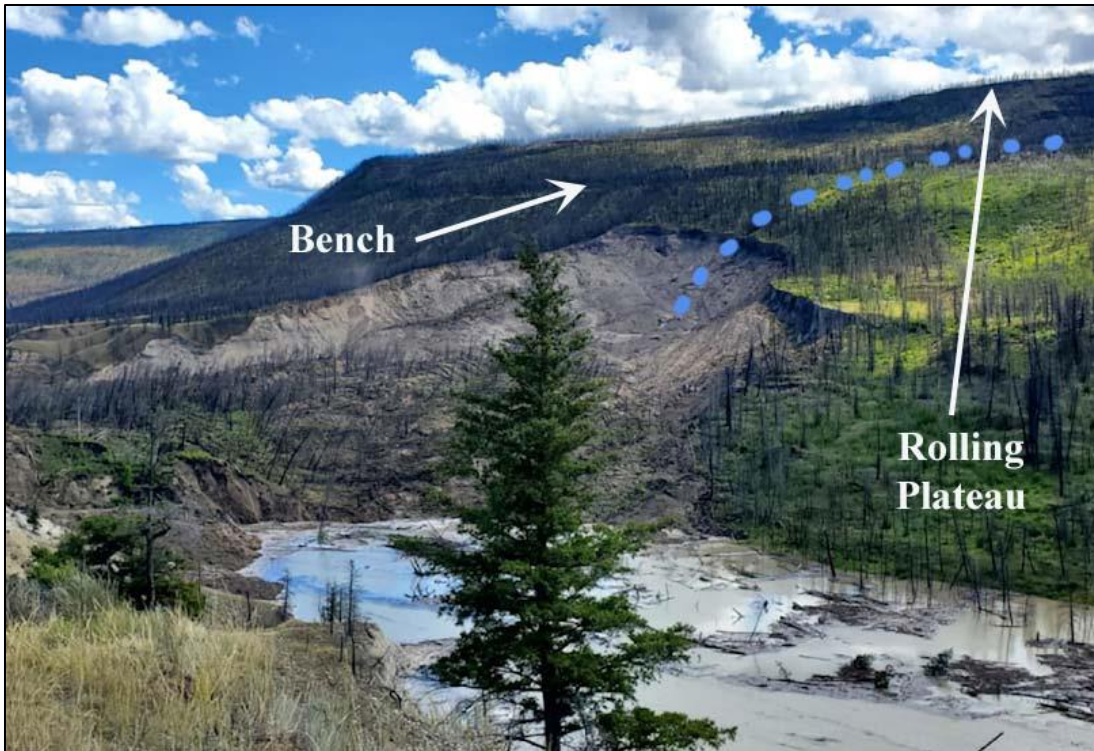
The top photo lends another perspective of the lower bench area.

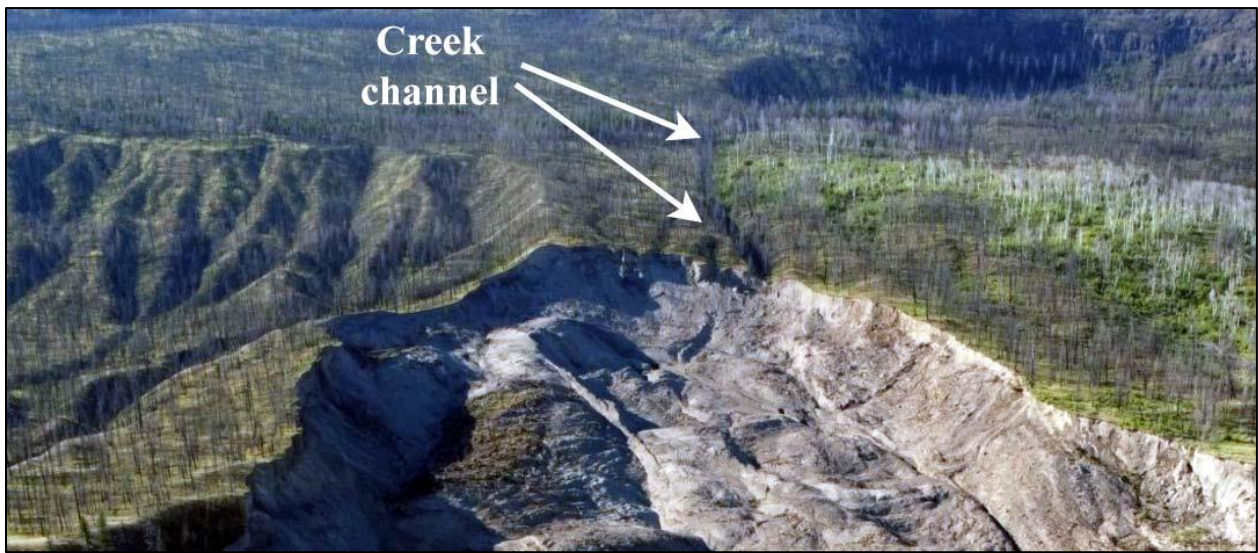
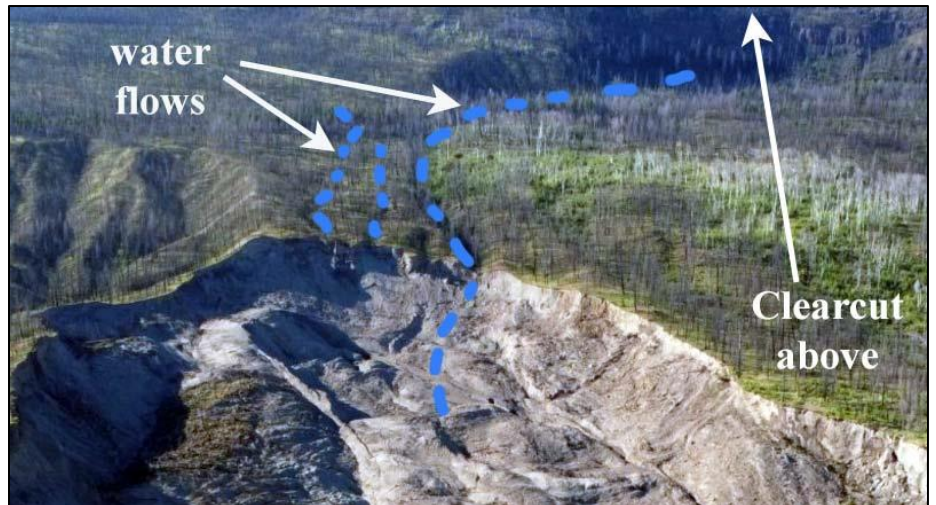
The middle and lower photos are close-up images from the top photo of the previous page. They help show the creek channel and the direction from where the creek stems.

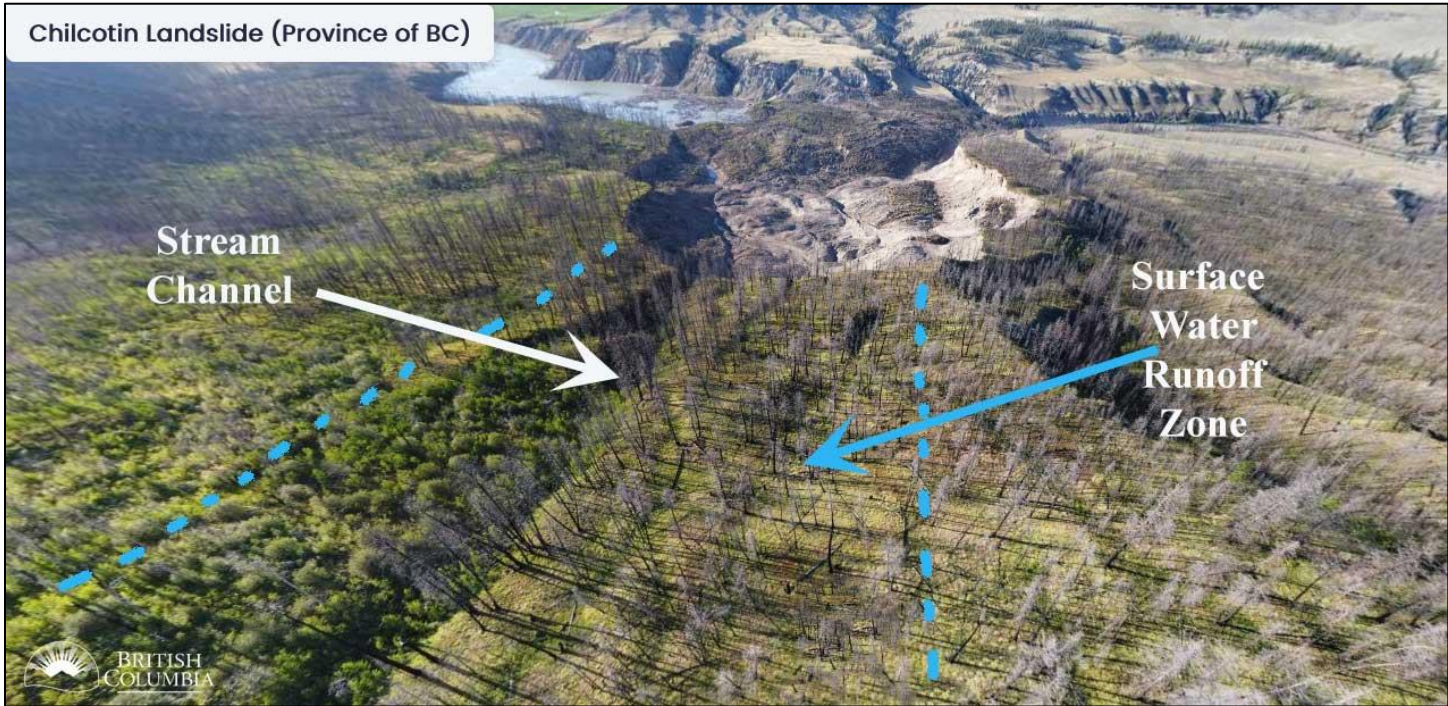
Close up of stream channel above slide (source: British Columbia province website, "EmergencyInfoBC")

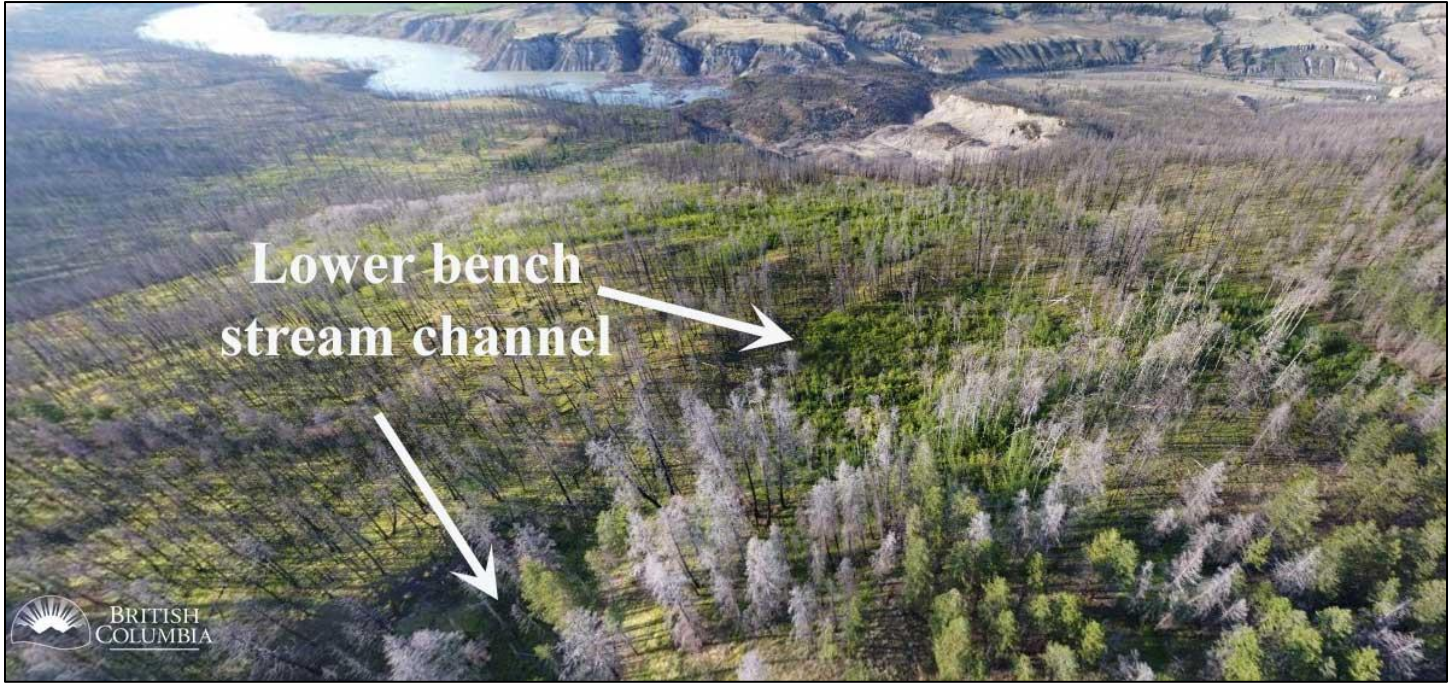
Close up of stream channel above slide (source: British Columbia province website, "EmergencyInfoBC")

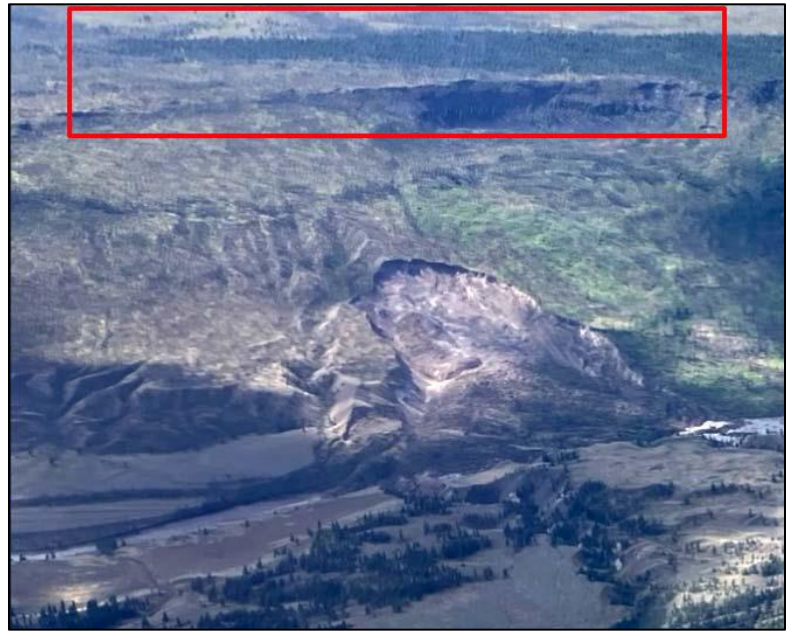
Note: For those that may have downloaded my first, second, and third reports (August 2, 3, 4), I made updates. I found an error in my second report on the afternoon of August 4, after scrutinizing a photo taken from an aircraft, the only photo (shown here to the right, with the red outline) I could find showing both the upper plateau and landslide areas. I noticed that the standing forest on the plateau on that photo was different than the information that I had collected from IMAP BC. The error made was a misunderstanding of the provincial map layer cutblock category, “consolidated cutblocks,” which is different from the “active cutblocks” category. The “consolidated” shows both active and future cutblocks, and the other only “active.” I have made the appropriate corrections.
